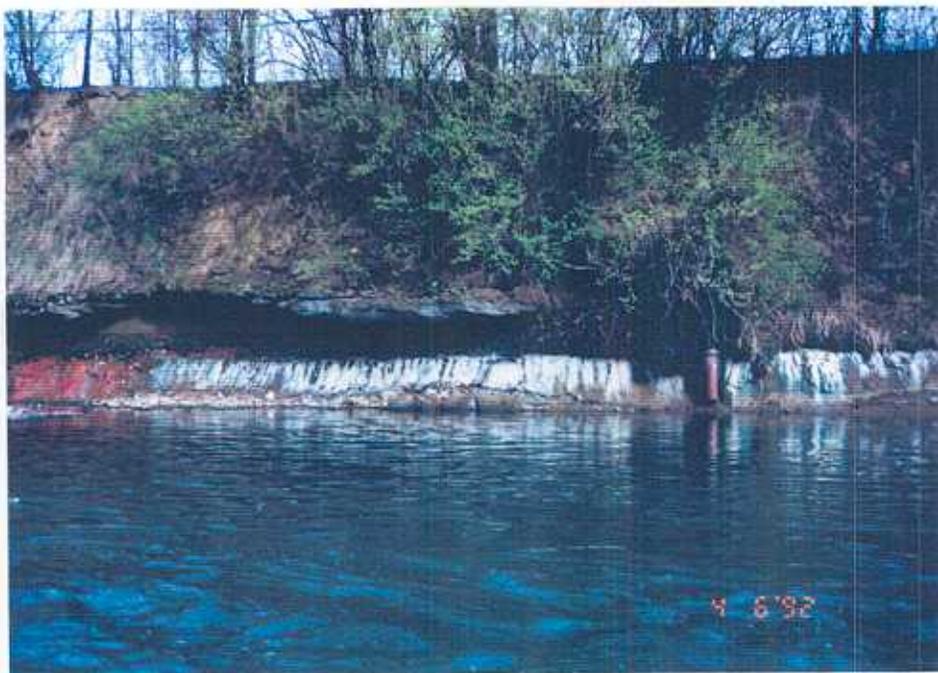
Plate 1. Seeps emanating from the banks of Mill Creek mainstem from potential hazardous waste sources. *Top Photo:* Multi-colored seep staining the bank of Mill Creek near Pristine/Cincinnati Drum property near Reading. *Bottom Photo:* Seep staining the bank of Mill Creek at the Ridgewood Arsenal site near Seymour Avenue in Cincinnati.

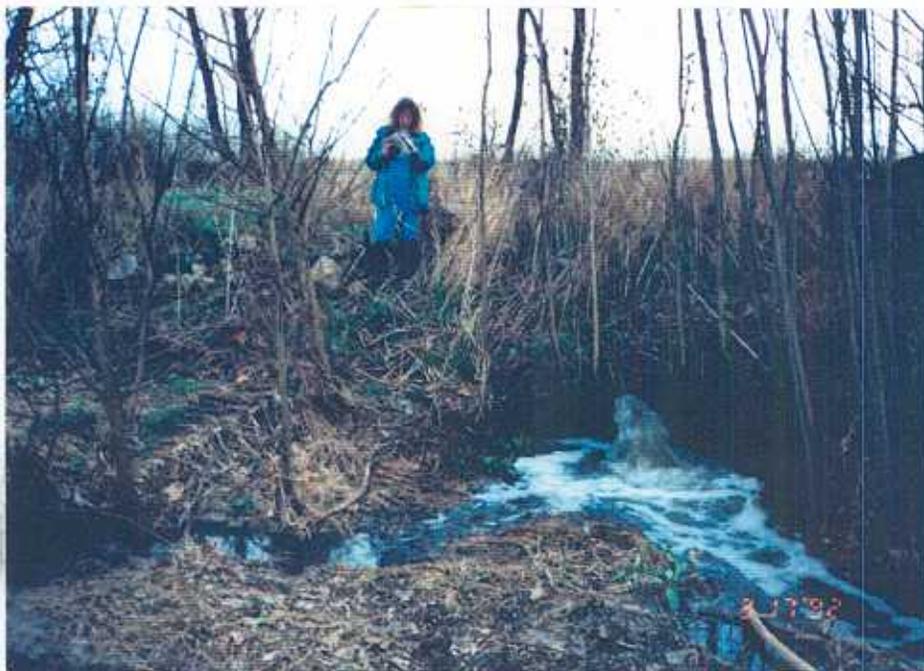
Plate 2. Sewer overflows in the Mill Creek basin. *Top Photo:* Raw sewage discharge to Mill Creek from broken sewer line cleanout at Windisch Road. *Bottom Photo:* Sewage solids trail leading to Mill Creek from an open manhole at the confluence of Mill Creek and Cooper Creek.

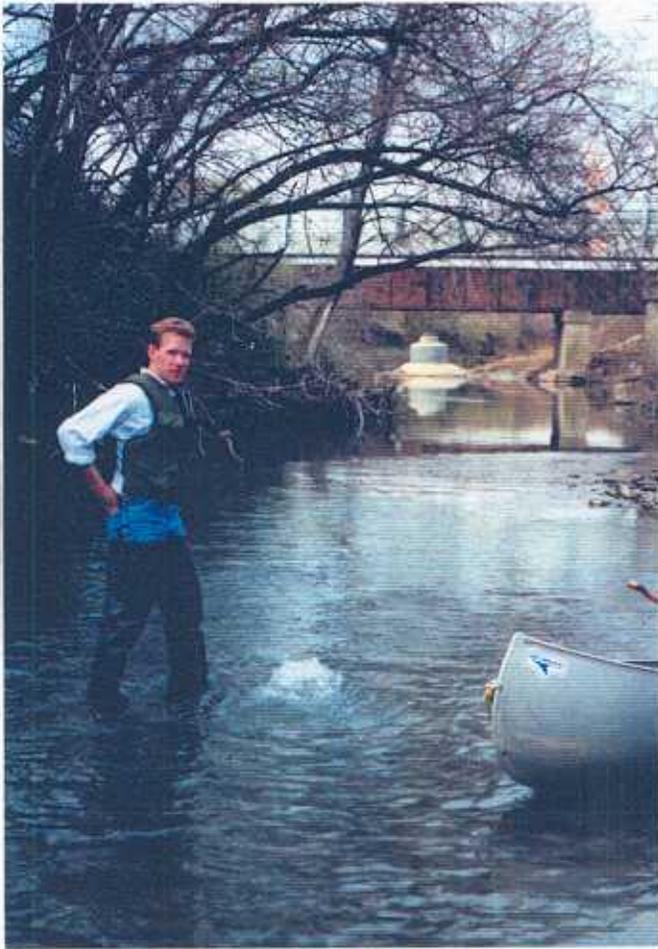
Plate 3. Sewer manhole located in the stream bed of Mill Creek discharging sewage into the stream downstream of the G.E. tributary.

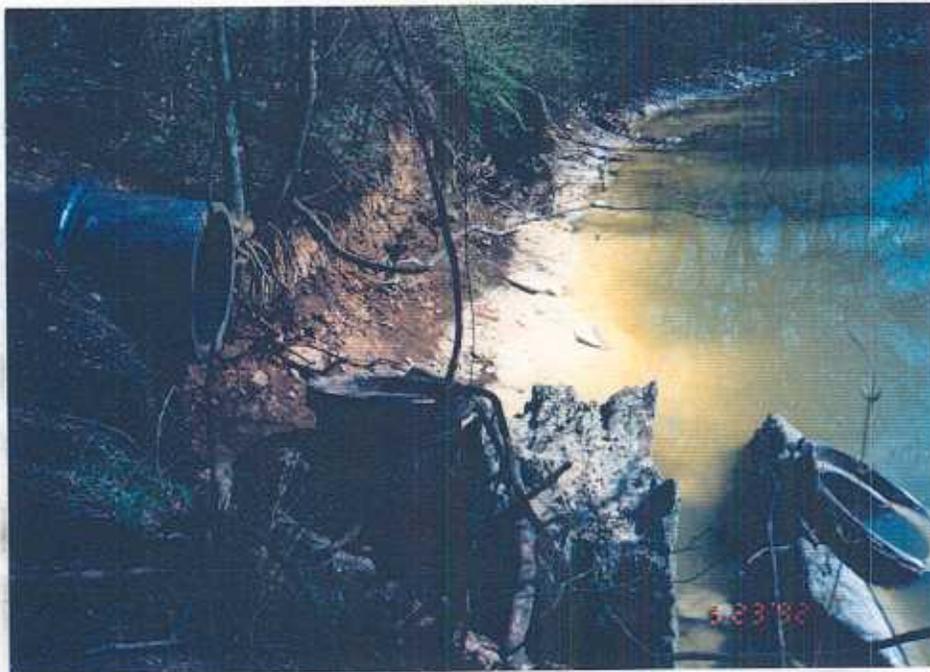
Plate 4. Remains of lime sludge from the City of Wyoming Water Treatment Plant and sewage overflows evident in West Fork Mill Creek near Gardner Park in Lockland.

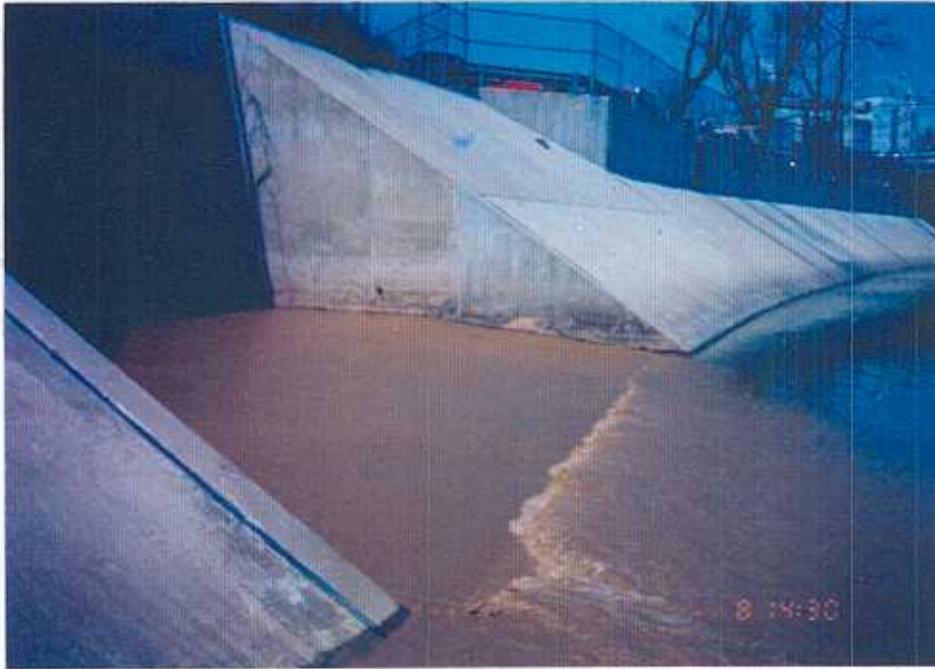
Plate 5. Discharges to Mill Creek from industrial activities. *Top Photo:* Silt laden discharge from Rack Sand and Gravel operation to Mill Creek in the concrete channel area. *Bottom Photo:* Cement discharge to Mill Creek from Plainville Concrete upstream from Clark Road. The concrete discharge had dried at the time of this photo.

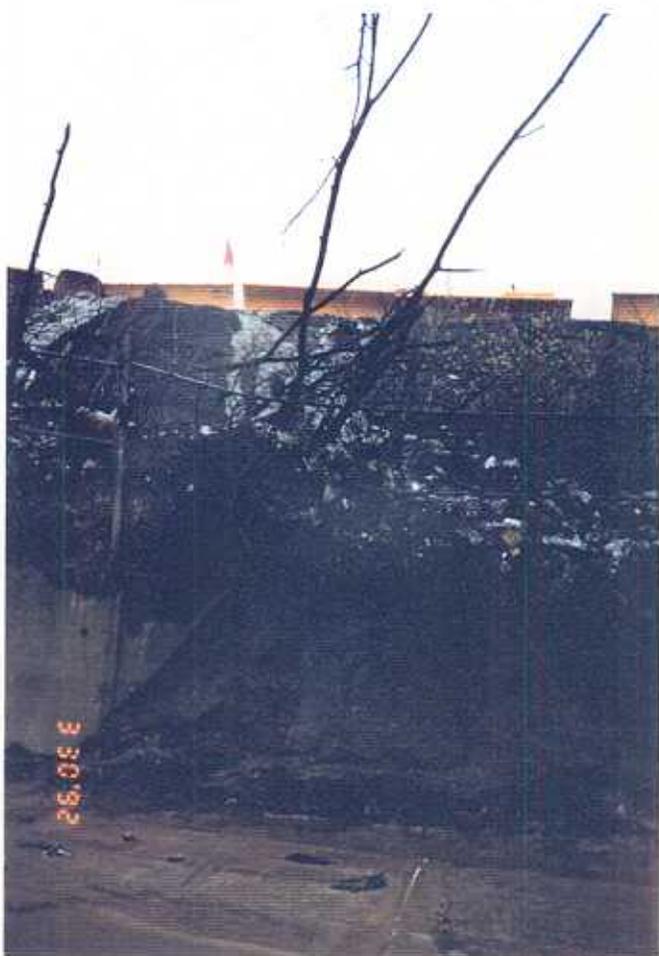
Plate 6. Asphalt, sealant and trash piled along the bank and entering the concrete channel of West Fork at the City of Cincinnati asphalt plant.

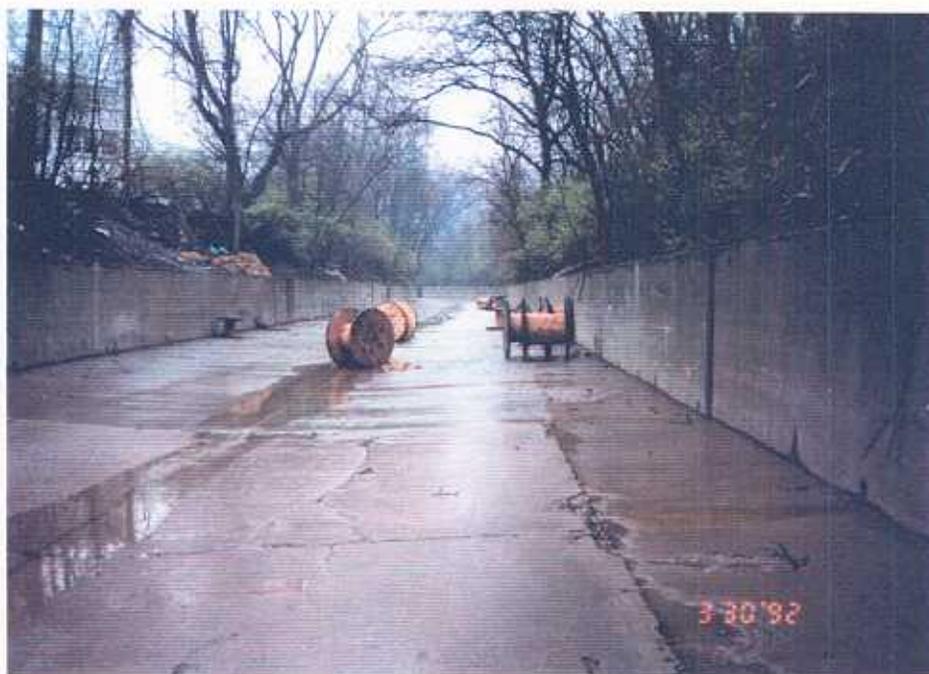
Plate 7. Large cable spools dumped into the channelized section of West Fork from a near by company.
