Coe Mfg. Site – Painesville, Ohio

An Untimely Brownfield Success Story

Tom Mignery, VAP CP
Melissa Haney, PM

Burgess & Niple, Inc

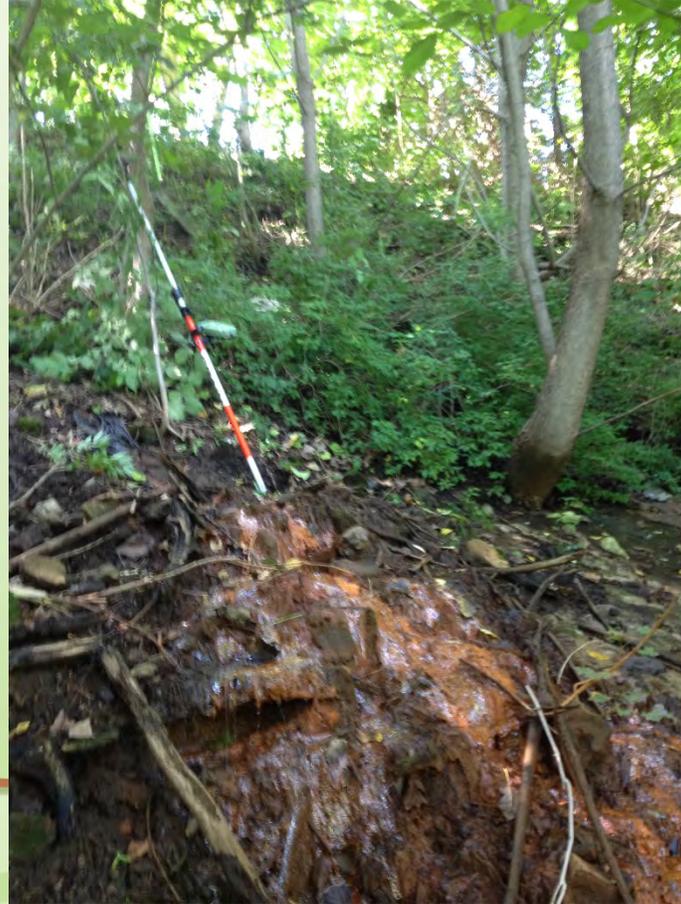
Seep looking uphill pre-remediation

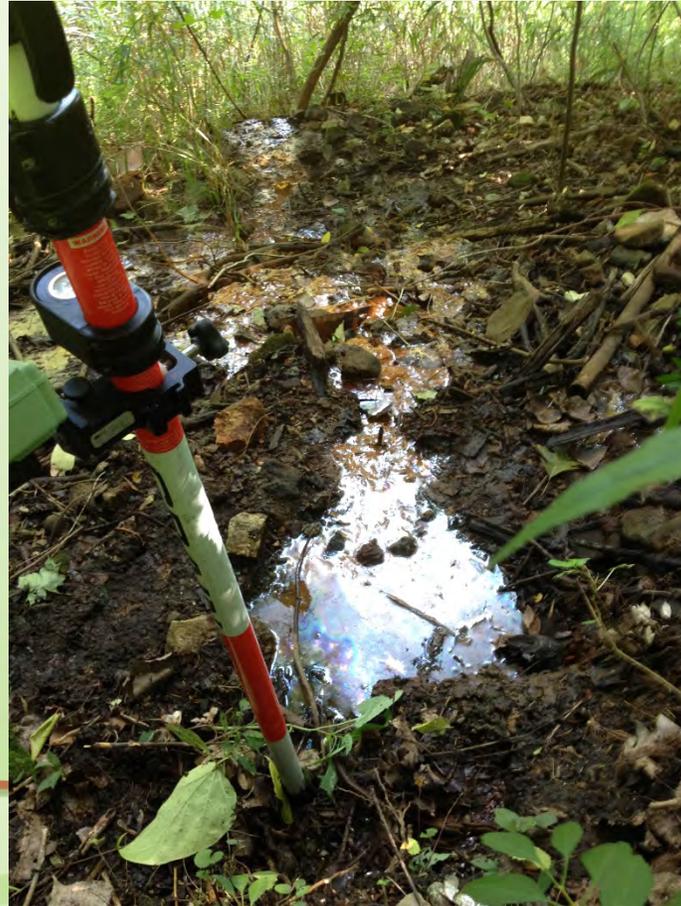
Seep looking downhill pre remediation

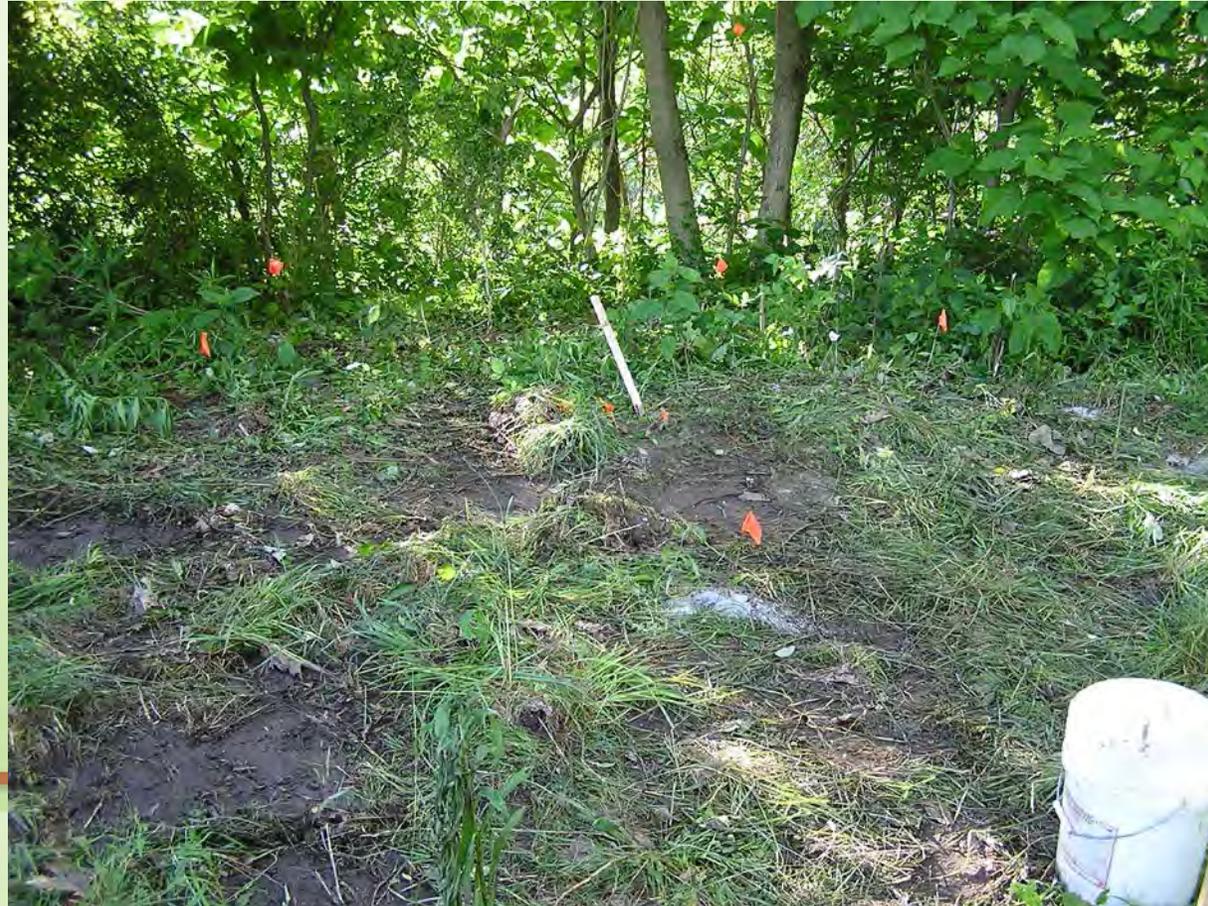
Delineating PCB impacts

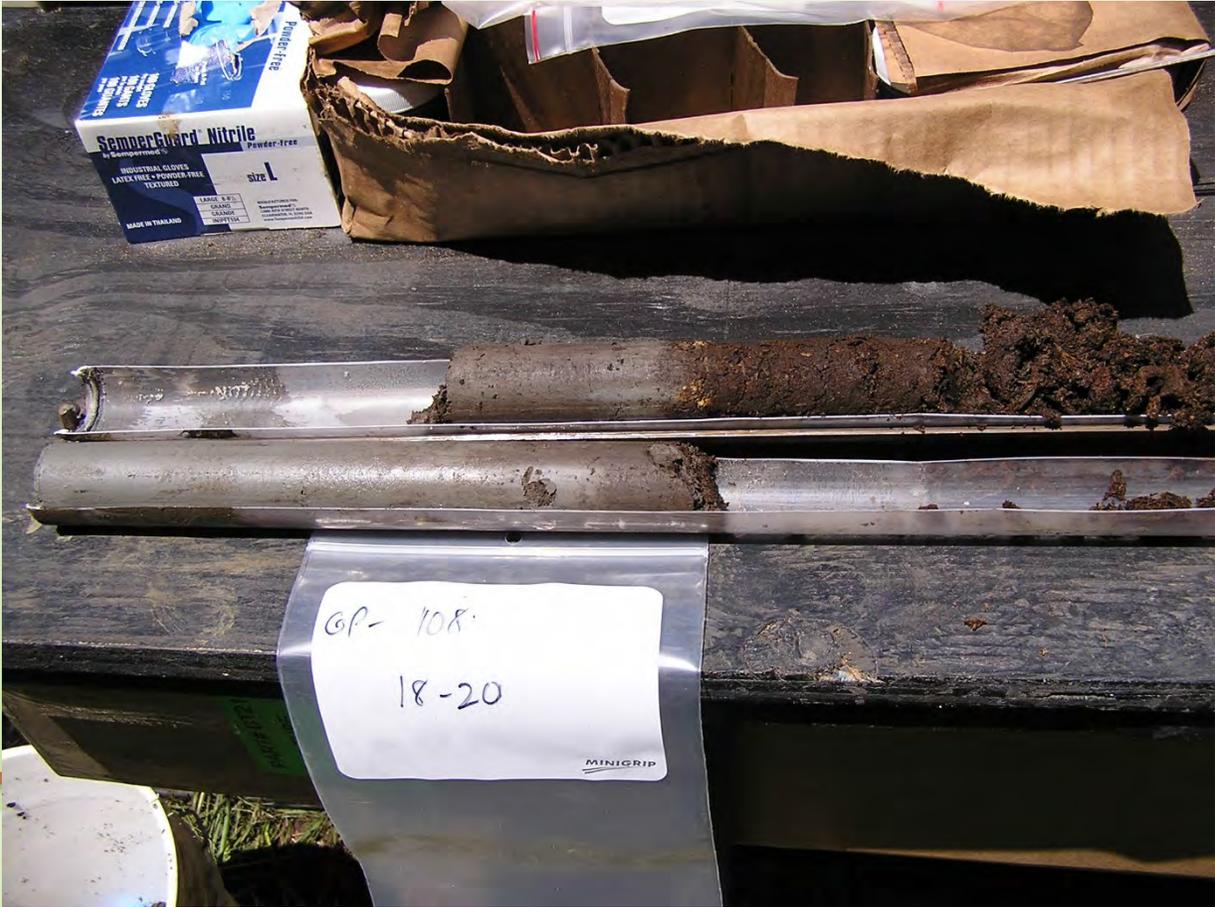
Soil sample during delineation phase

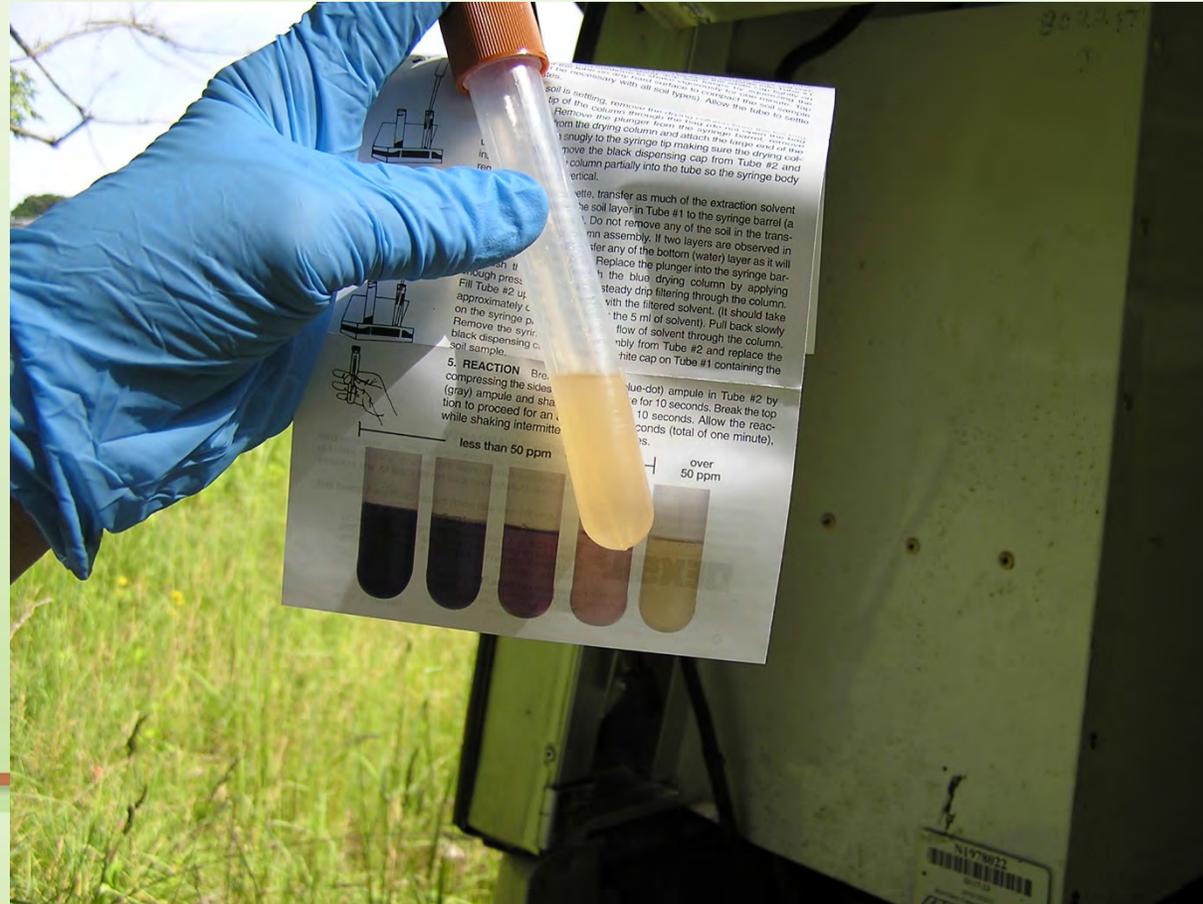
Field test kit for PCBs

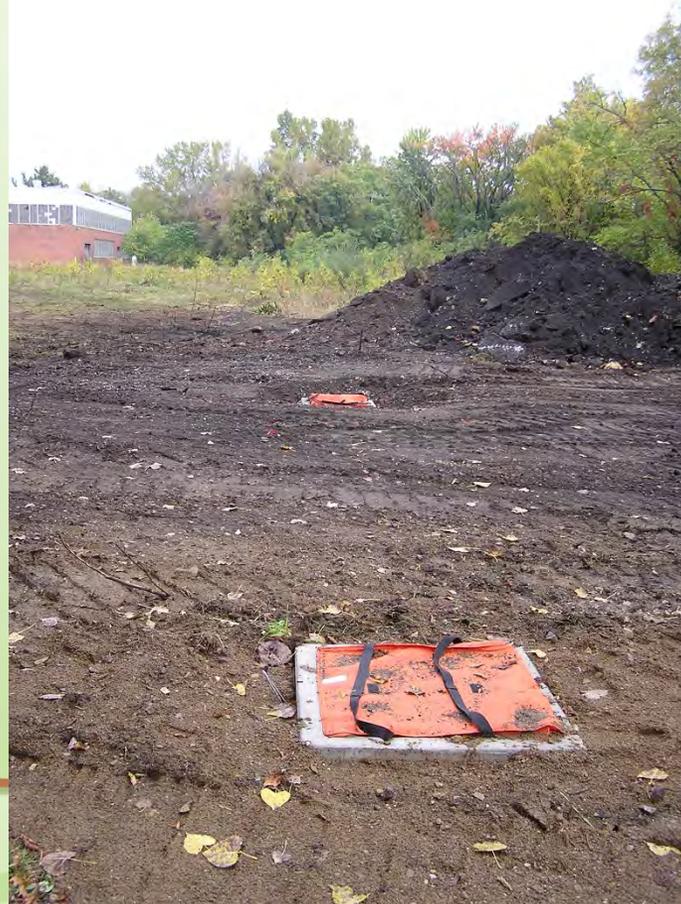
Reroute storm drain–Don't forget about Stormwater!!!

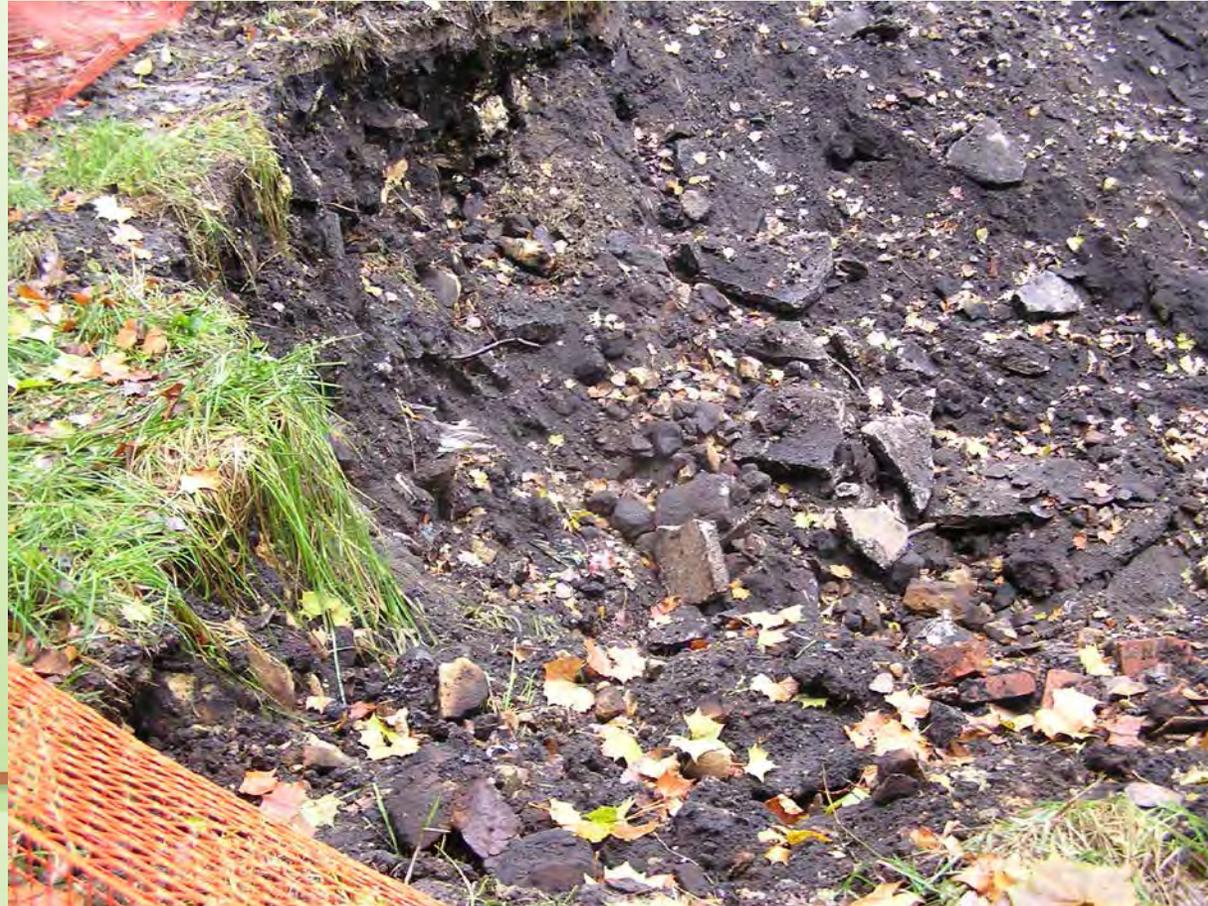
Excavating the first 12 feet and stockpiling

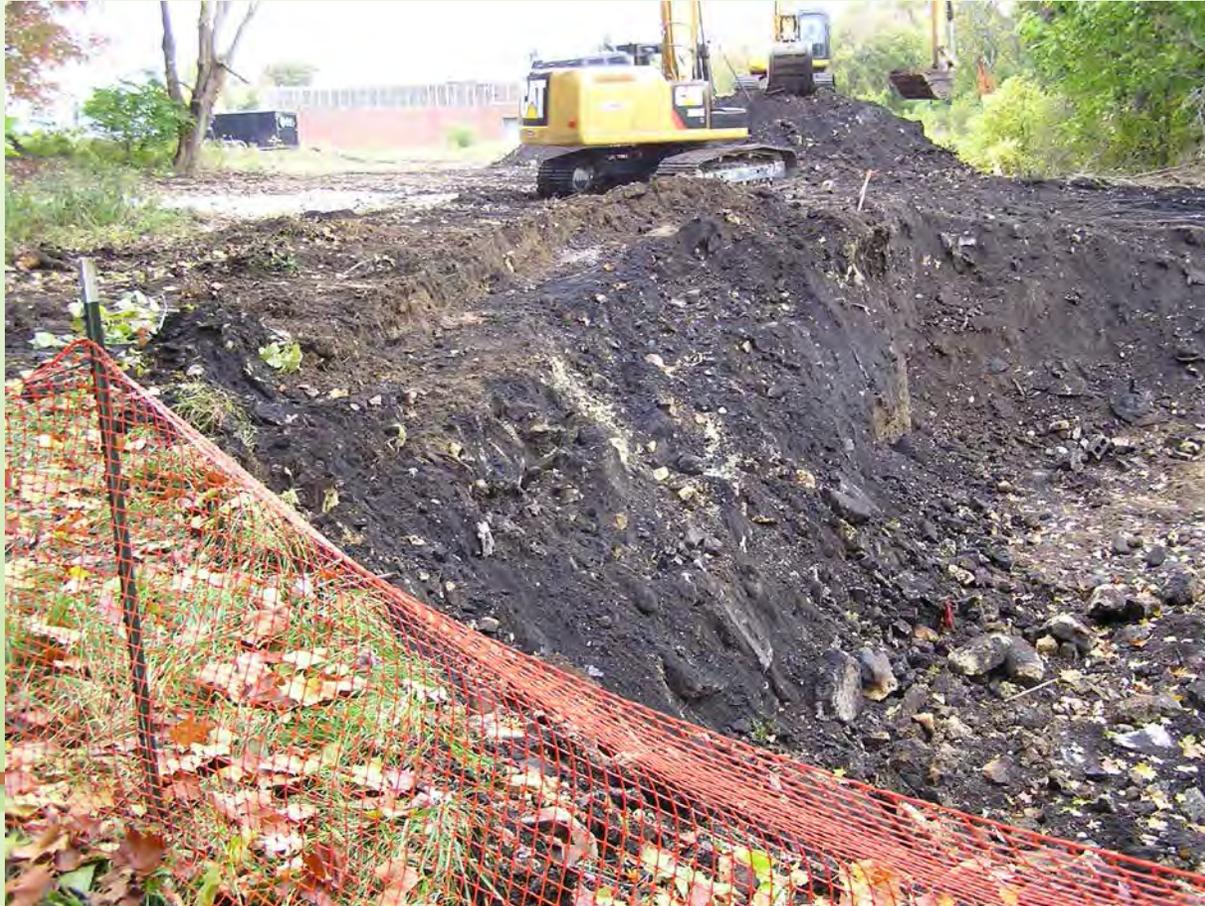
Stockpiling first 12 feet

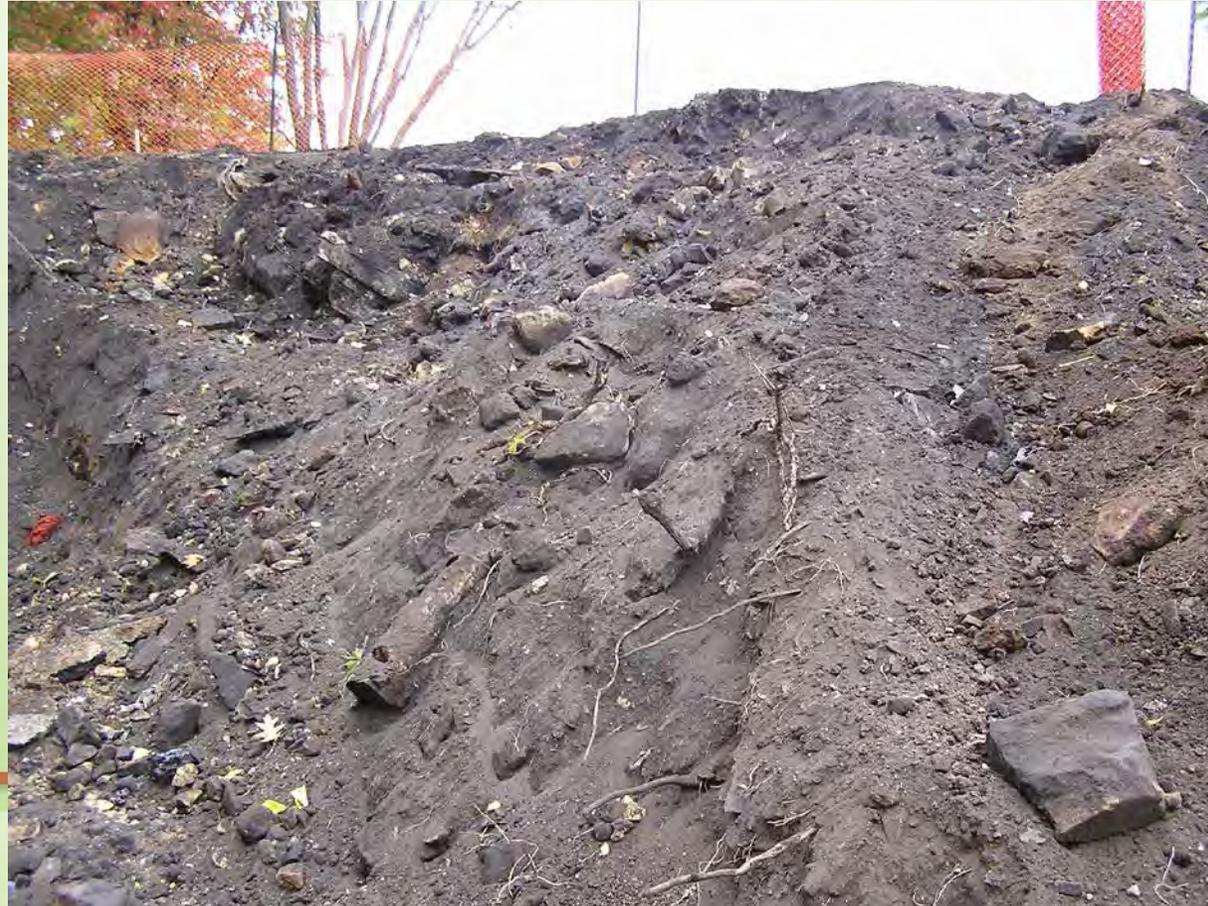
Fill materials in excavation

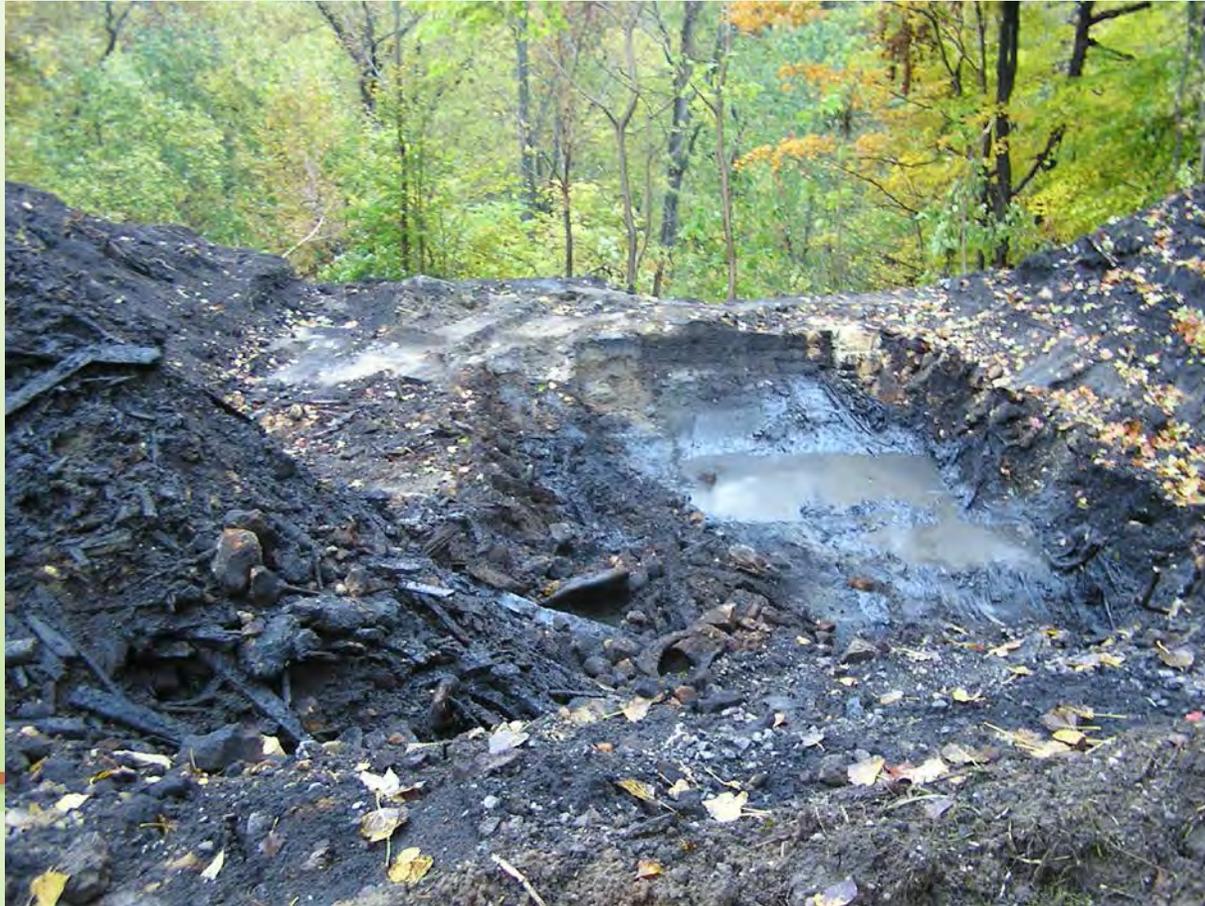
Removing contaminated materials

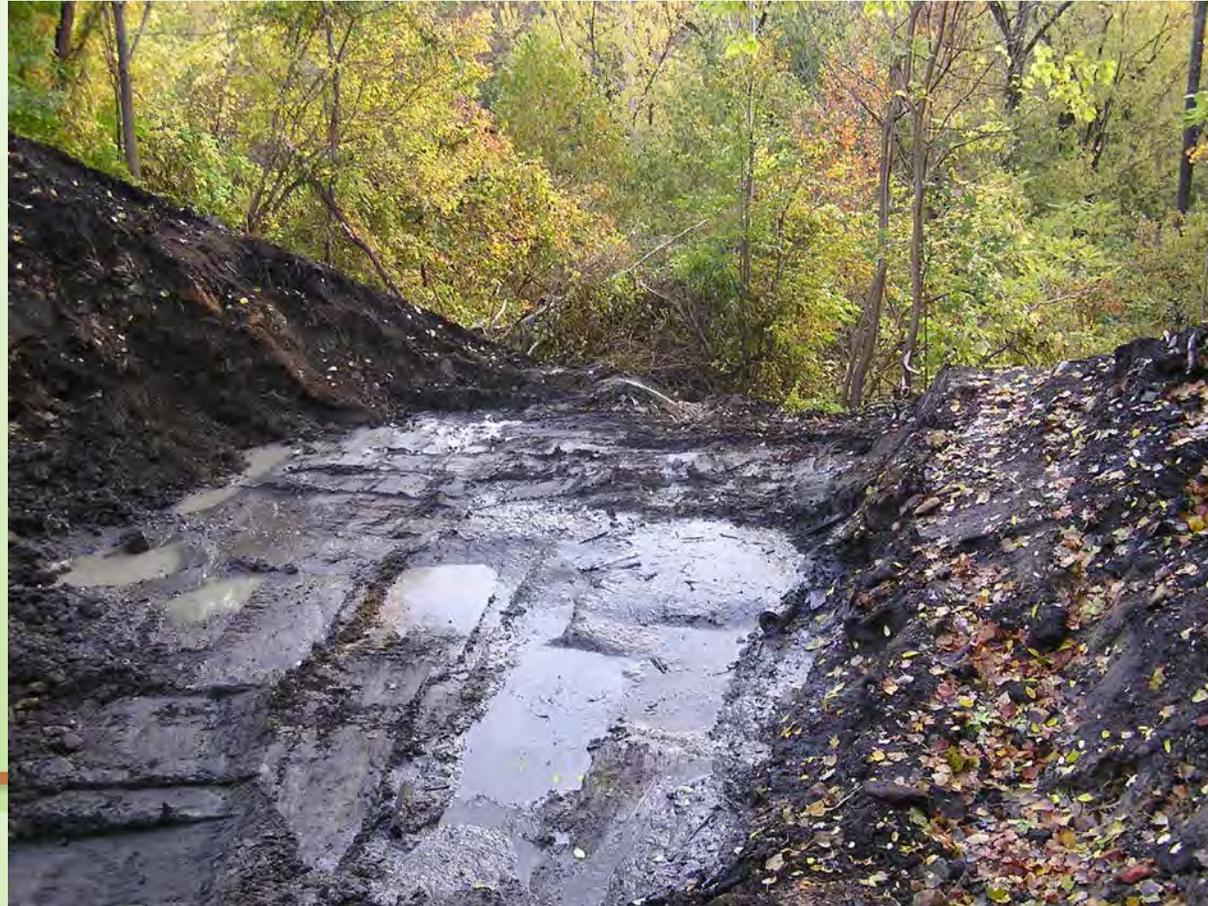
Bottom of Excavation

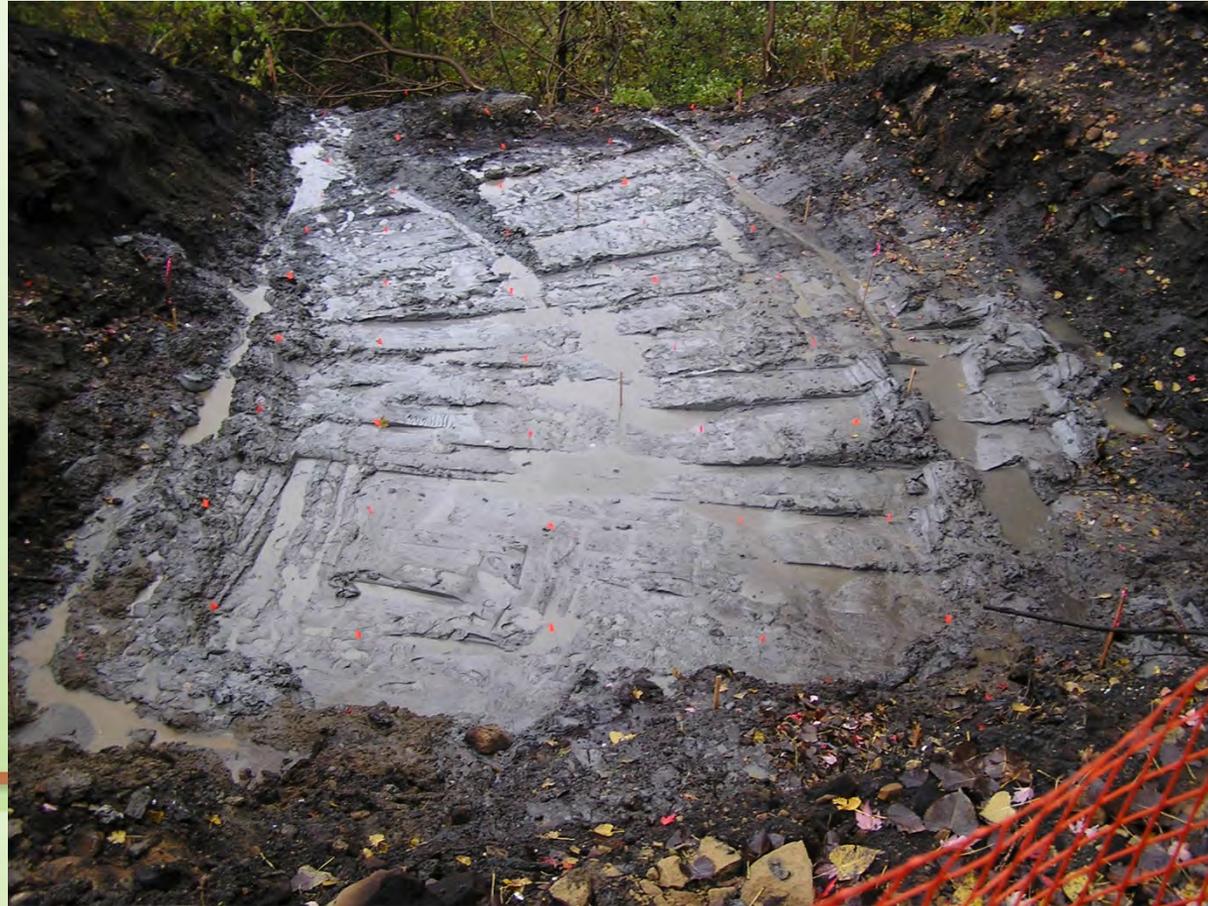
Excavation sampling grid

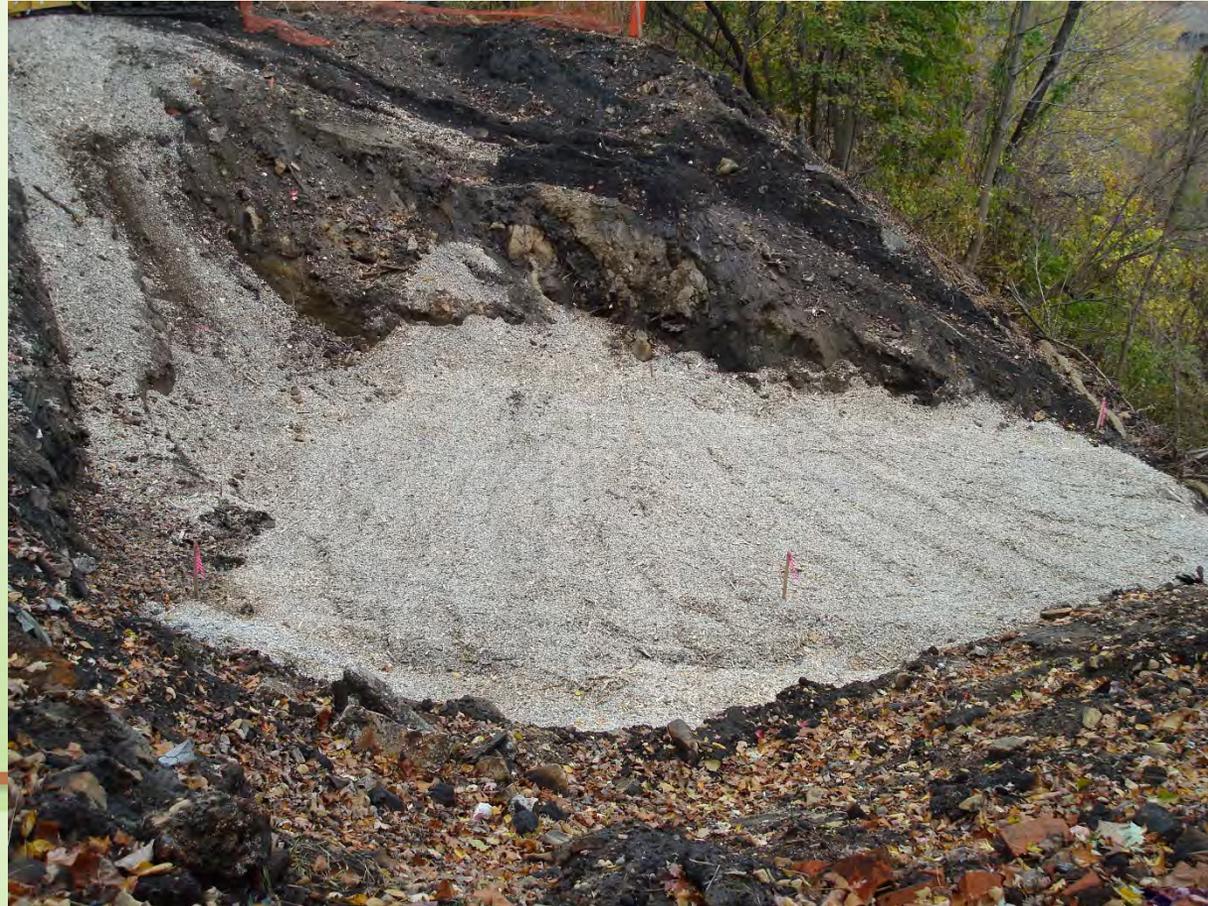
Adding backfill to excavation – wood chips, molasses for fertilizer and gravel

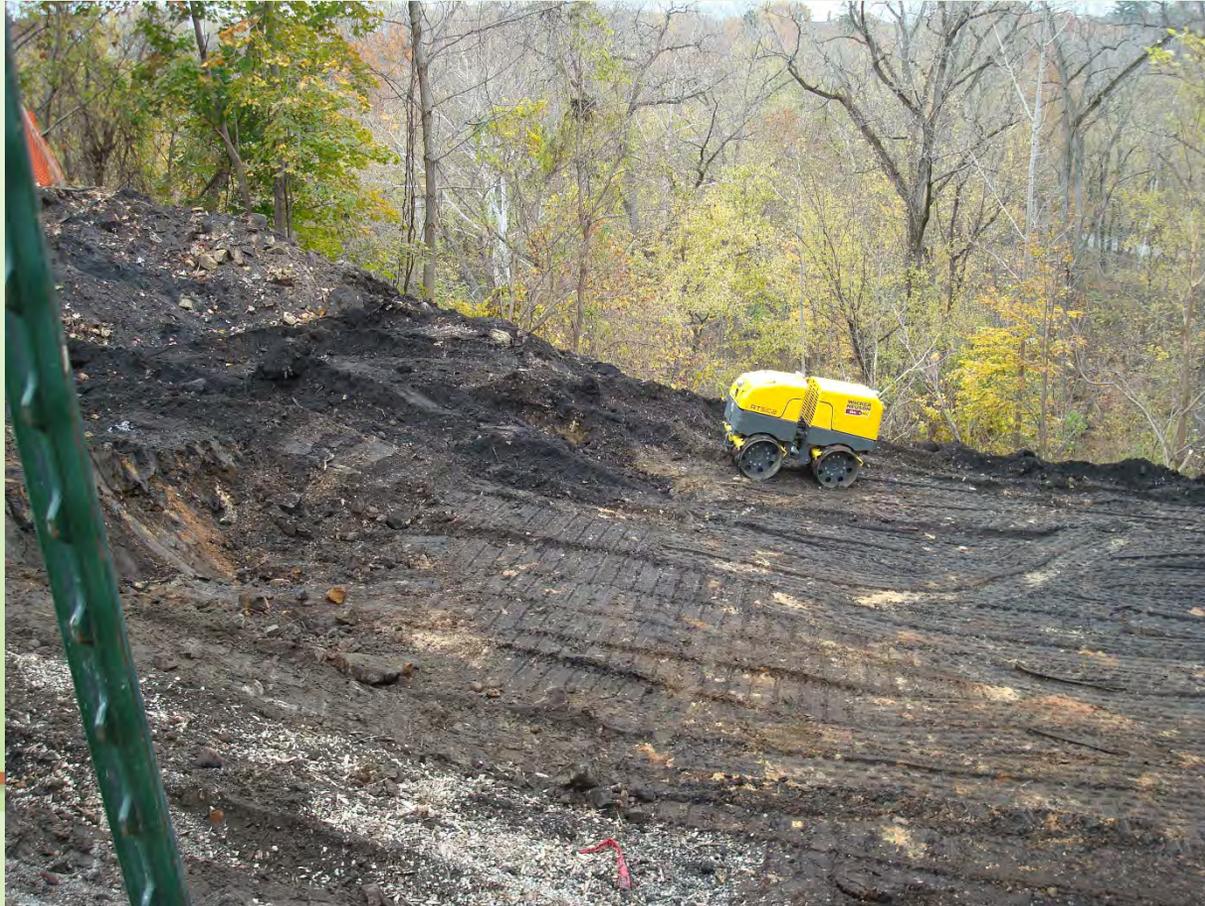
Compacting backfill in excavation using remote powered equipment sensitive soils

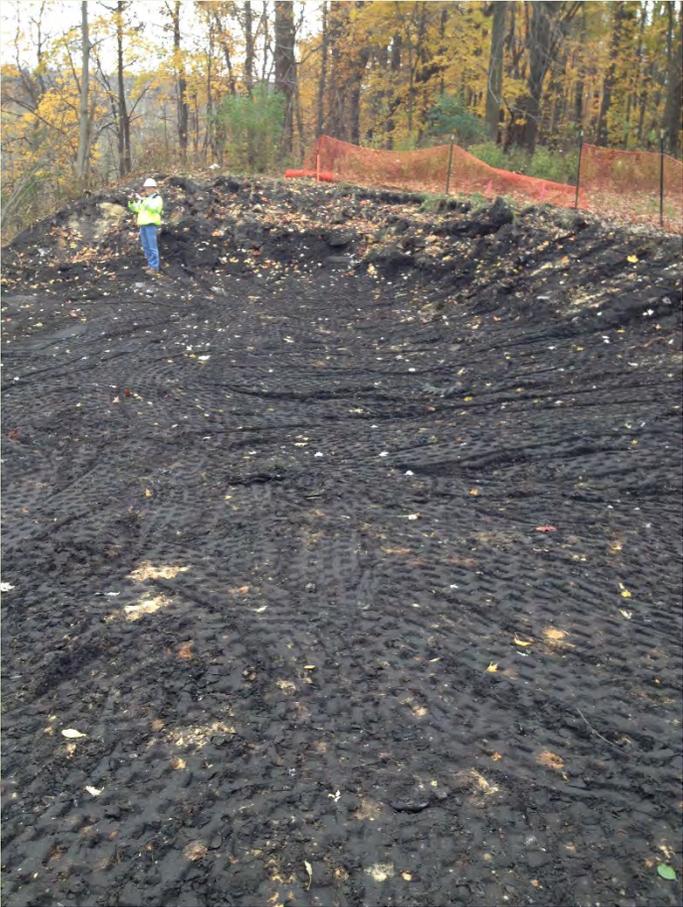
Compacting backfill

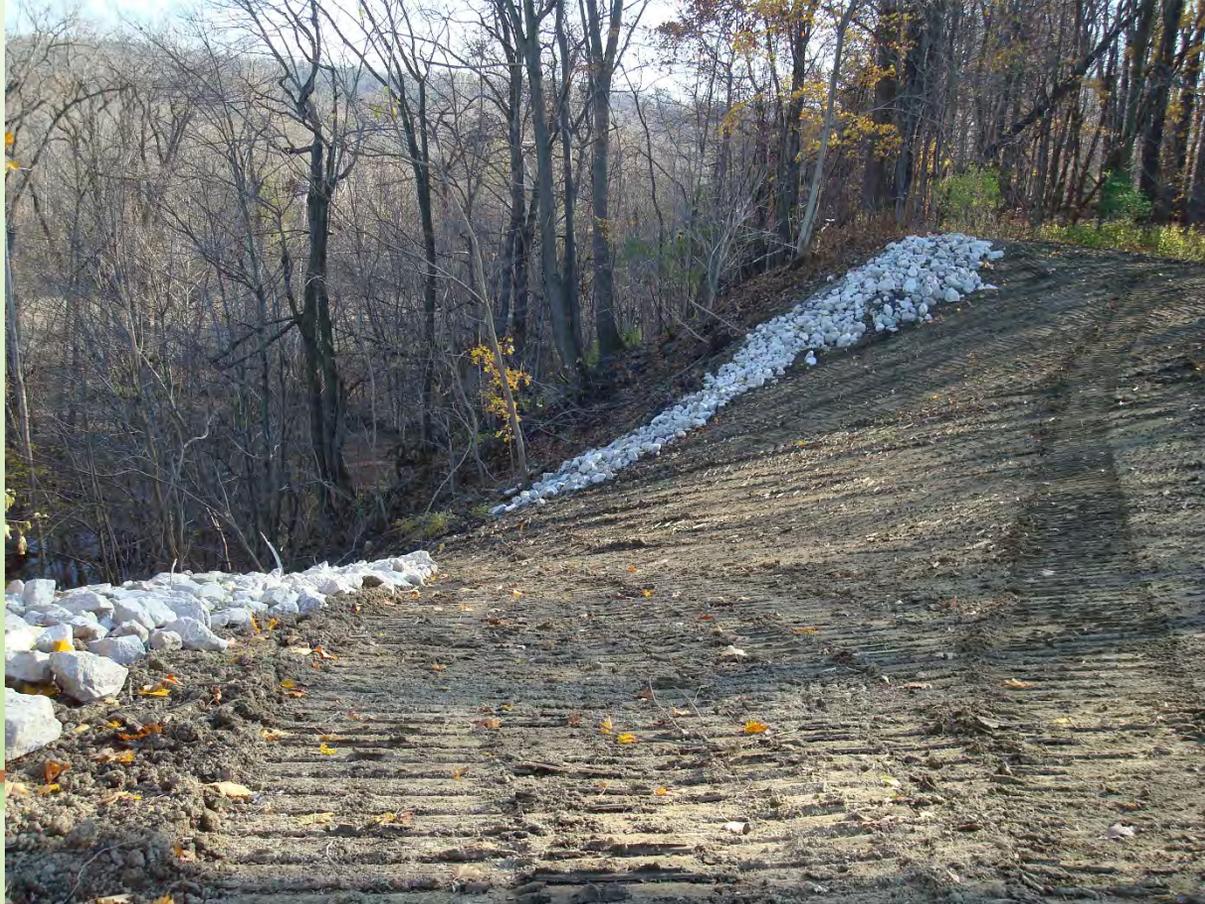
Final grade

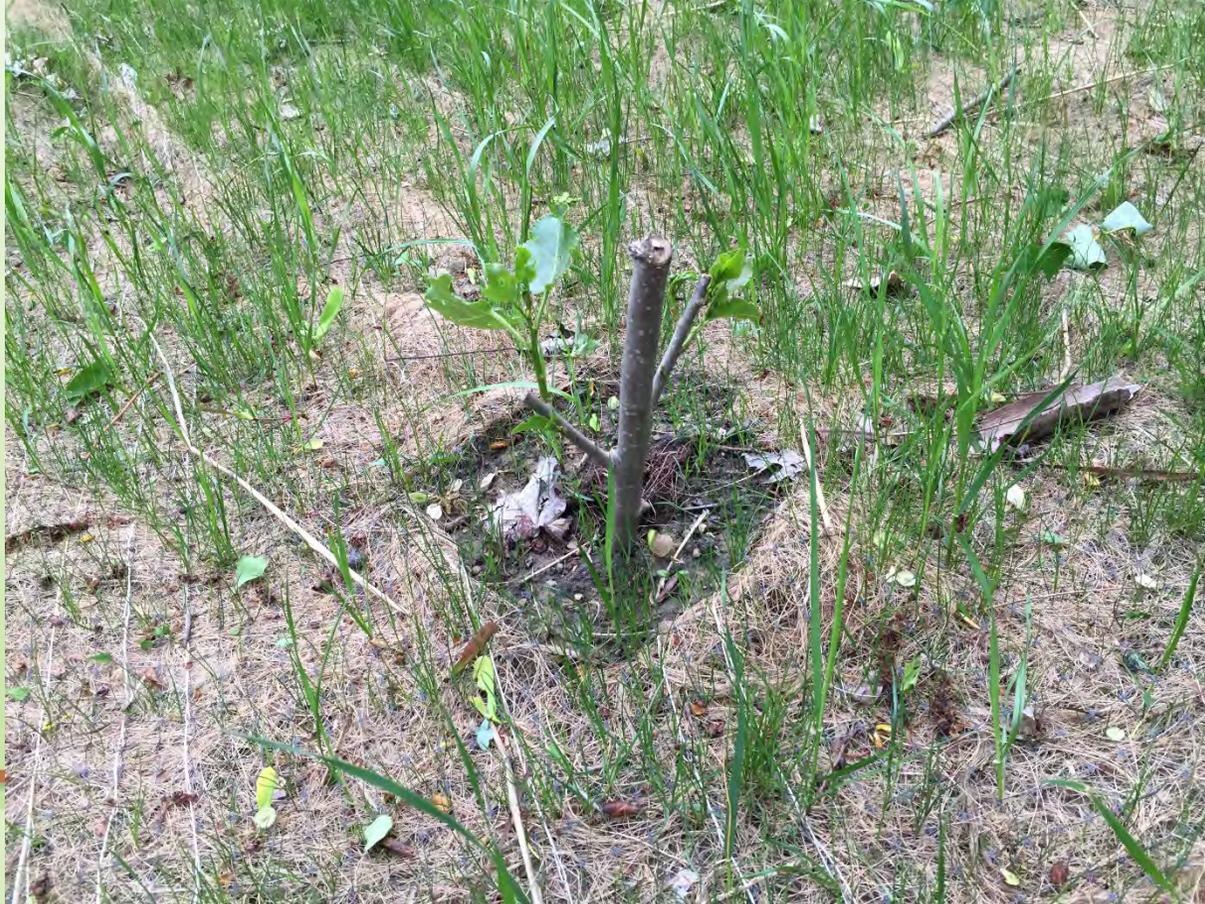
Trees Planted to Address PCBs in Seep

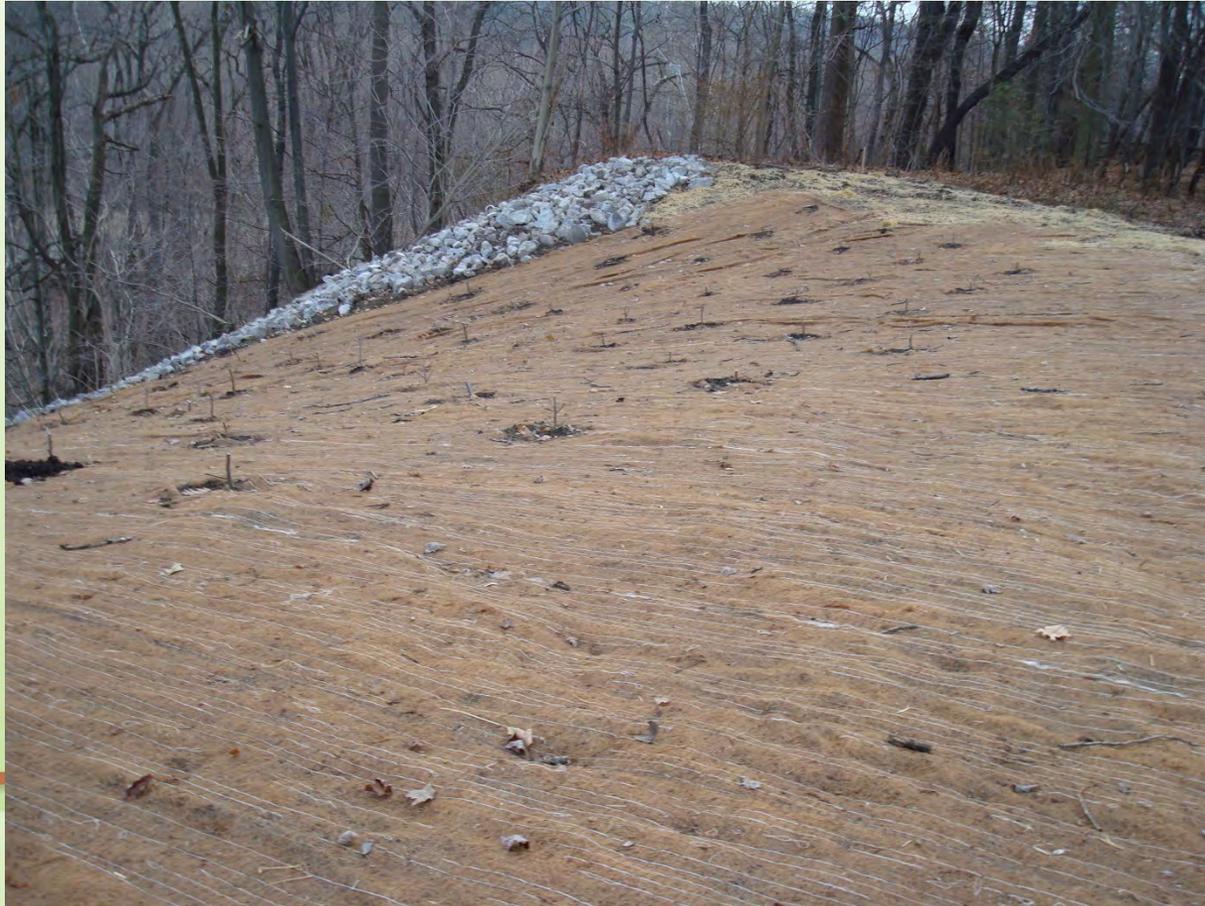
Site seeded, stabilization fabric and Phytoremediation

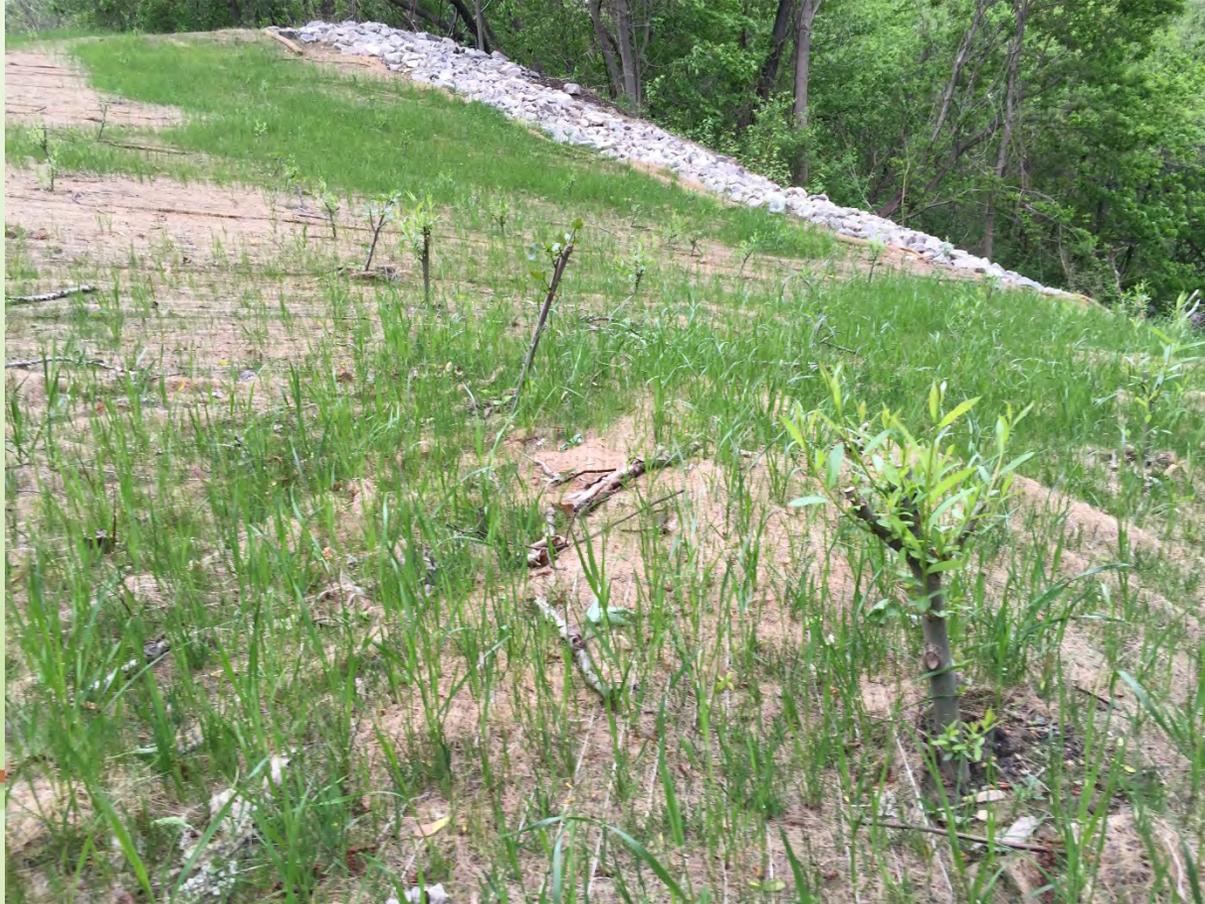
Post remediation 2015

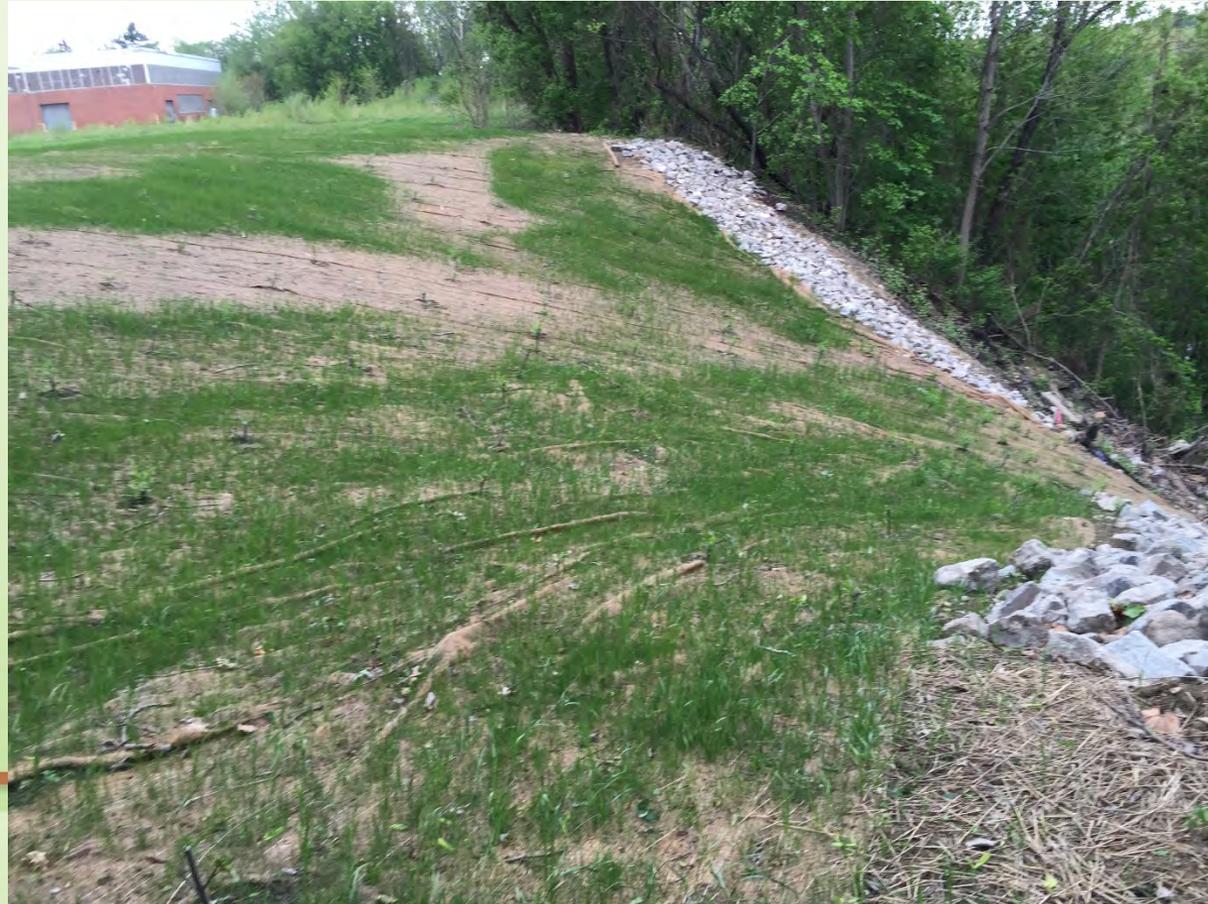
Post remediation showing steepness of slope

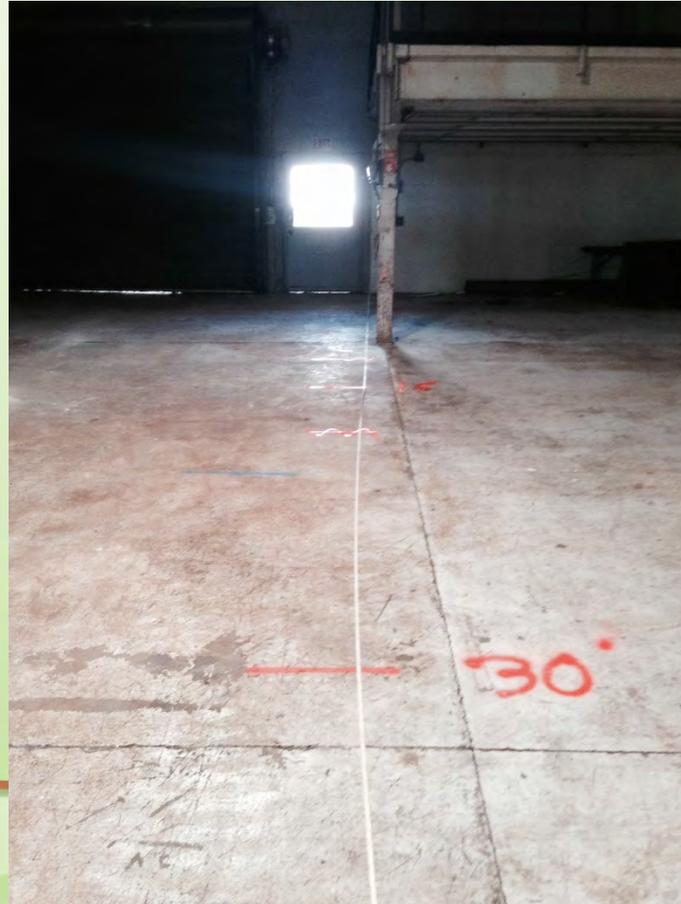
Laying out grid for Vapor Mitigation system (VMS)

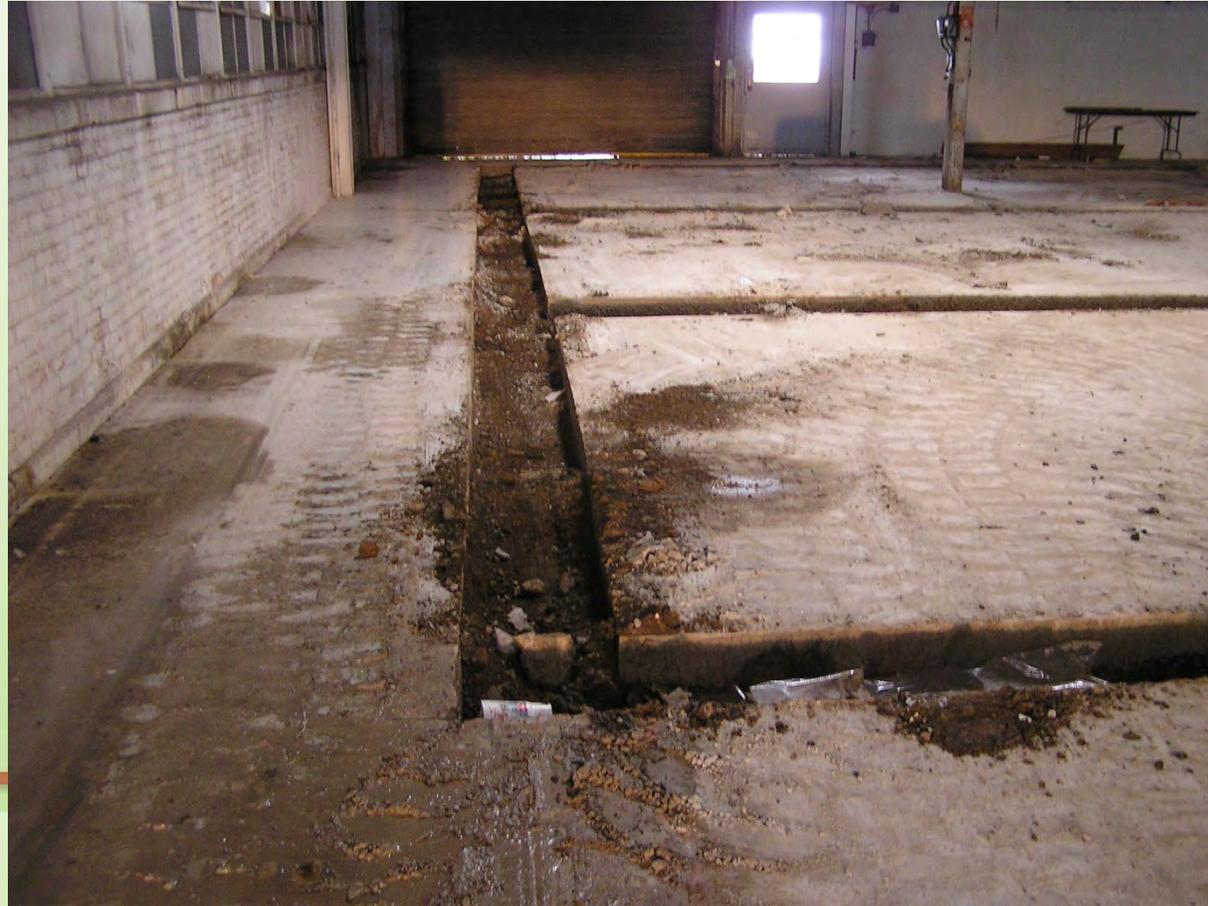
Saw cutting floor for VMS system

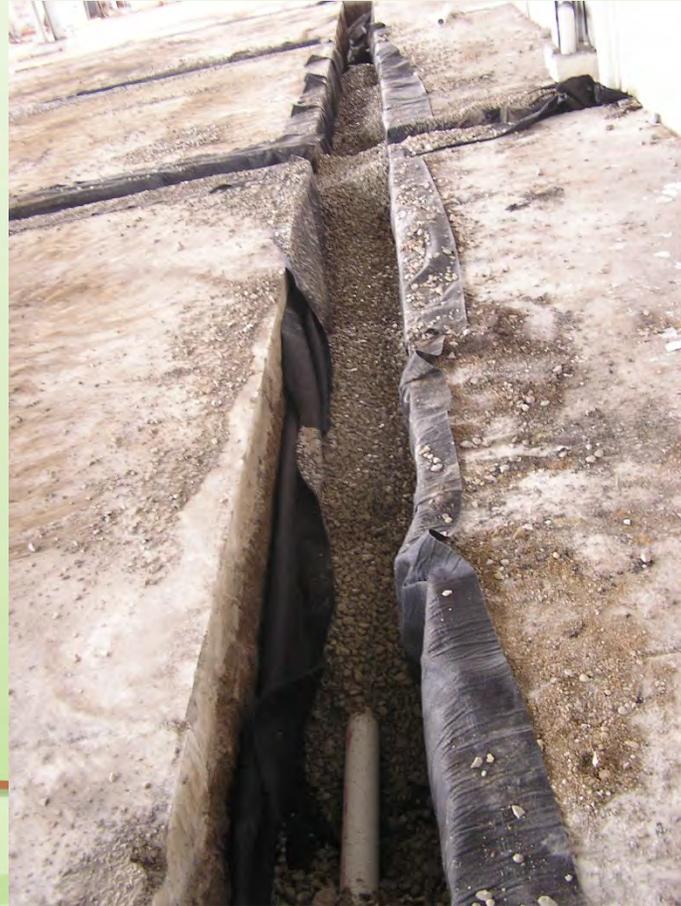
VMS pipe installation

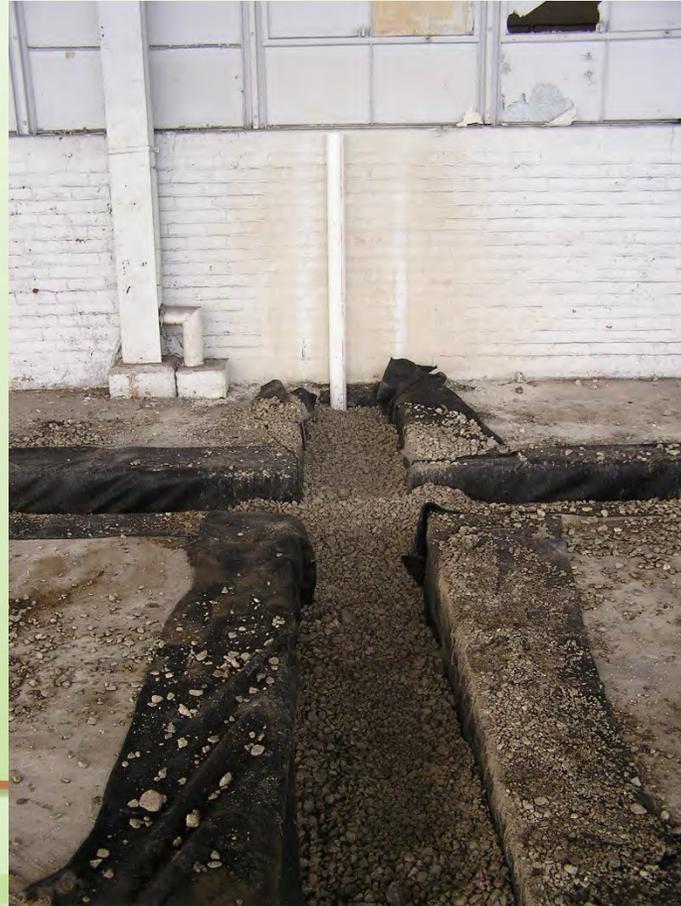
VMS plastic riser
