Coe Mfg. Site – Painesville, Ohio

An Untimely Brownfield Success Story

Tom Mignery, VAP CP
Melissa Haney, PM

Burgess & Niple, Inc

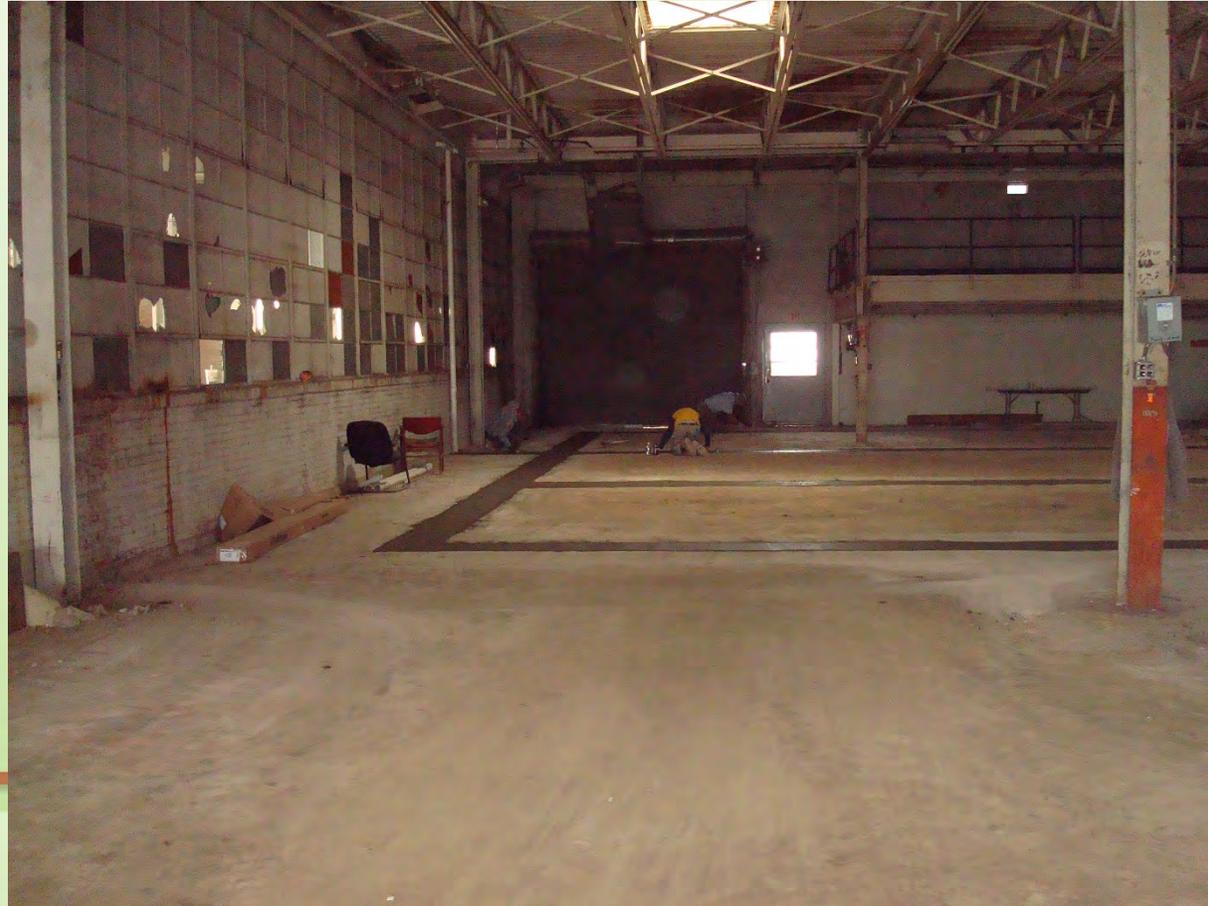
Final concrete work for VMS

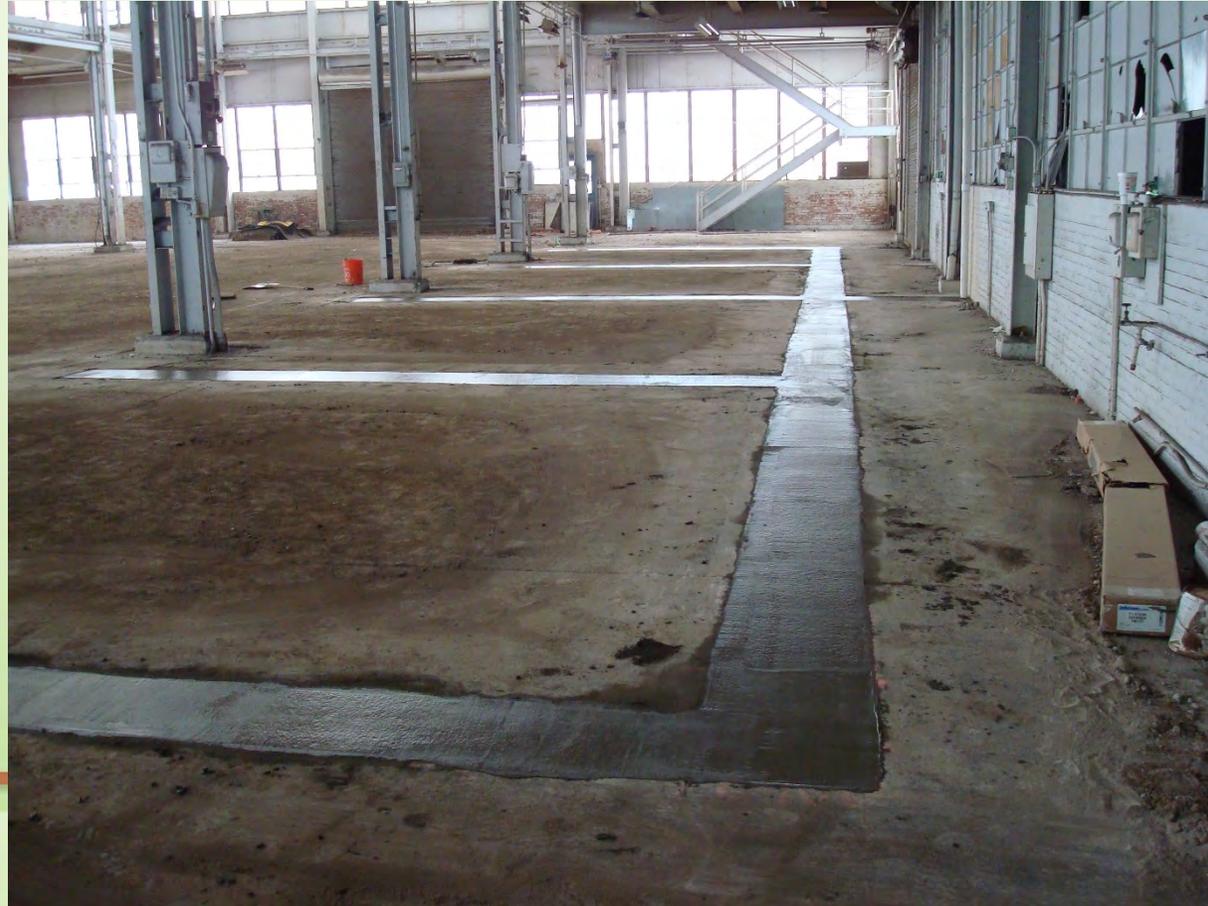
Finished VMS
