## North Cove Landfill - Toledo

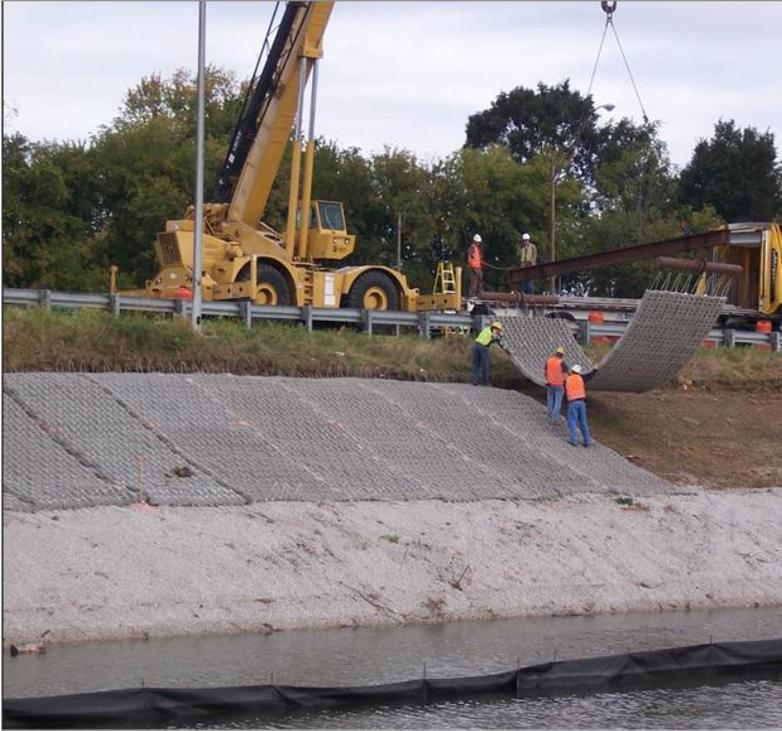
Installation of concrete-filled fabric blanket on the bank of the Ottawa River to prevent erosion of the river bank.

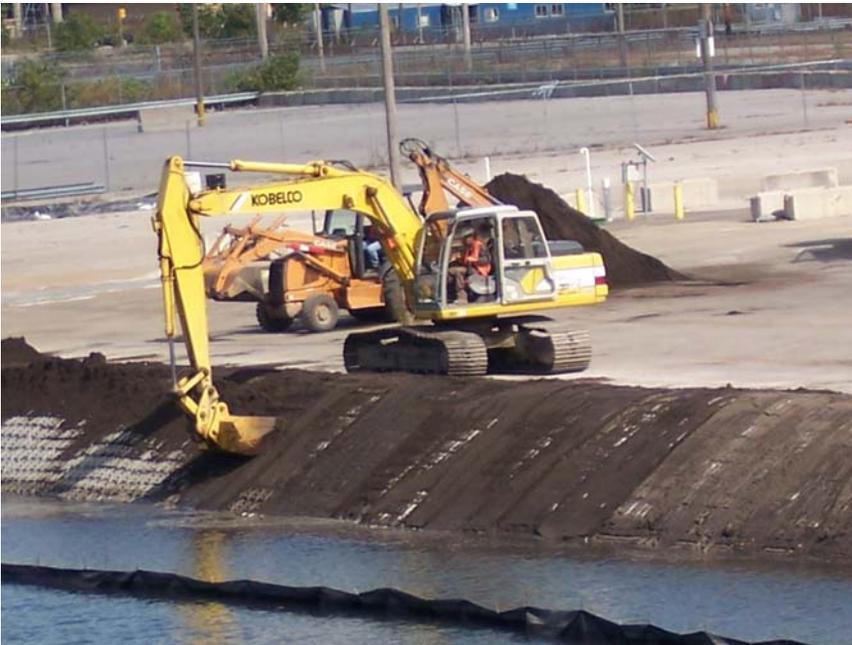
Covering the concrete-filled fabric blanket with topsoil to promote natural vegetation,

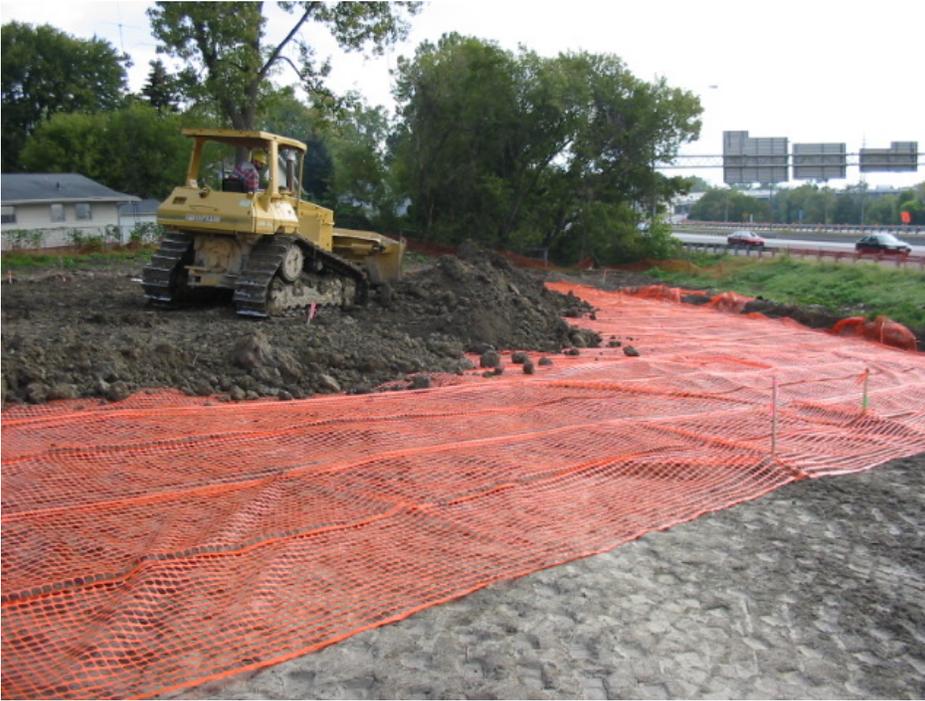
Compacting and covering the east edge of the North Cove Landfill. I-75 is in the background.

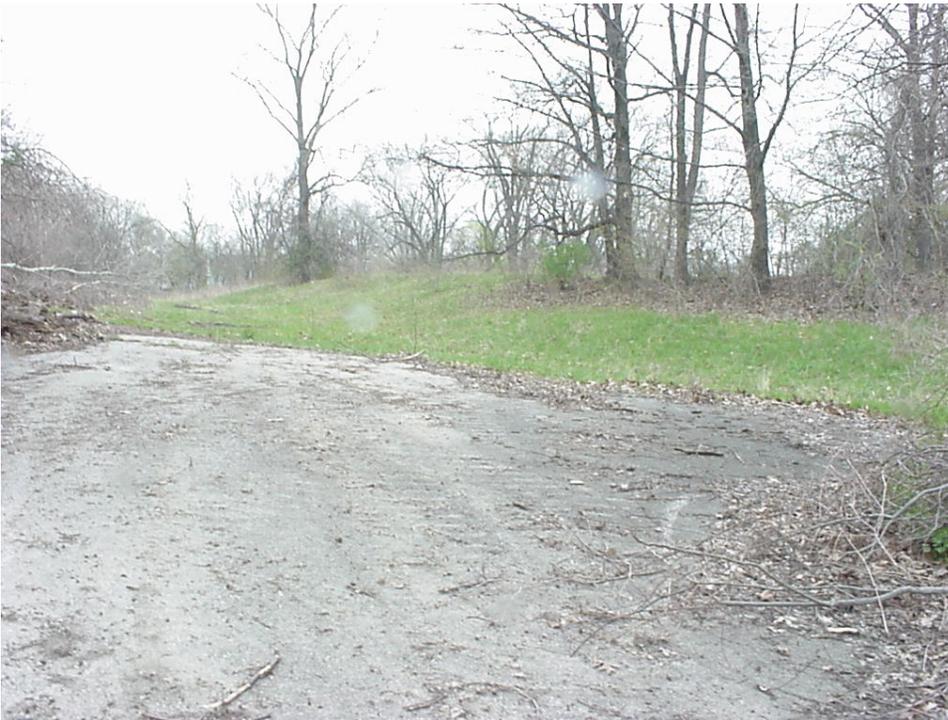
Portion of Former North Cove Landfill before remediation.

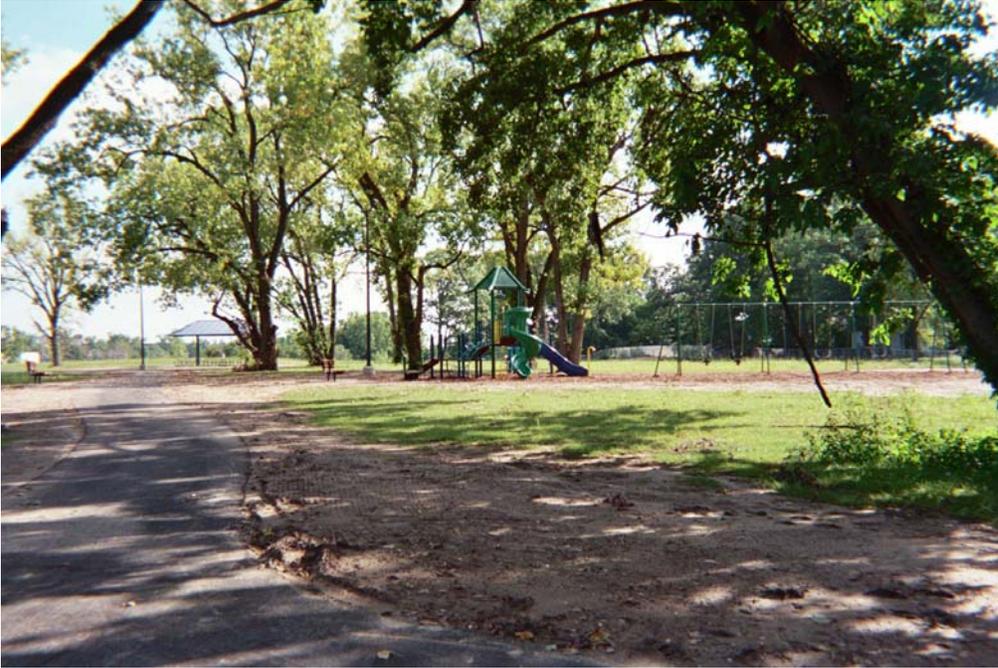
Portion of former North Cove Landfill after remediation and establishment of a city park with walking trails.
