# THE LITTLE PARK THAT COULD

## A Case Study: Toledo's UpTown Green

October 27, 2015

Sally Gladwell · Mannik & Smith Group, Inc.

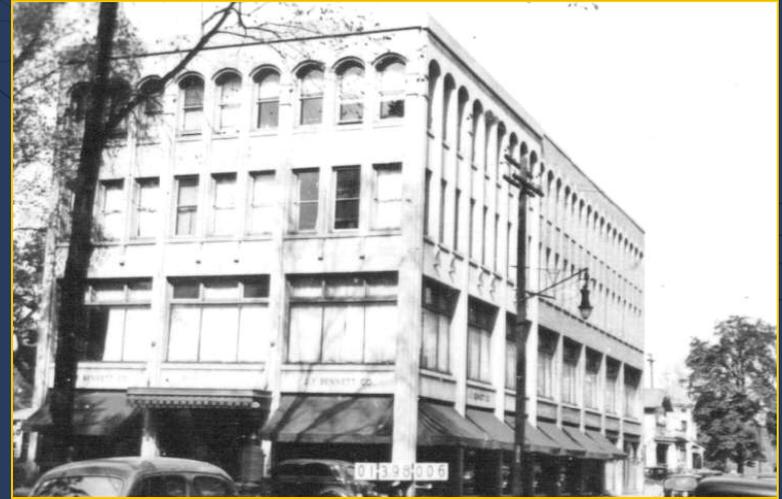
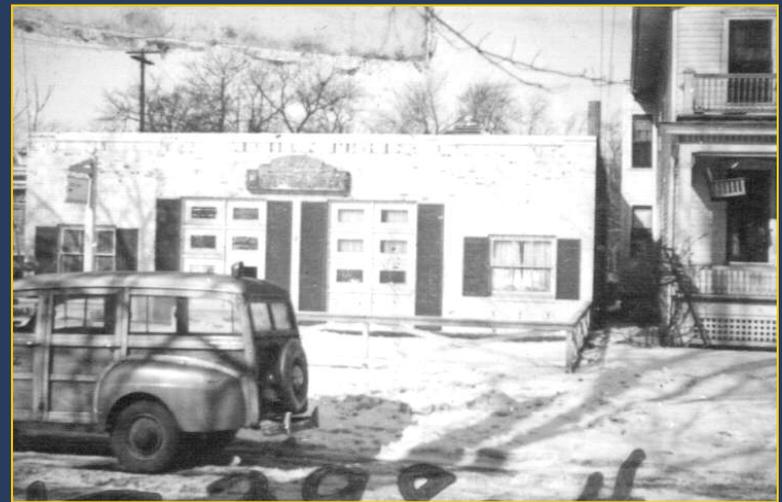
- In the 1930s and 1940s the property was developed with a mix of residences and commercial establishments including a gasoline filling station, a chemical laboratory, an automotive repair shop, and a furniture repair shop that included spray lacquer applications.
- Three buildings remained on the property and each contained friable asbestos; two buildings were in extreme disrepair.
- Two USTs were located on the property in the area of the former filling station and a third was discovered during park construction.

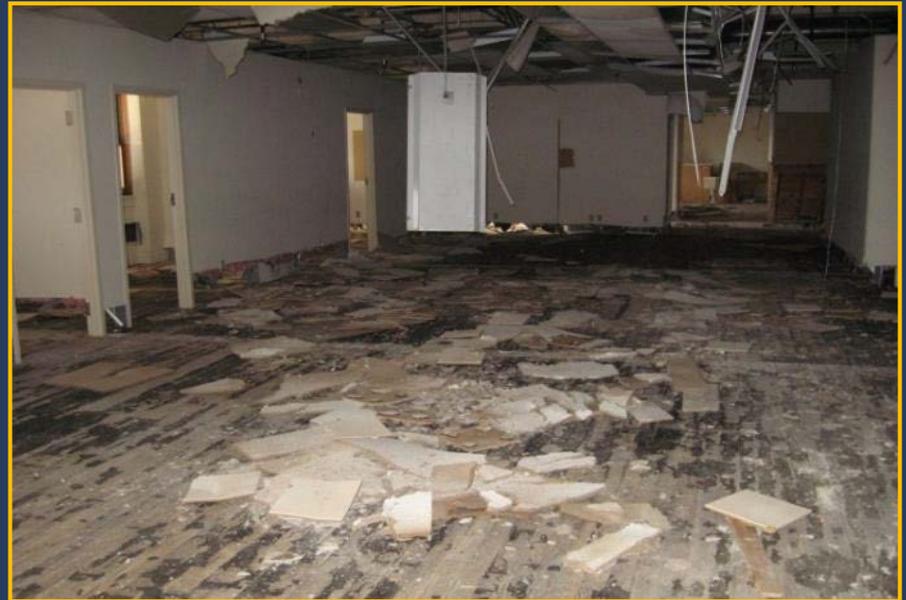
- The project property comprises approximately 2.5 acres and over the years, was used for varied purposes that included the handling of hazardous substances and petroleum products.
- VAP-compliant Phase I & II Property Assessments indicated the presence of:
  - two (~1,000 gallons each) underground storage tanks (USTs);
  - confirmed asbestos containing materials in the three on-site buildings;
  - soils exhibiting elevated readings of volatile organic compounds.
- Redevelopment hindered by presence of two dilapidated buildings and deteriorated parking lots and remnant concrete foundations and slabs.

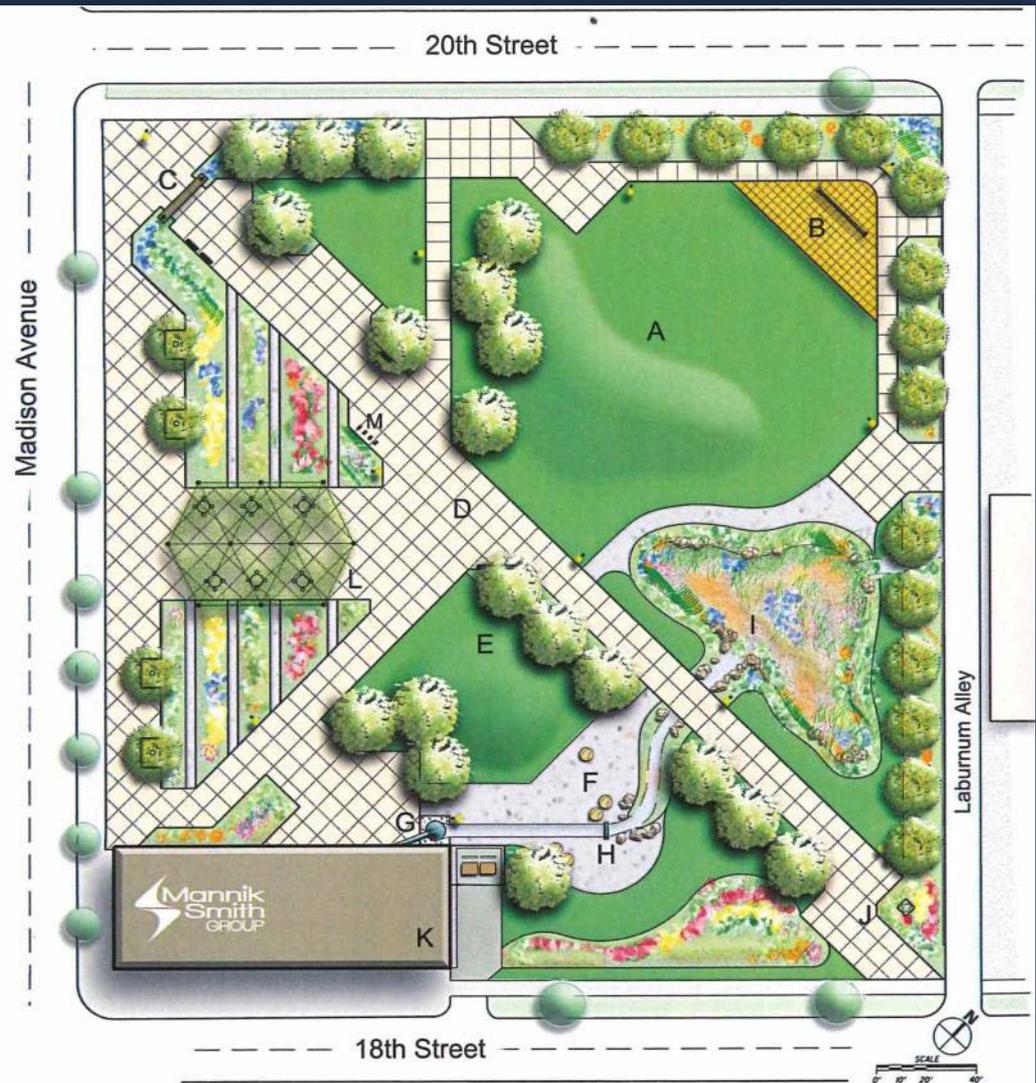
## PARK AMENITIES

| A. Lawn and stage viewing area | H. Interactive water feature |
| B. Elevated stage with backdrop | I. Rain garden area |
| C. Main entrance archway | J. Artwork display area |
| D. Plaza walkway | K. 311 18th Street building |
| E. Mounded lawn area | L. Overhead trellis and seating |
| F. Crushed limestone surface | M. Bicycle parking |
| G. Water cistern | |

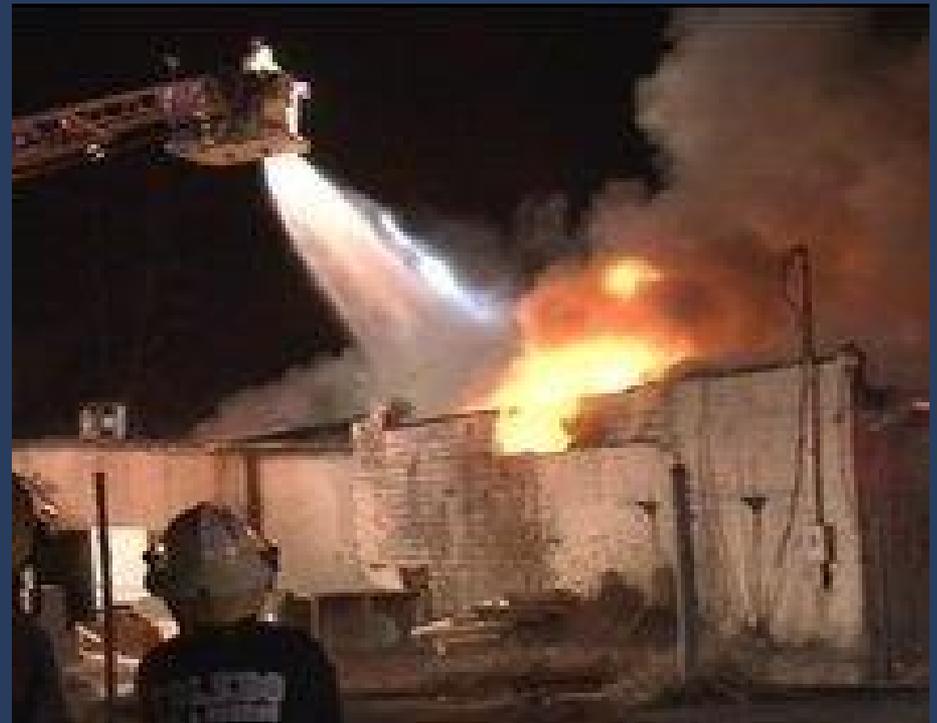
A vacant building went up in flames just after midnight Tuesday on 18th Street in the Uptown District. The building was located between Madison and Adams.

Flames were so intense that crews had to stay outside the building. A part of the roof and a wall soon collapsed.

The fire is being ruled suspicious by arson investigators who are looking for the cause. The building will be torn down.

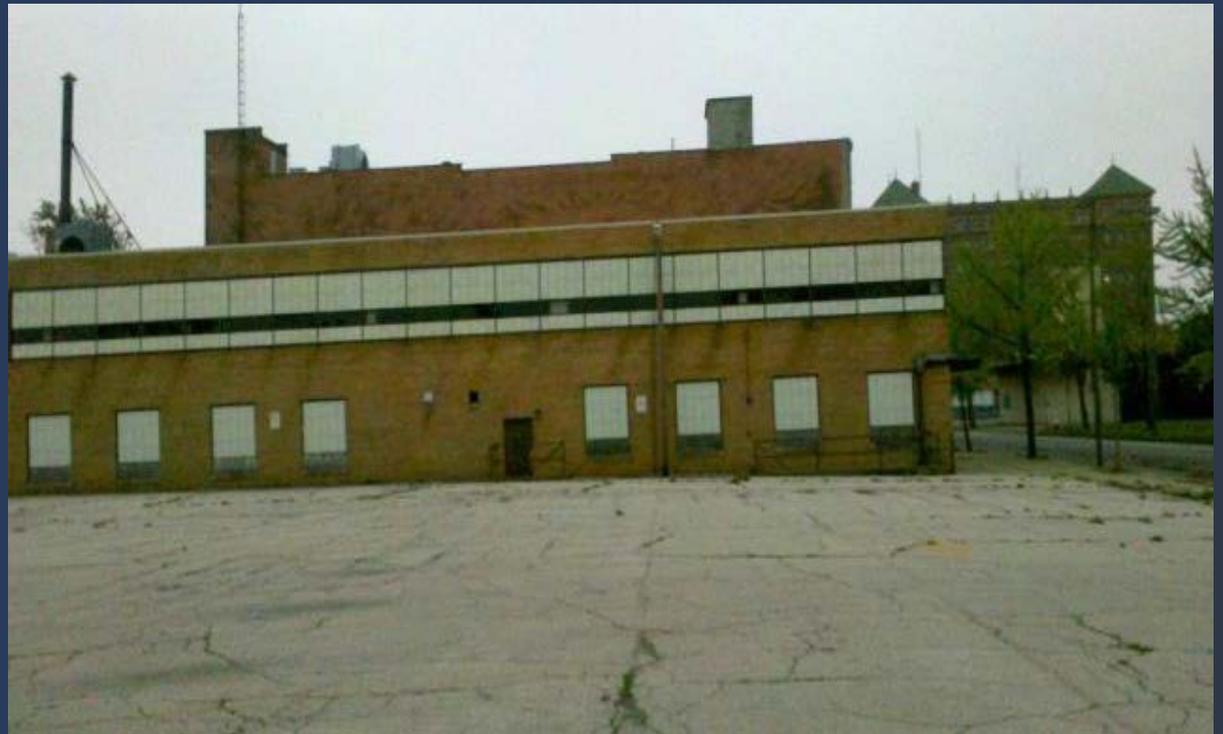
- Site buildings were not well secured – additional arson threat existed
- City used \$170,000 of what would have been granted demolition monies to demolish a building prior to the grant agreement to avoid damage to the building intended to be renovated

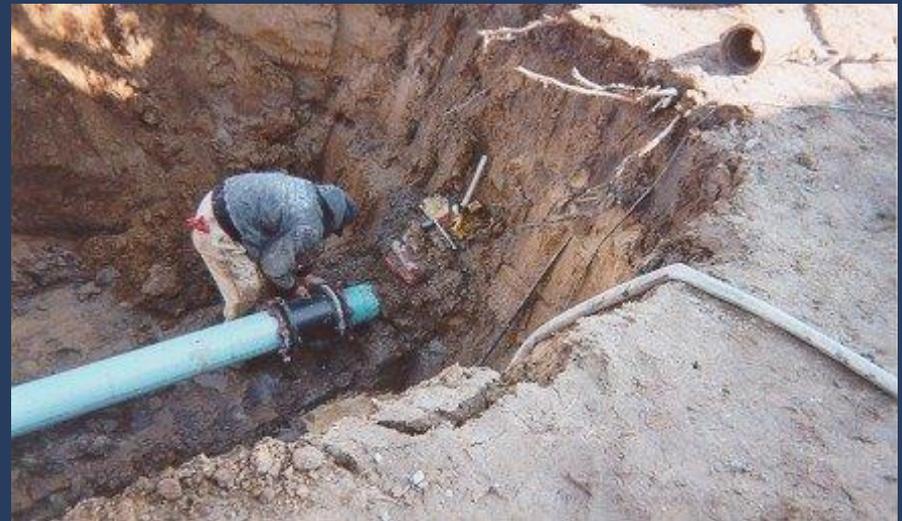
- Phase II PA focused on evidence of contamination
  - Samples selected based on PID readings, depth of sample, or visual or olfactory contaminant indicators
  - All Phase II samples analyzed from greater than 10 feet in depth
- During CORF review process, Ohio EPA / ODOD identified the lack of samples within the POCs to be a deficiency
  - Required supplemental samples be collected during the cure period

- Threat of additional arson and use of demolition monies prior to Grant Agreement
  - What are to ramifications in terms of Phase II investigation activities, etc.?
- Points of Compliance
  - CORF process allowed resolution as part of the “cure” but what if this NFA Letter was not part of that process?
    - INOD deficiency? Would site conditions allowed for the additional sampling with INOD/FNOD timeframe?

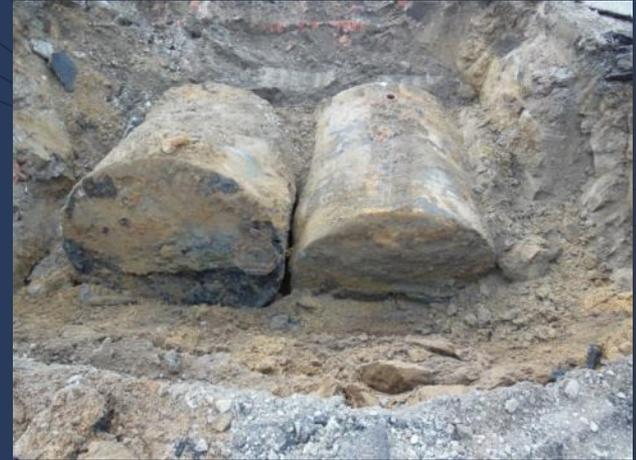
- Two USTs were identified during Phase I
  - Phase II did not identify remnant petroleum in vicinity of USTs
  - Determined to be “scrap metal in the ground”
  - Were found to have leaked when excavated
  - Required Volunteer to get BUSTR Class D Determination
- Additional UST unearthed and excavated by contractor during park development
  - Addressed via contractor affidavit & post-removal confirmation sampling

- Impacts from USTs
  - Potential for an additional Identified Area(s) based upon excavation activities
    - Determining next steps to ensure regulatory concerns are adequately addressed
      - BUSTR Class C determination
      - Contractor affidavit and confirmation sampling and analysis
