**Biological and Water Quality Study  
of  
Mill Creek Watershed  
2009, 2012 & 2013**

OHIO EPA Technical Report EAS/2014-02-02

Biological and Water Quality Study  
of the  
Mill Creek Watershed  
2009, 2012, & 2013

Delaware, Logan and Union Counties, Ohio  
May 23, 2014  
OEPA Report DSW/EAS 2014-02-02

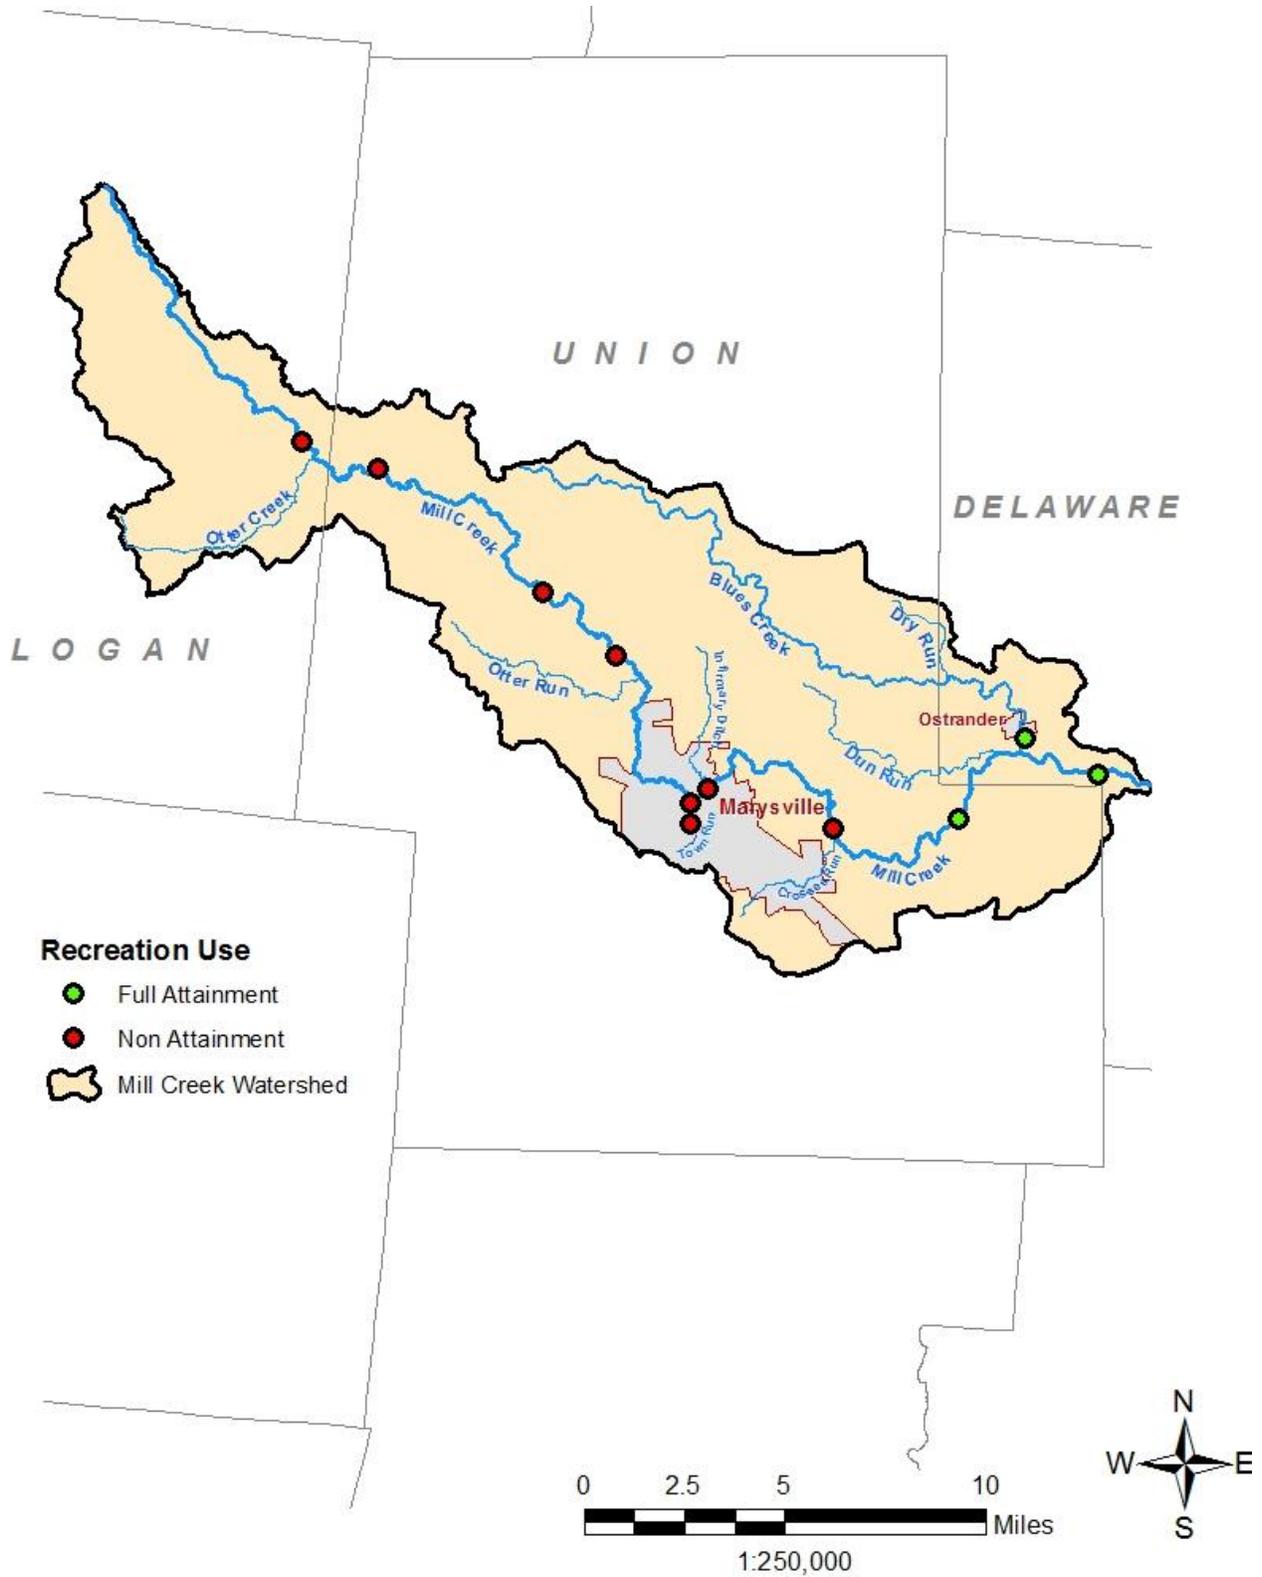
Figure 21. Recreation use attainment map for the Mill Creek watershed, 2012. All sites are designated or recommended Primary Contact Recreation Class B.

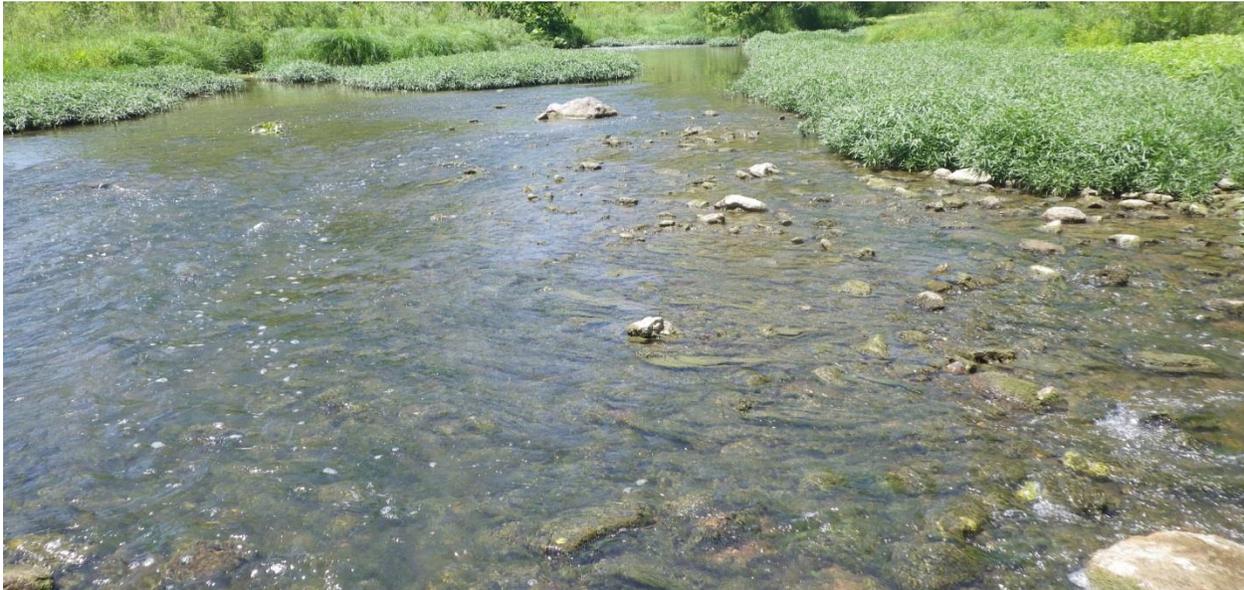
Figure 22. Exceptional physical habitat pictured above in Mill Creek (RM 1.57) upstream from Bellport Road.

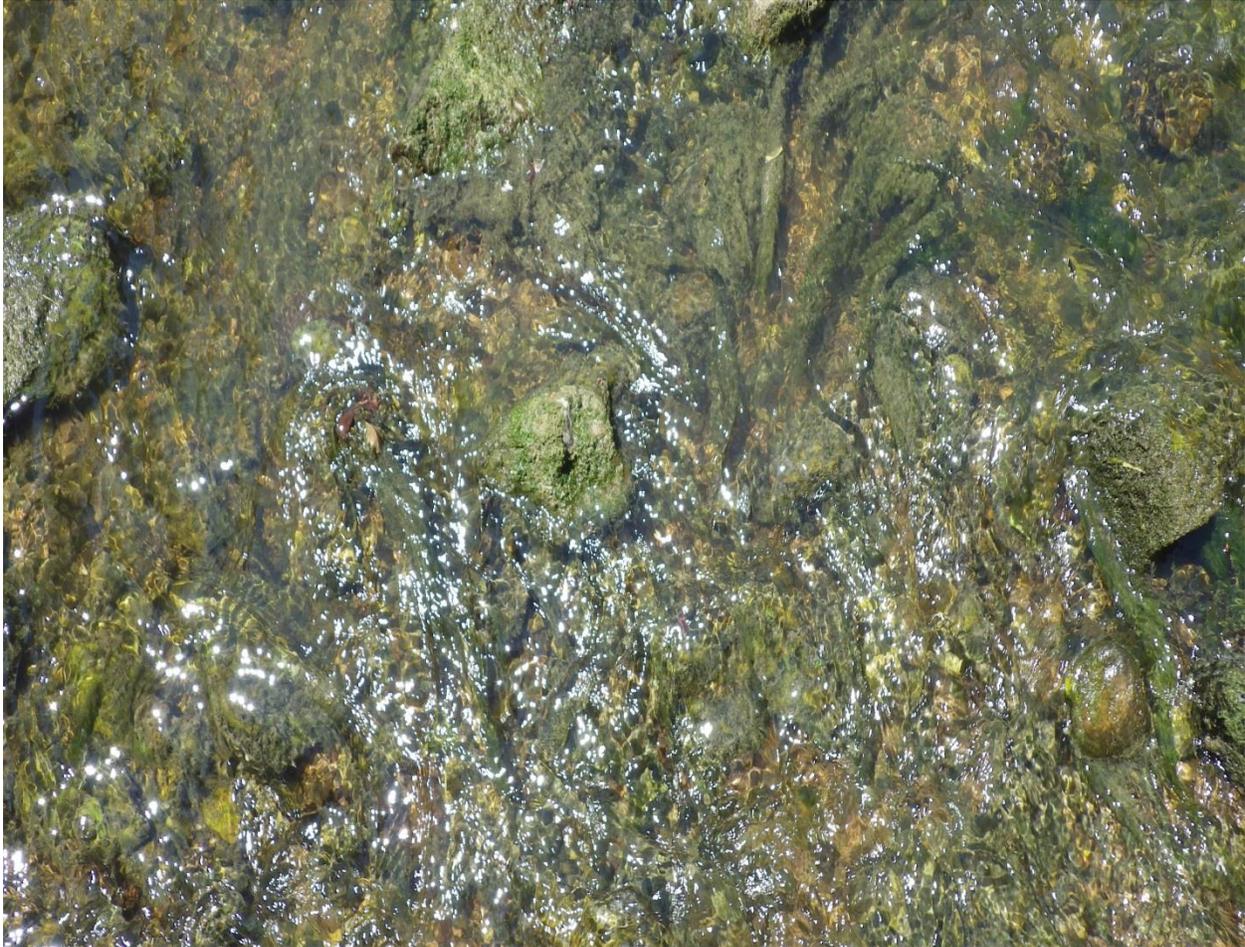
Figure 23. Pictured above, algae mats in the riffles in Mill Creek at Bellpoint Road (RM 1.57) limited the quality of the macroinvertebrate community.

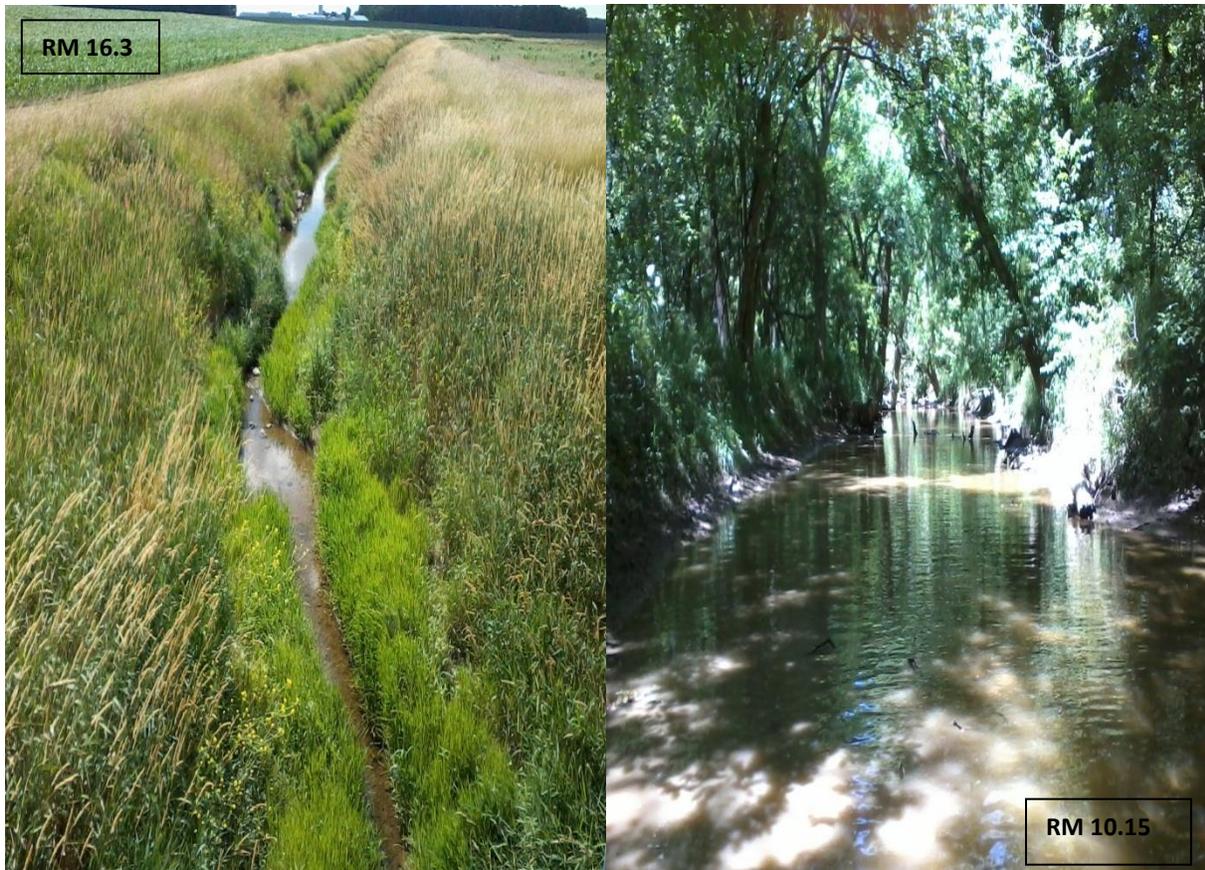
Figure 24. Two Blues Creek sites pictured above show examples of both poor (RM 16.3) and fair (RM 10.15) quality habitats, 2012.

The fair (RM 10.15, QHEI = 47.0) and poor (RM 16.3, QHEI = 41.0) habitat quality at two Blues Creek sites was related to upstream and adjacent agricultural land use practices. Stream substrates at the sites were almost entirely comprised of silt and fine sediment (Figure 24 and Appendix A). At Taylor Claiborne Road (RM 16.3), Blues Creek is channelized and incised with no woody riparian corridor. A narrow CRP type buffer has been planted or allowed to grow along the tops of both incised banks; however, it doesn't appear to be filtering much of the surface water runoff as the adjacent field was tiled. Unstable instream substrates were evidence of flashy stormwater events. Further evidence of these flashy storm events was noted downstream at Leeper Perkins Road (RM 10.15). Despite a more natural woody riparian buffer and channel sinuosity, the instream substrates found at this site continued to reflect storm water impacts from flashy flows and sediment transport.

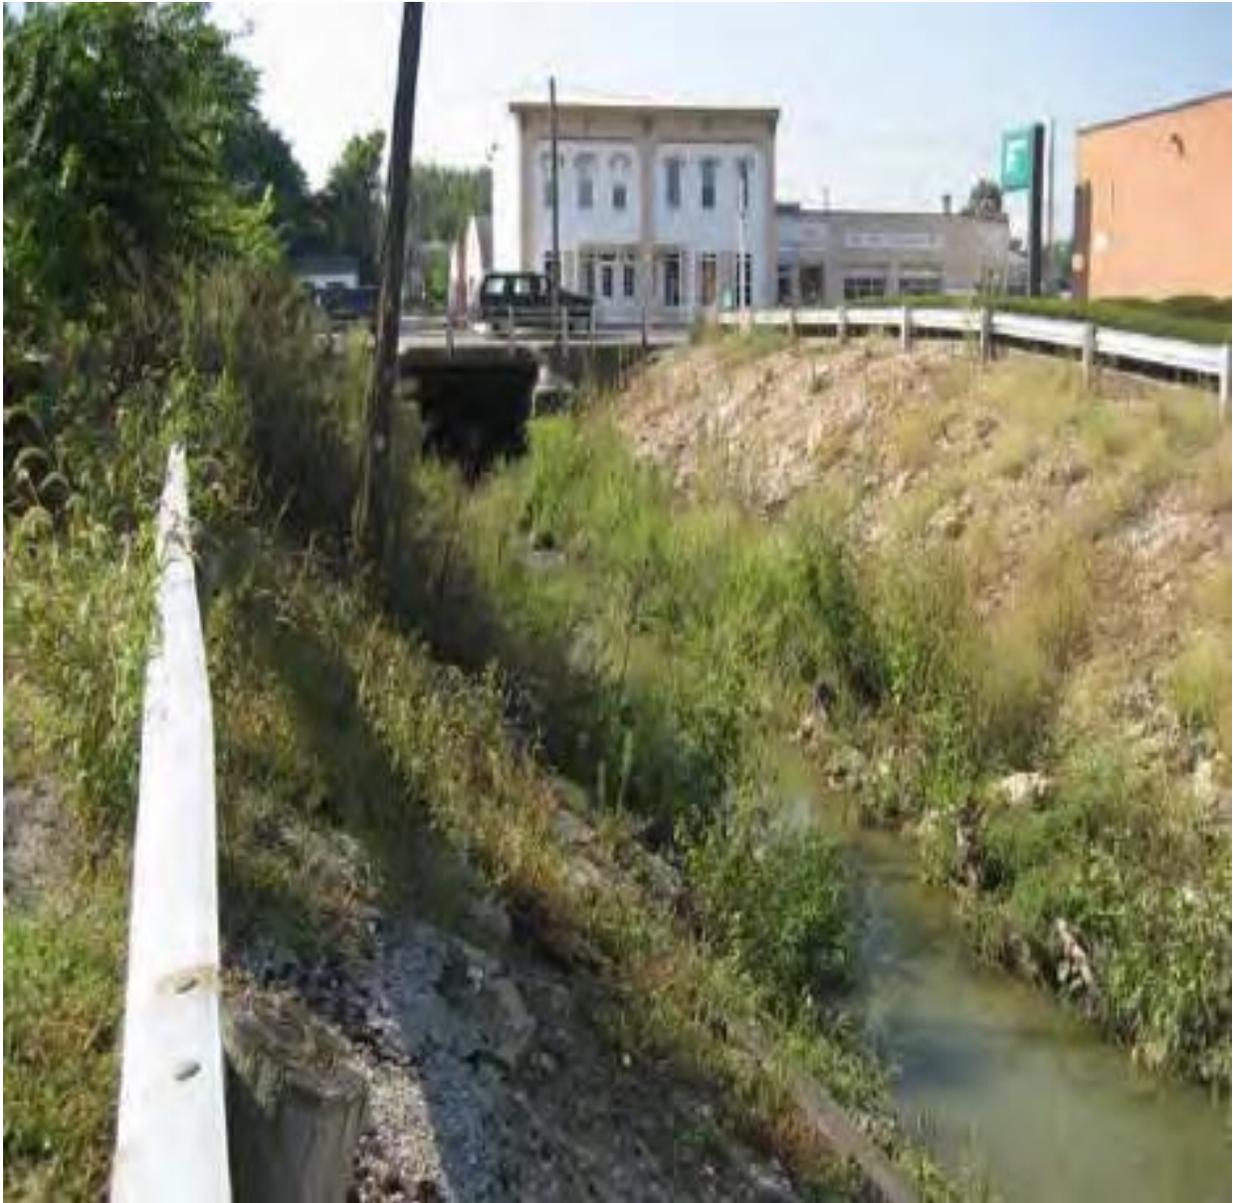
Figure 25. Fair quality habitat (QHEI = 50) at Town Run RM 0.20.

Fair quality habitat in Town Run (QHEI scores of 44 and 50 at RMs 0.7 and 0.2, respectively) was attributed to raw sewage, sedimentation from urban stormwater runoff and major habitat modifications. For part of its length, Town Run flows in an underground concrete culvert through the city of Marysville. The substrates in both sampling locations were covered in raw sewage from illicit discharges which turned the channel margins black and grey. While the upstream site had more natural features as it flowed through a city park, the downstream site was incised and channelized with riprap and surrounded by concrete and blacktop parking lots (Figure 25). Regardless of whether physical habitat quality is improved in daylighted reaches of Town Run, WWH use attainment will likely not be attained unless the illicit discharges are eliminated.

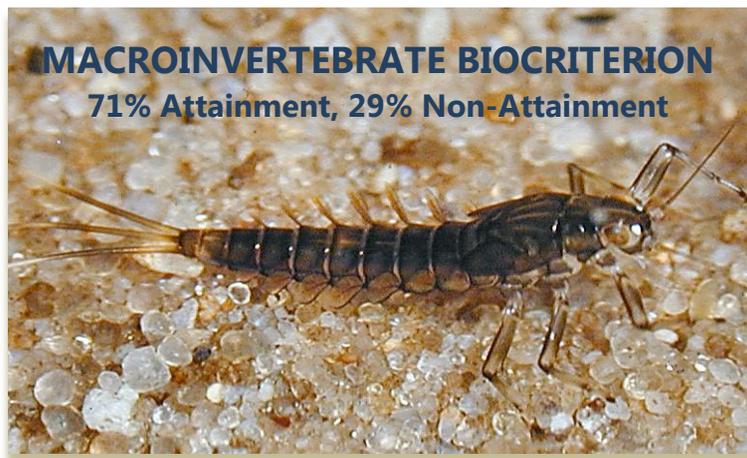
At the Mill Creek sites, the longitudinal trend in sensitive taxa mirrored the ICI and was illustrative of macroinvertebrate community condition where an ICI score was not available (Figure 31). In particular, the sensitive taxa showed declines within the city of Marysville followed by significant recovery before declining again downstream from Crosses Run and the Marysville WRF.

Figure 31. Longitudinal trend of Invertebrate Community Index (ICI) scores and number of sensitive taxa collected from Mill Creek, June- October, 2012.

Urban storm water runoff and illicit discharges, particularly via Town Run, were likely contributors to a decline in macroinvertebrate community condition within the Marysville city limits. A marginally good community was present at RM 19.00, where ten Ephemeroptera, Plecoptera and Trichoptera (EPT) and five sensitive taxa were collected. At the next site (RM 18.20), the macroinvertebrate community was negatively affected by degraded water quality, slow current and heavy sedimentation. Just twenty-five taxa and three sensitive taxa were collected from natural substrates. The macroinvertebrate community met or exceeded WWH expectations at the next three sites (RMs 16.80, 14.54 and 12.17) downstream from the city of Marysville. The ICI score at RM 16.80 was in the excellent range (ICI= 46), but the collection of just five sensitive taxa suggested a lingering impact related to upstream pollution sources noted previously. Additional improvement was evident in the qualitative natural substrate sampling at RM 14.54, which was reflective of a good community condition. Eleven sensitive taxa were recorded and the total number of taxa (63) was the highest number collected from natural substrates at a single site for the entire survey.
