Total Maximum Daily Loads for the Moxahala Creek Watershed

Final Report
April 4, 2012

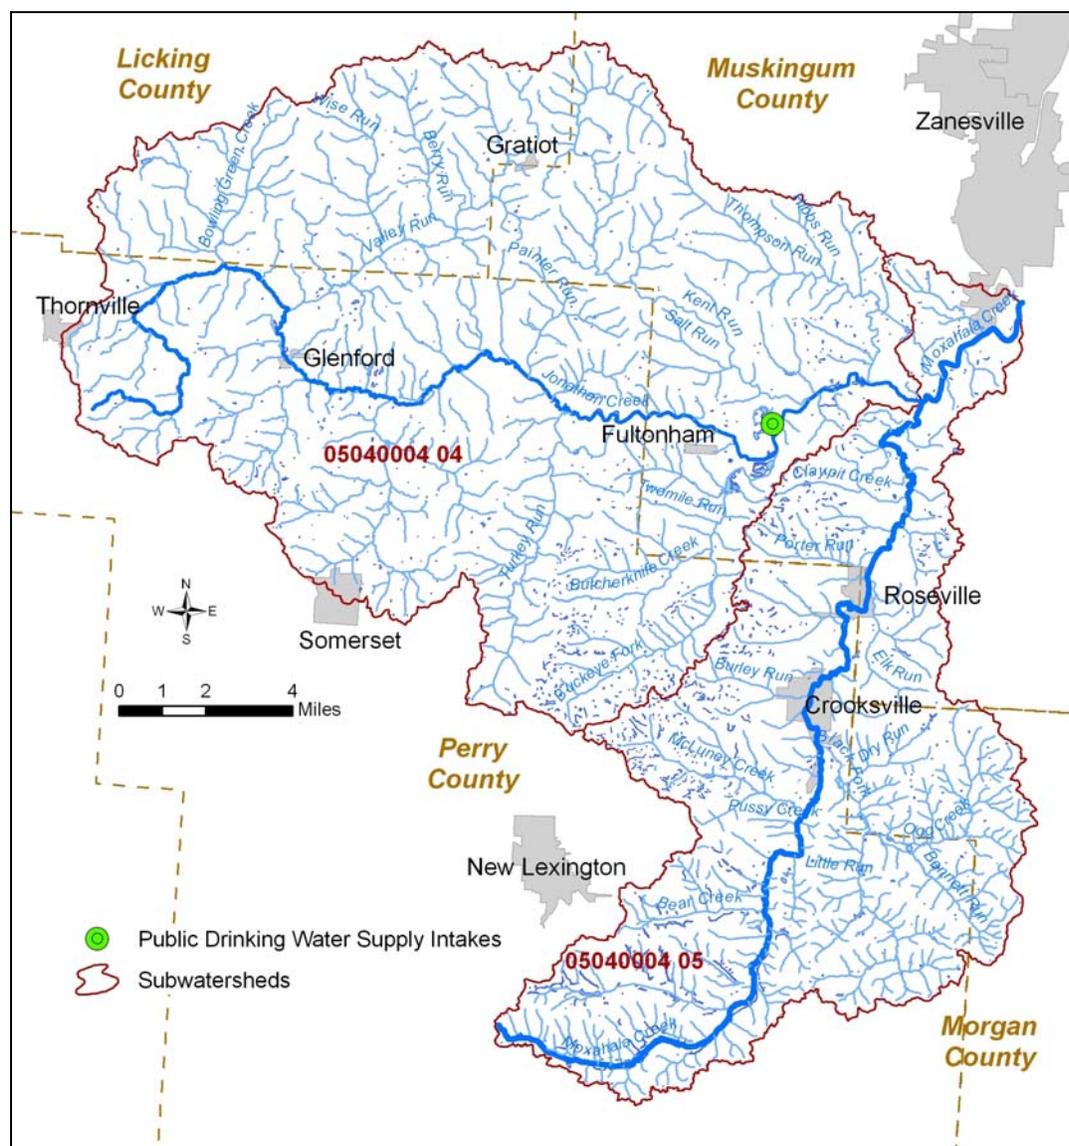
Figure 2-5. Public drinking water supply intakes in the Moxahala Creek watershed.

The public drinking water supply use includes surface waters from which public drinking water is supplied. This beneficial use provides an opportunity to strengthen the connection between Clean Water Act and Safe Drinking Water Act (SDWA) activities by employing the authority of the CWA to meet SDWA objectives of source water protection and reduced risk to human health. Criteria associated with this use designation apply within five hundred yards of surface water intakes. Figure 2-5 shows public drinking water supply intakes in the watershed.

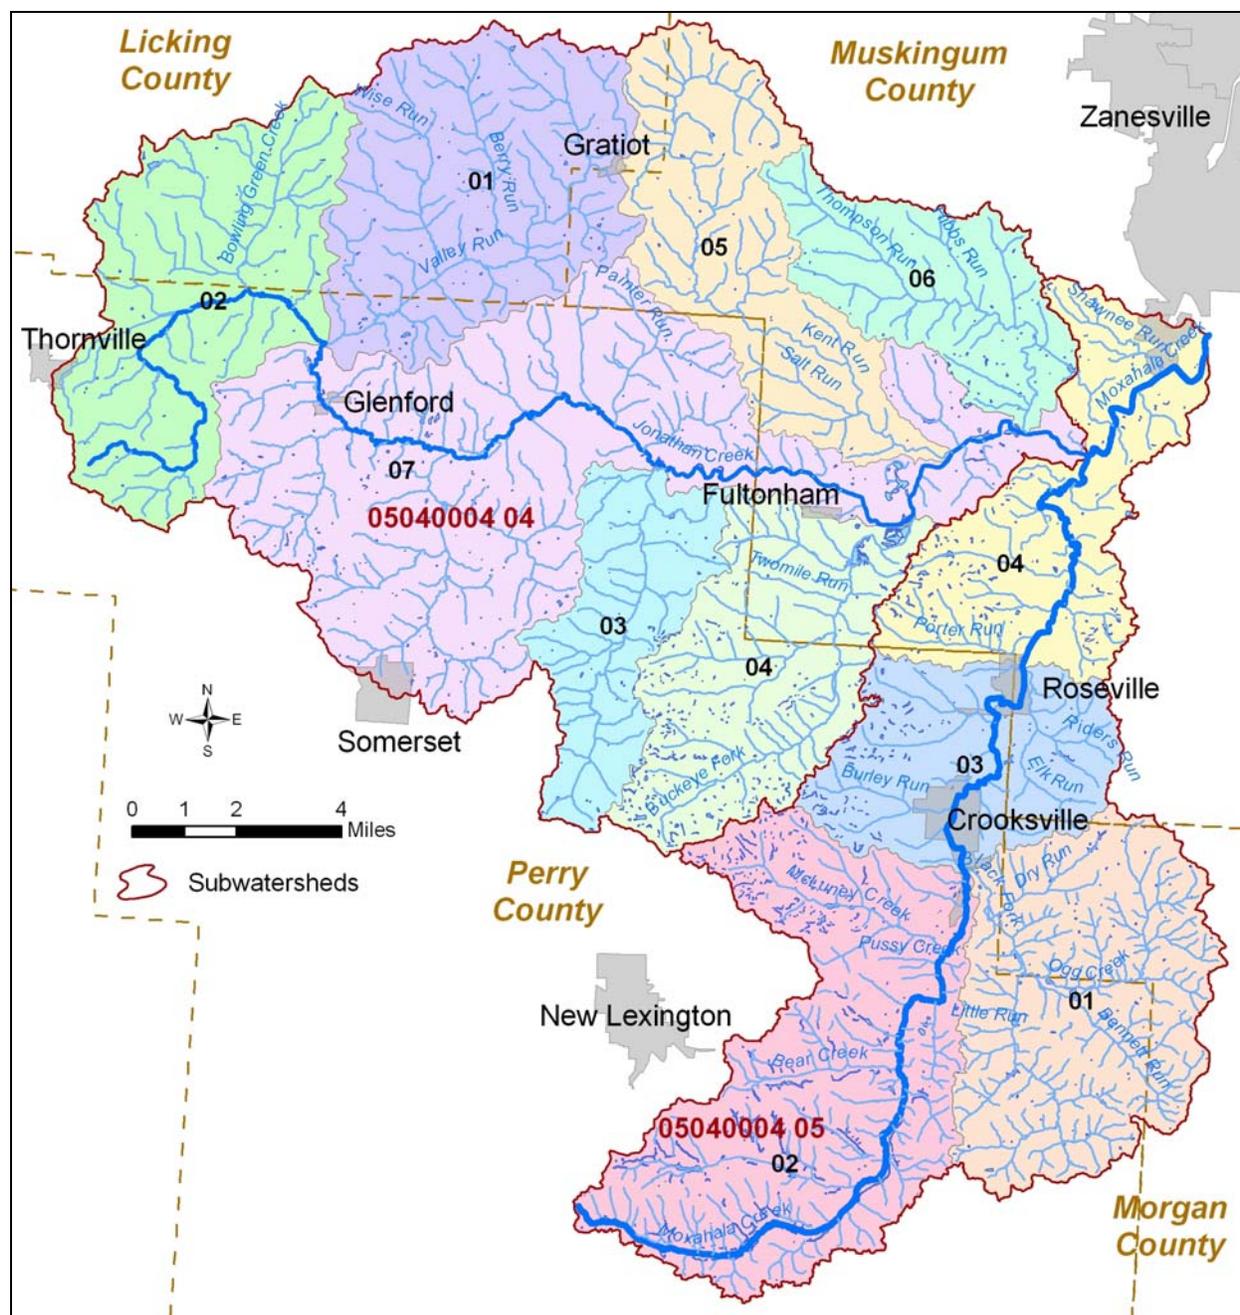
Figure 3-1. Map of the Moxahala Creek watershed.

The Moxahala Creek watershed TMDL includes two subwatersheds (Figure 3-1). Within each of the two subwatersheds, smaller watersheds are nested (12-digit assessment units). This chapter discusses conditions in each of the subwatersheds with detail added in unique nested subwatersheds. Overall, impairment for aquatic life and recreation uses was more common in the southern portion of the watershed. Non-attainment of biological criteria was caused by a variety of metals, nutrients and acidity, primarily from acid mine drainage and coal mining sources. Partial attainment in the Jonathan Creek subwatershed was caused by acidity and metals from acid mine drainage and by habitat alterations from channelization and low dissolved oxygen from a dam impoundment.

Table 6-1 shows an overview of all of the nested subwatersheds that contain sites with partial and non-attainment of aquatic life and recreation uses. Causes of impairment are shown within parentheses following each source that might contribute to that cause. Table 6-3 and Table 6-4 each represent a separate subwatershed (see Figure 3-1 for a map). For each nested subwatershed, specific actions are recommended.

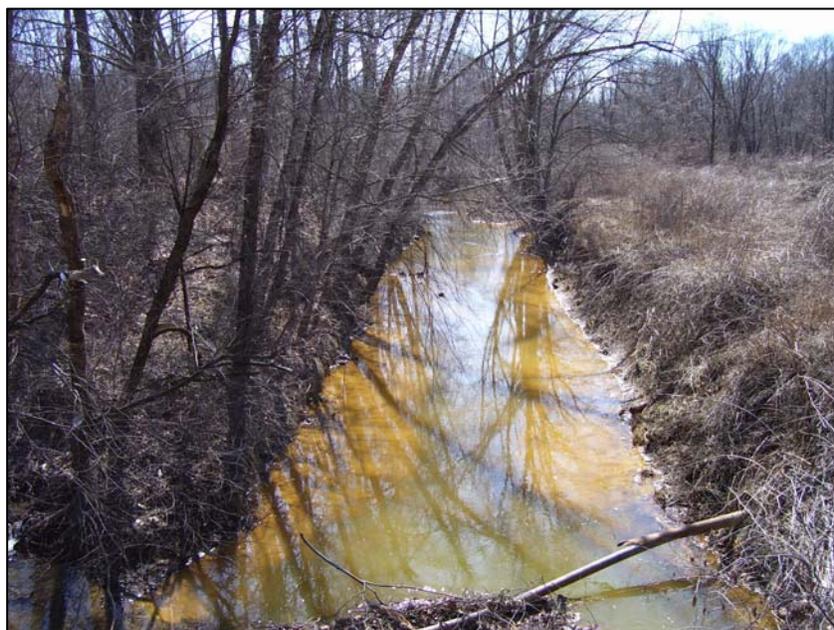
Buckeye Fork at Old Rainer Road. Note the orange coloration of the water, which indicates AMD influence.

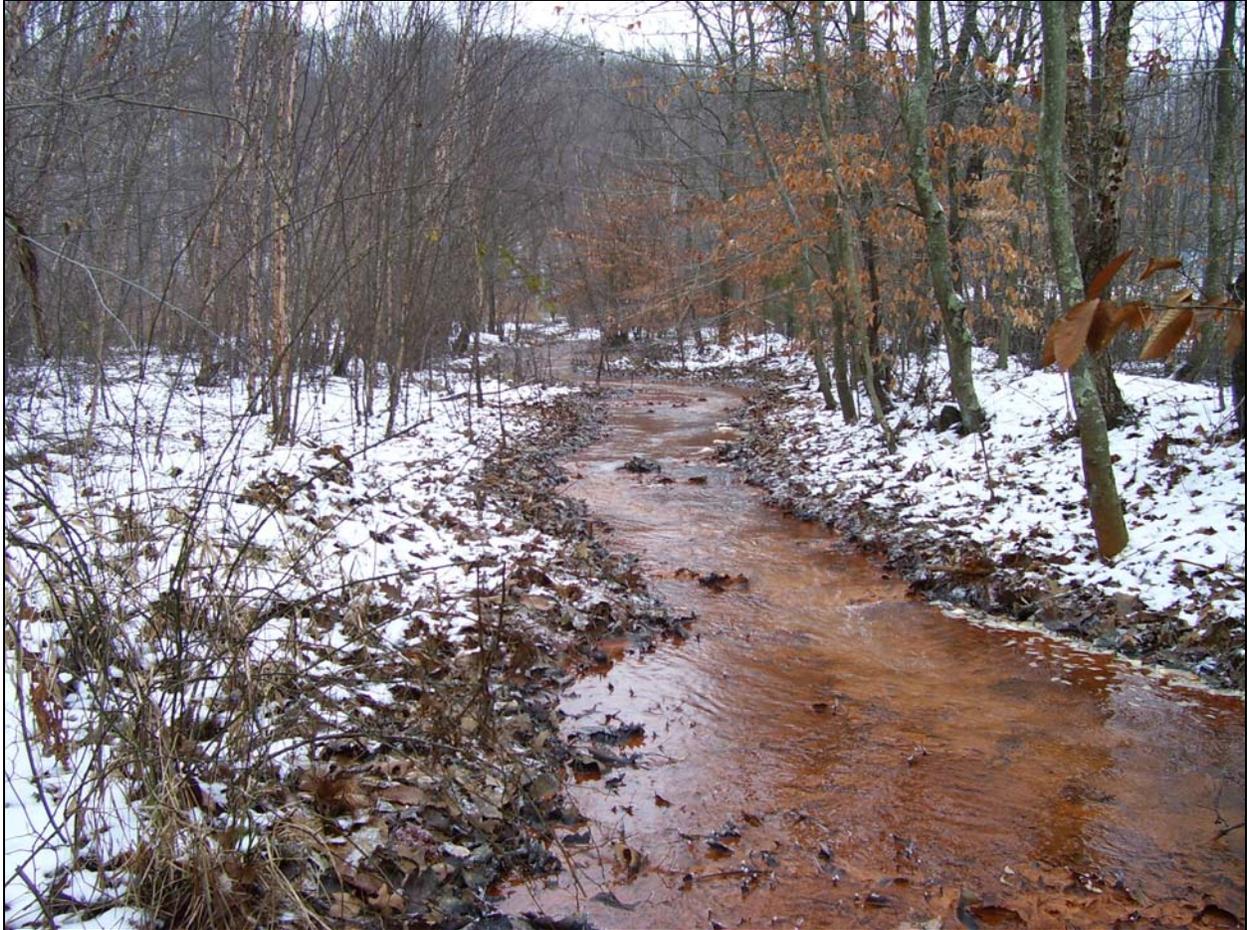
Mining in the Black Fork nested subwatershed (05 01) is concentrated in the lower part of the nested subwatershed. This nested subwatershed has the potential to meet its use designation with more AMD abatement with improvements to the existing Tropic AMD Treatment System and the capture and treatment of the Whitehouse Seep (see Figure 3-12).

Figure 3-12. The Whitehouse Seep in winter. Note the orange coloration of the water, indicating acid mine drainage.
