Rainbow Creek Sanitary Sewer Repairs

City of South Euclid

Problem: Raw Sewage Found in Euclid Creek

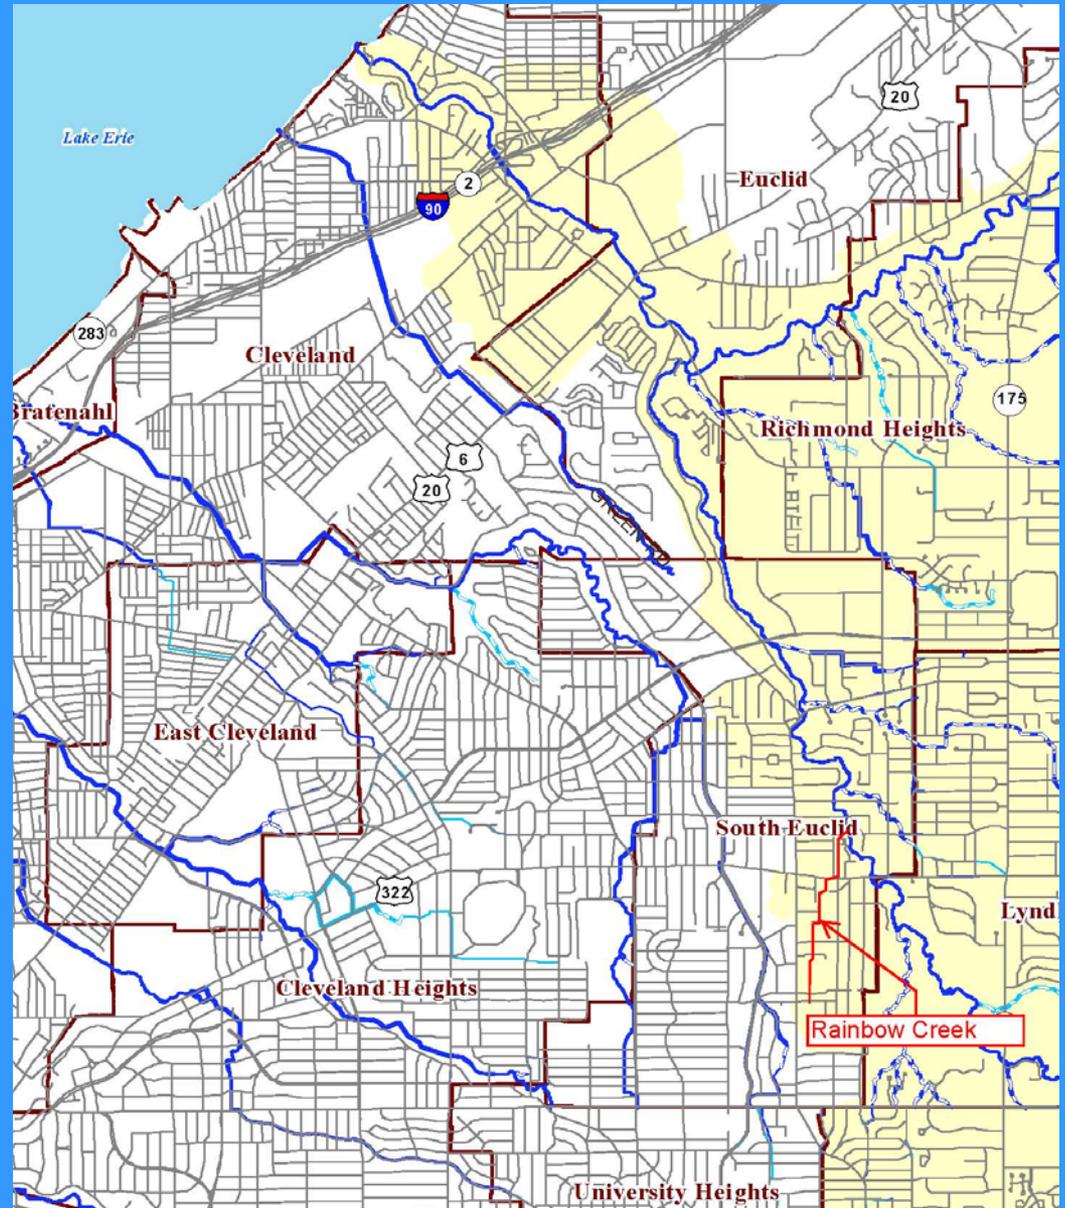
Rainbow Creek
– a forgotten tributary stream, completely enclosed by storm sewers

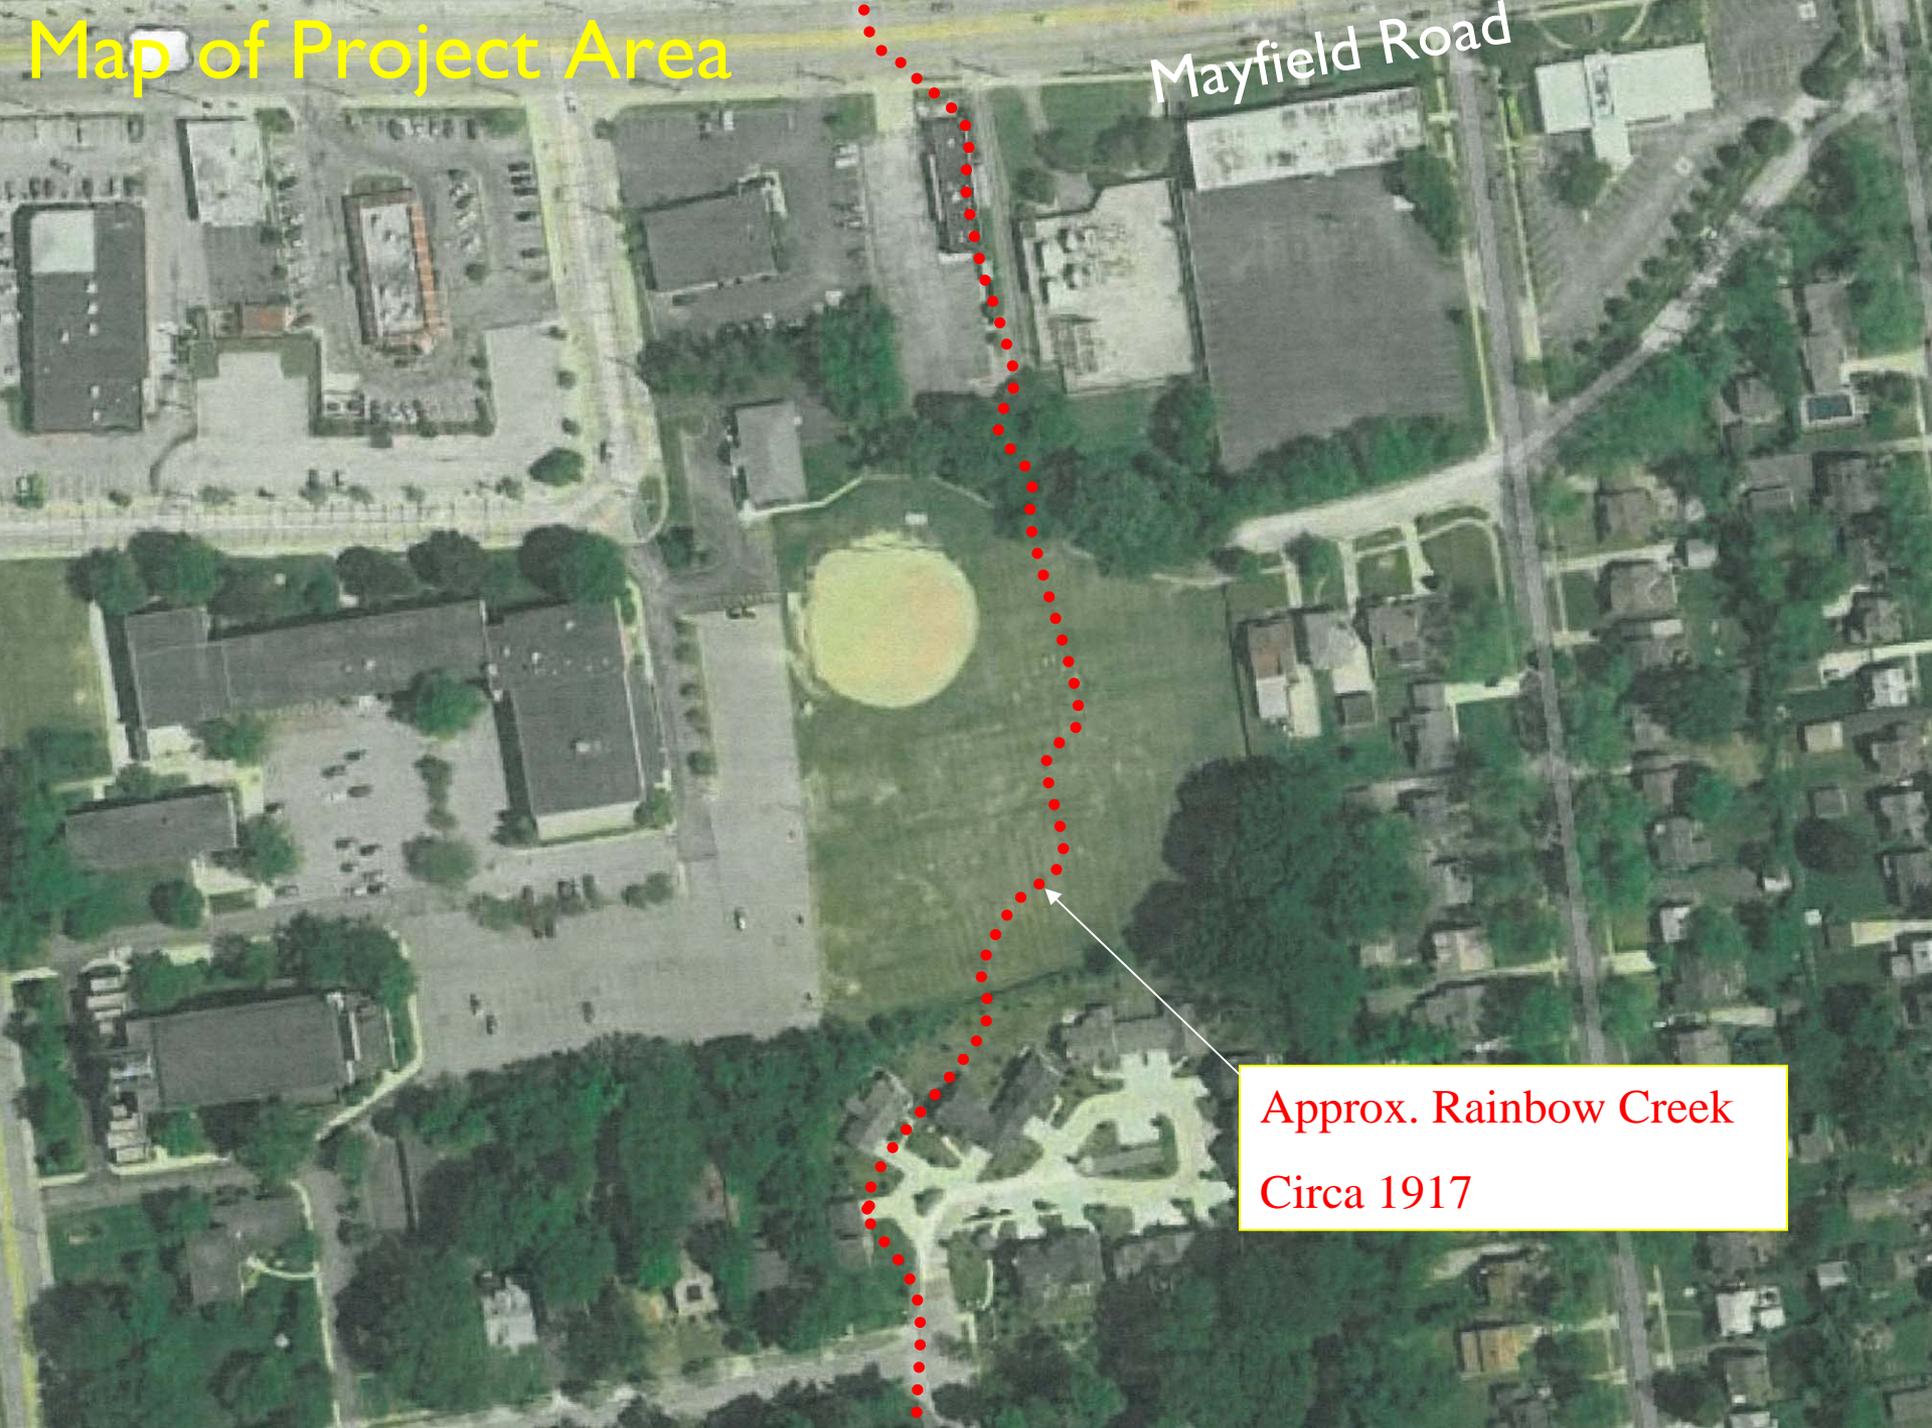
Map of Project Area

Approx. Rainbow Creek
Circa 1917

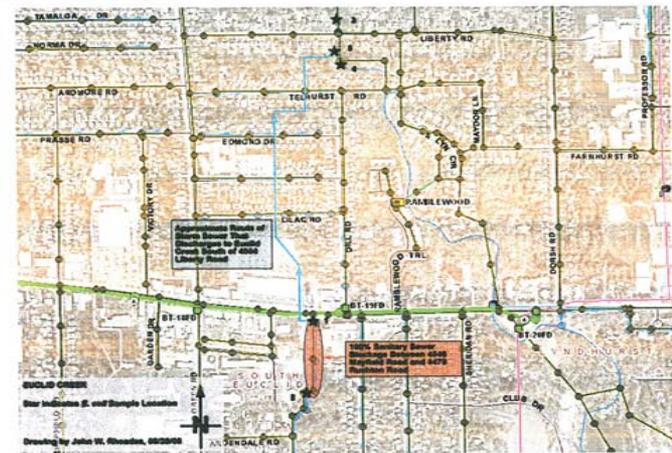
Figure 4: Collection system with sample locations.

Below are the locations and results of the samples analyzed for *E. coli*. The *E. coli* densities are in colony forming units per 100 mL.

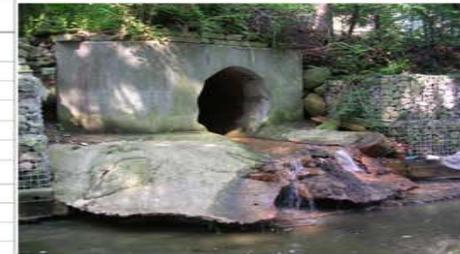
Outfall Photograph

Pipe Height (in): 48

Pipe Material:
 RCP PVC
 VCP Cast Iron
 CMP Other, describe:
 brick

Height from Invert to Stream Flow Level (ft): 3

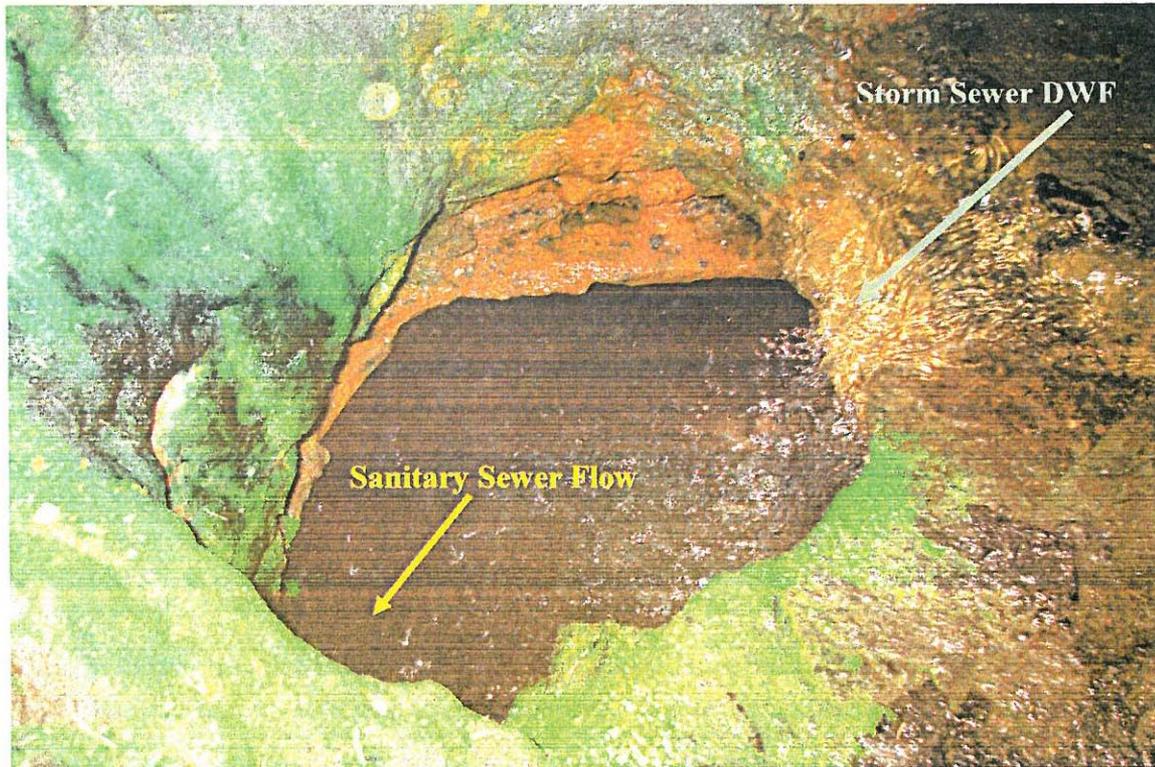
Figure 2: Storm DWF entering sanitary sewer through hole in the invert of the storm sewer.

- Eliminate Sanitary Inflows into an Existing 42” Storm, Including:
 - Installing New Sanitary Manholes for access and separation
 - New 8 inch Sanitary Sewer within existing easement
 - Point Repairs of Sanitary Sewer
 - CIPP lining of old Sanitary Sewer
 - Seal Existing Sanitary Manholes
 - Eliminate 90 degree bends at Mayfield Road

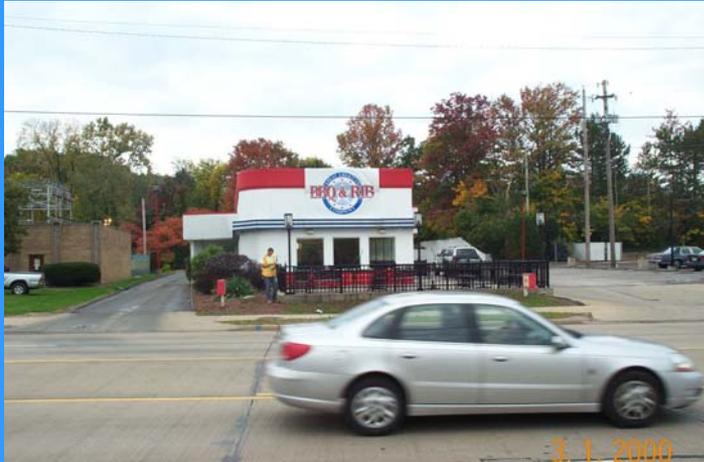
Located under restaurant drive,
near CEI substation

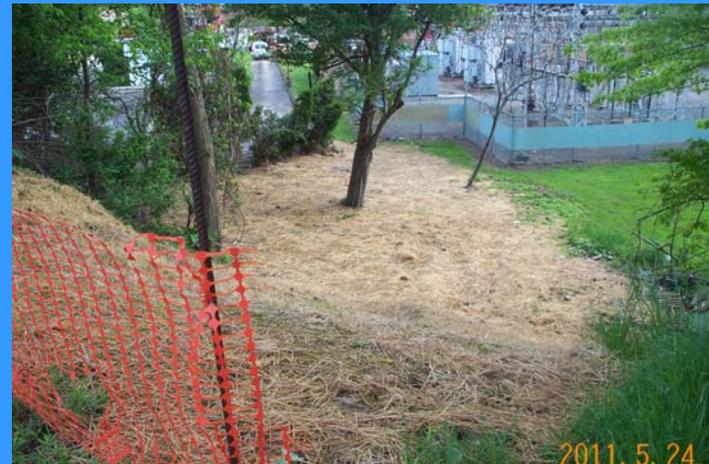
Manhole buried in overgrown,
steep hillside

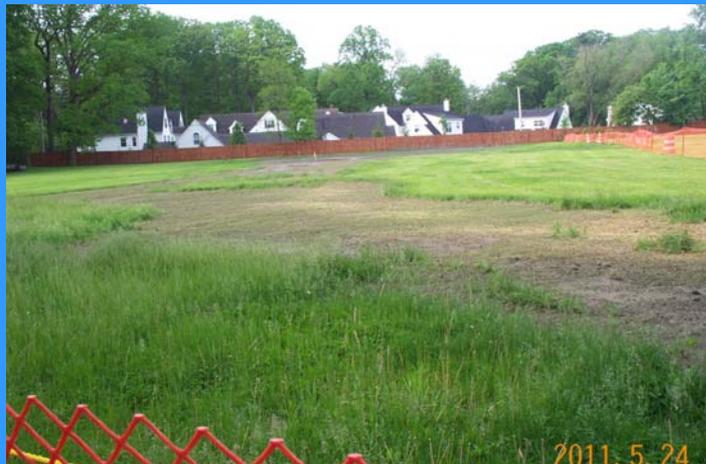
Located under ball field, and into
new condominium development

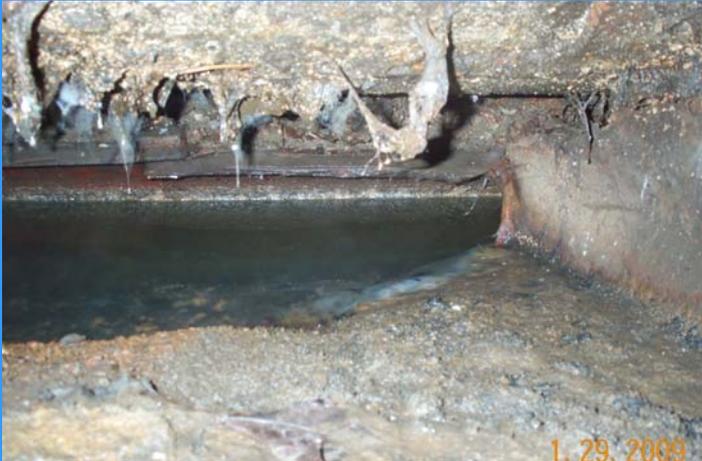
Sewers built in over/under configuration made access a problem

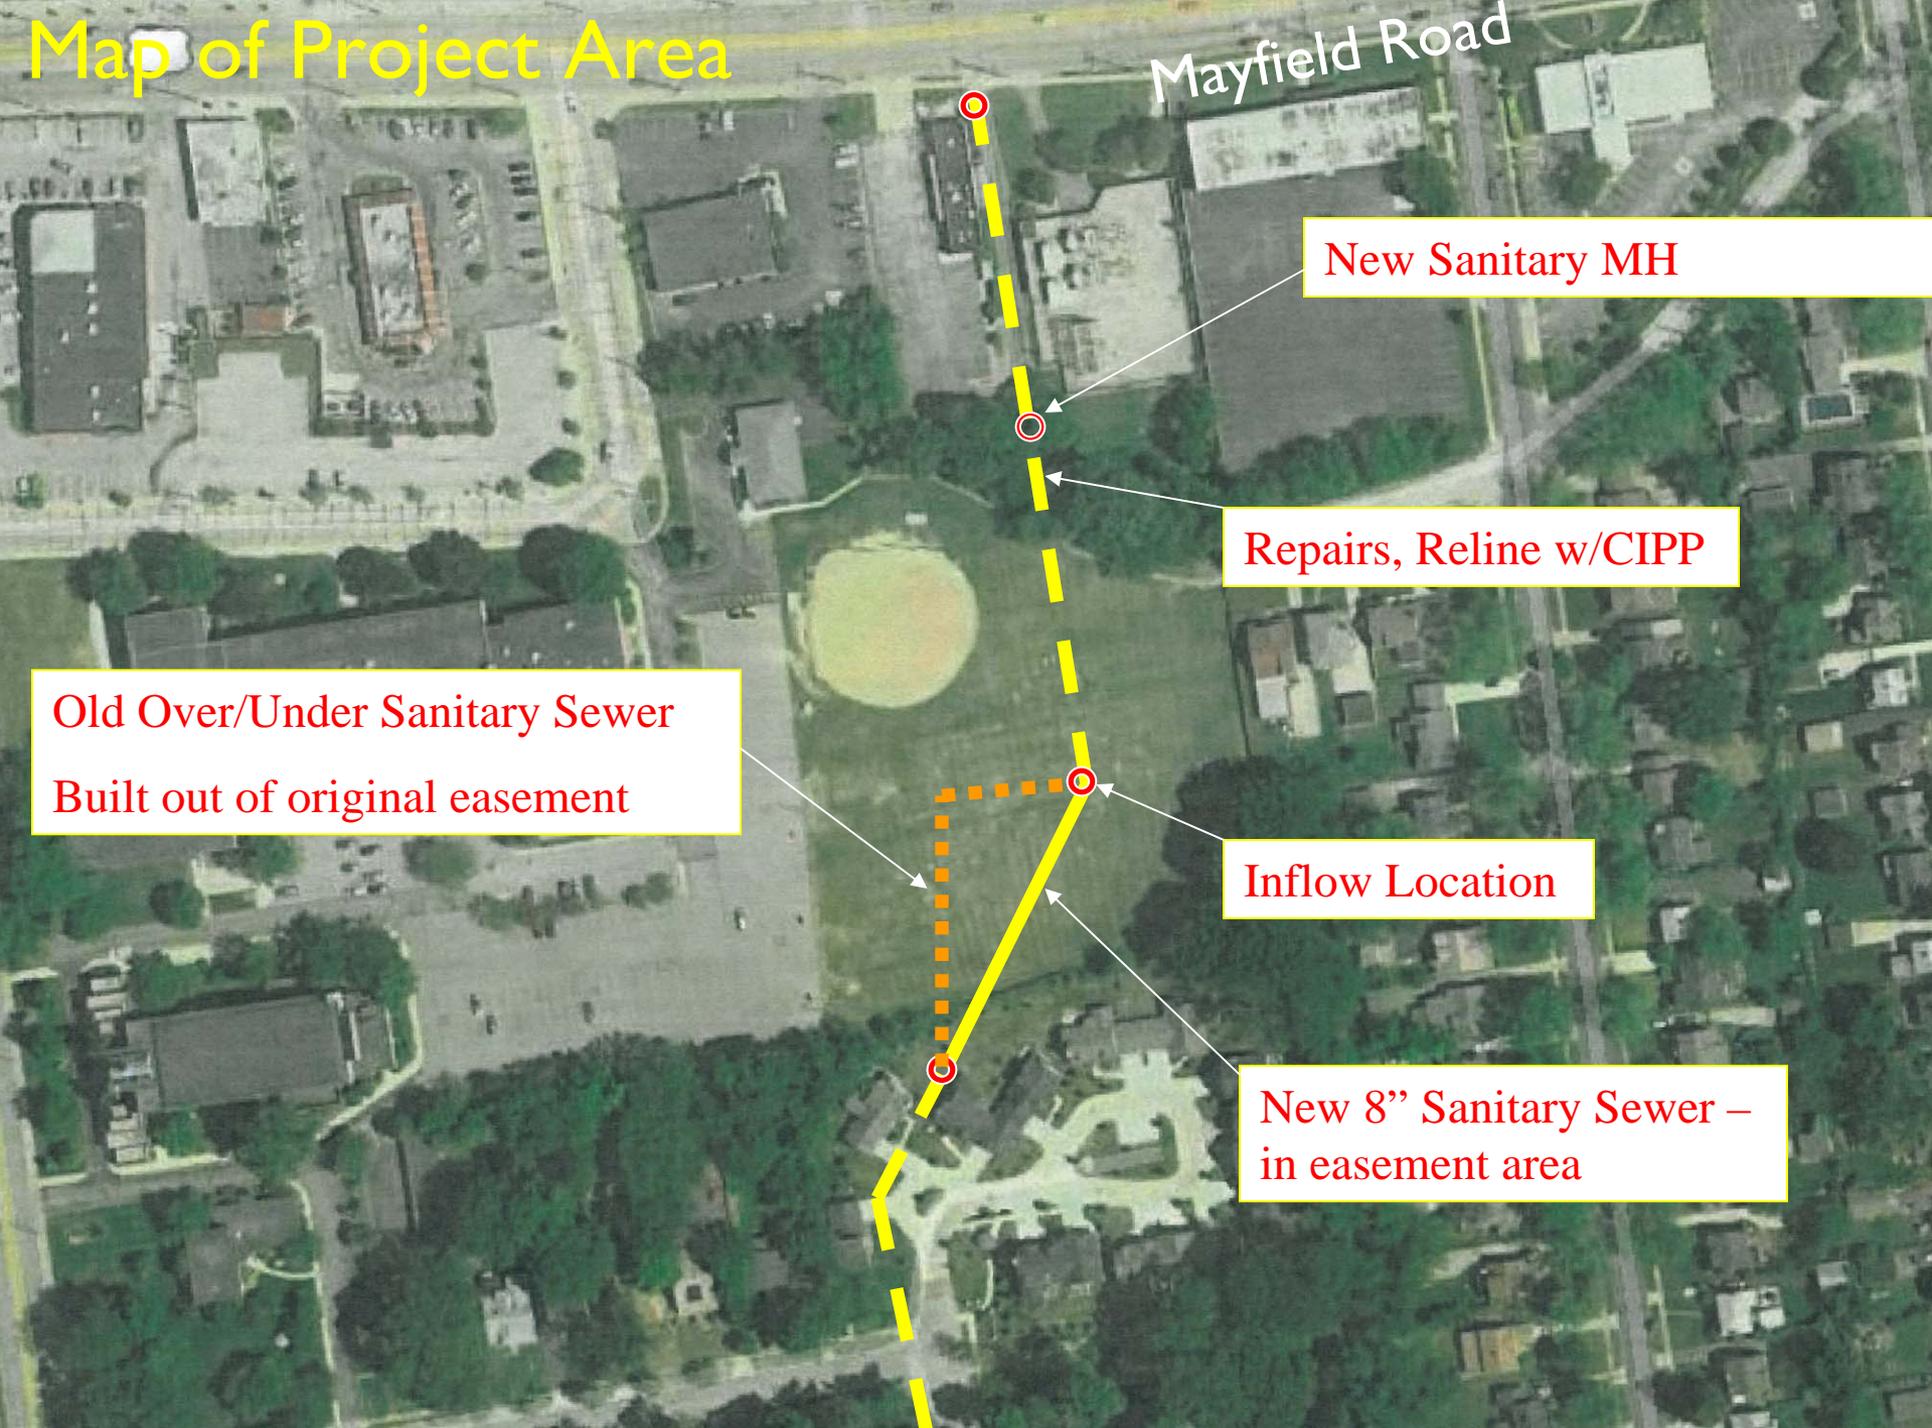
Map of Project Area

New Sanitary MH

Repairs, Reline w/CIPP

Old Over/Under Sanitary Sewer
Built out of original easement

Inflow Location

New 8" Sanitary Sewer –
in easement area
