Targeted Brownfield Assessment Review

Rickenbacker House

**Targeted Brownsfield Assessment (TBA) Review  
for  
Rickenbacker House  
Columbus, Franklin County, Ohio**

**September, 2003**

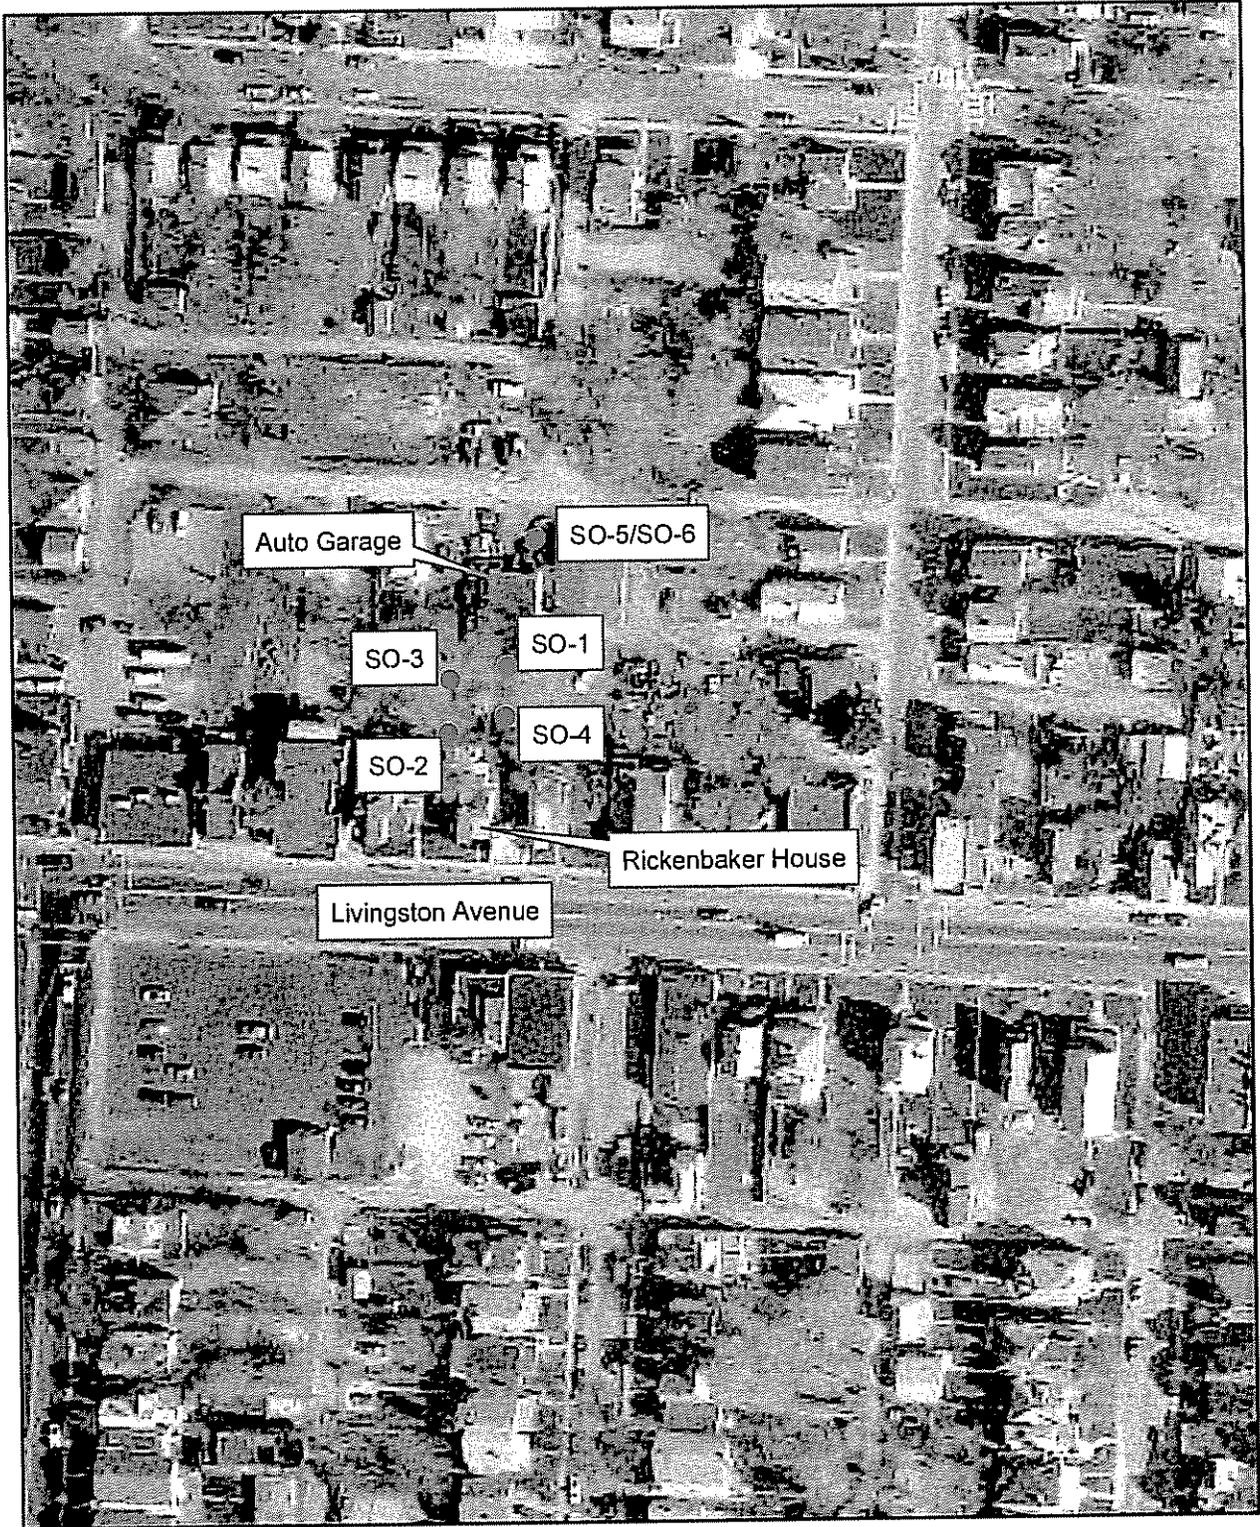
FIGURE 3  
Rickenbaker House  
Soil Sample Locations  
2000 Aerial Photograph

On May 22, 2003, the Ohio EPA conducted the site investigation. A total of 6 surficial soil samples were collected, as shown on Figure 2. Sample SO-1 through SO-4 were collected in the area between the auto garage and the Rickenbacker House. Samples SO-5 and the duplicate SO-6 were collected in the oily area along the fence line of the auto garage.

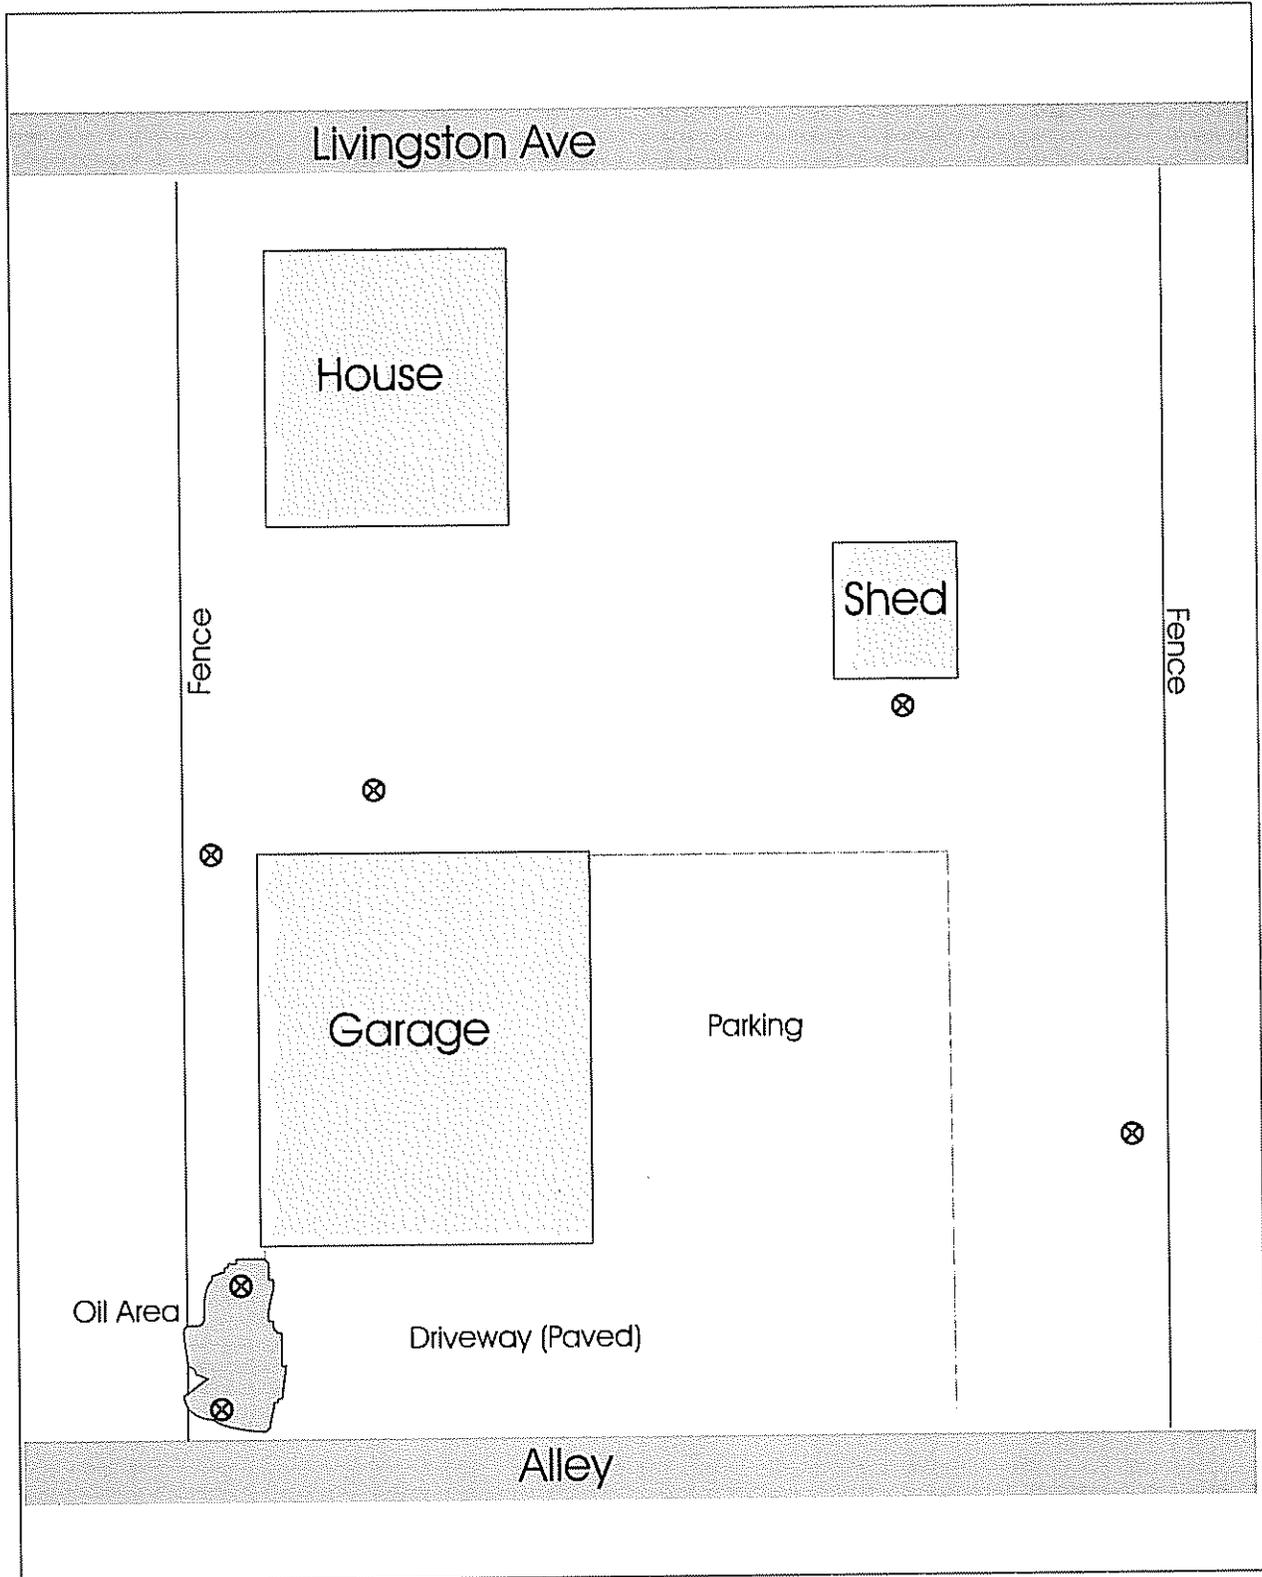
FIGURE 3  
Rickenbacker House  
Sample Location Map

The samples will be submitted Ohio EPA's contract lab for analysis of volatile and semi-volatile organic compounds, pesticides/PCB's and Target Analyte List (TAL) metals and cyanide. Sample locations can be found on Figure 3.
