NO ACTION DECISION DOCUMENT

BRAC Portion of Rickenbacker Air National Guard Base (Ohio)

**Sites SS005, SS013, SS014, SS015, SS016, SS017, SS026,
SS039, SS040, EBS 7, EBS 8, EBS 9, EBS 11,
EBS 20, EBS 21, EBS 30, EBS 31, and Bldg. 553**

September 2014

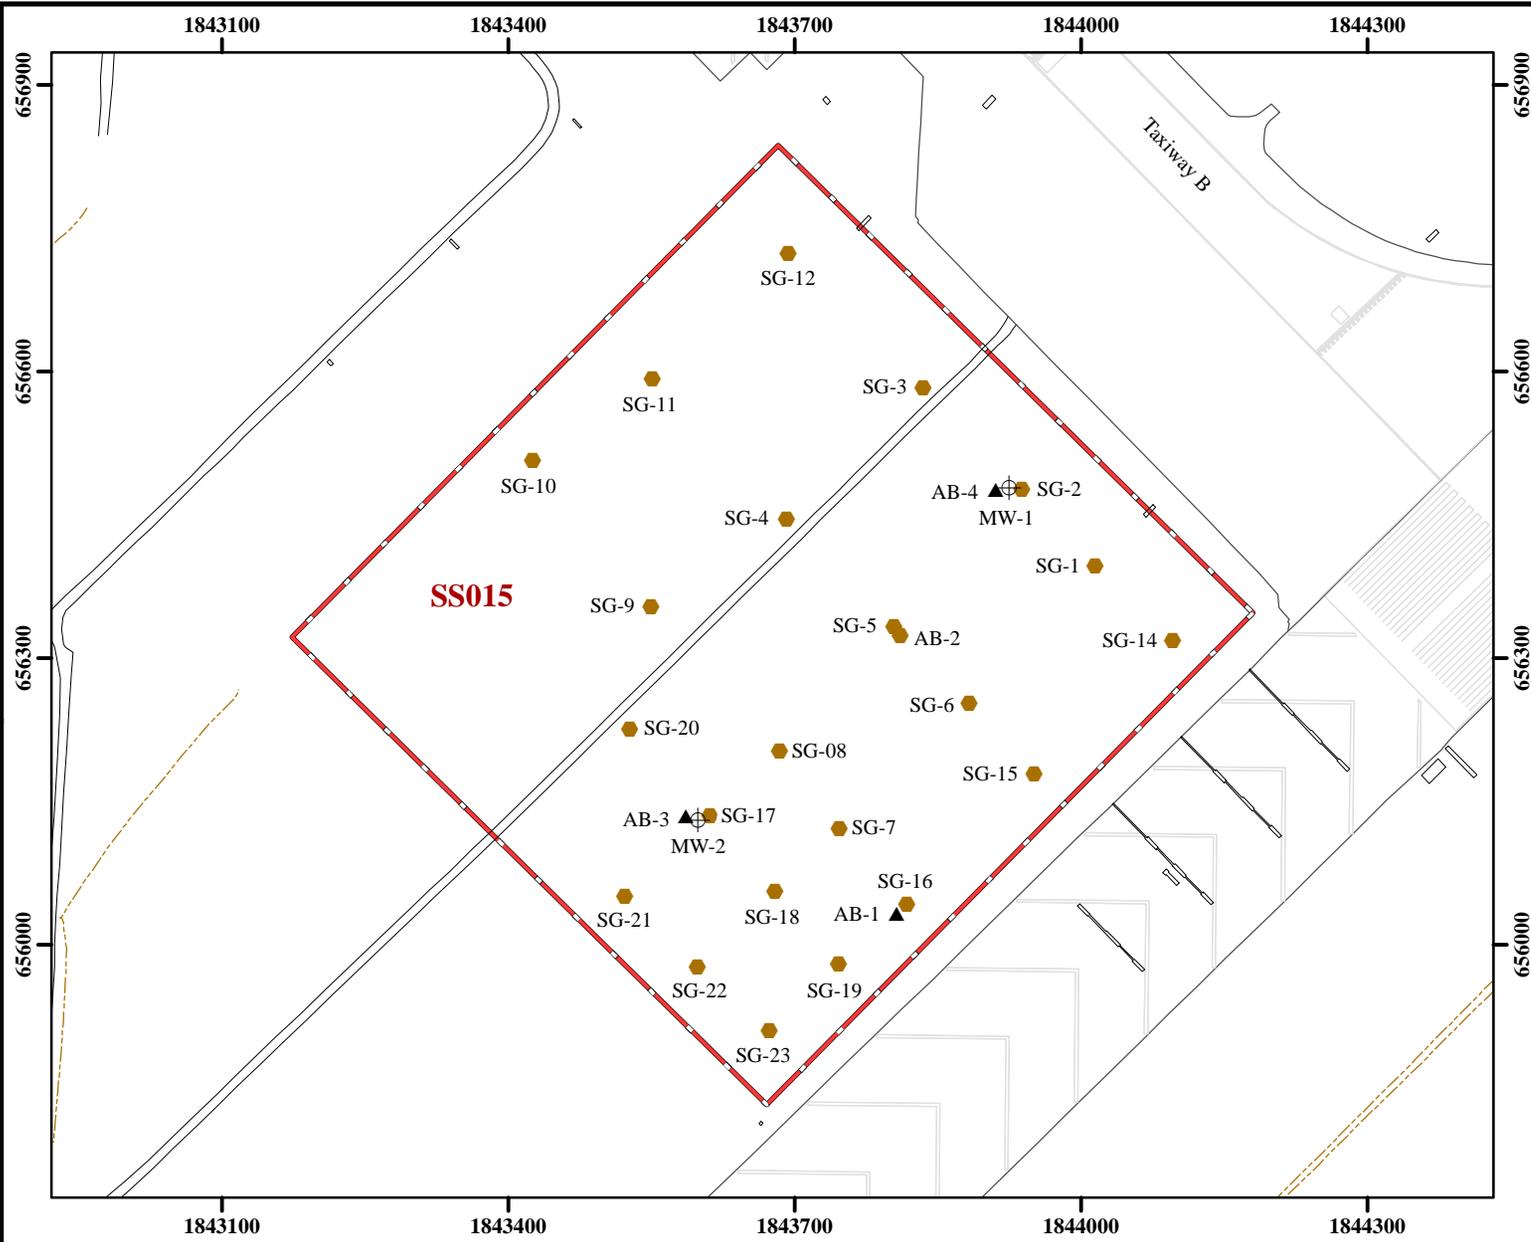
The Southwest Fuel Dump Area (Site SS015) is located near the western corner of the intersection of the NE-SW Primary Instrument Runway and Taxiway B within Parcel D1.A. Site SS015 consists of a flat, broken asphalt area, locally covered with grass, approximately 25 feet wide by 75 feet long. The site was reportedly used as a fuel dump area for aircraft prior to entering hangars for maintenance. The site may have been used for defueling as early as the 1940s. **Figure 1-5** shows the Site SS015 location.

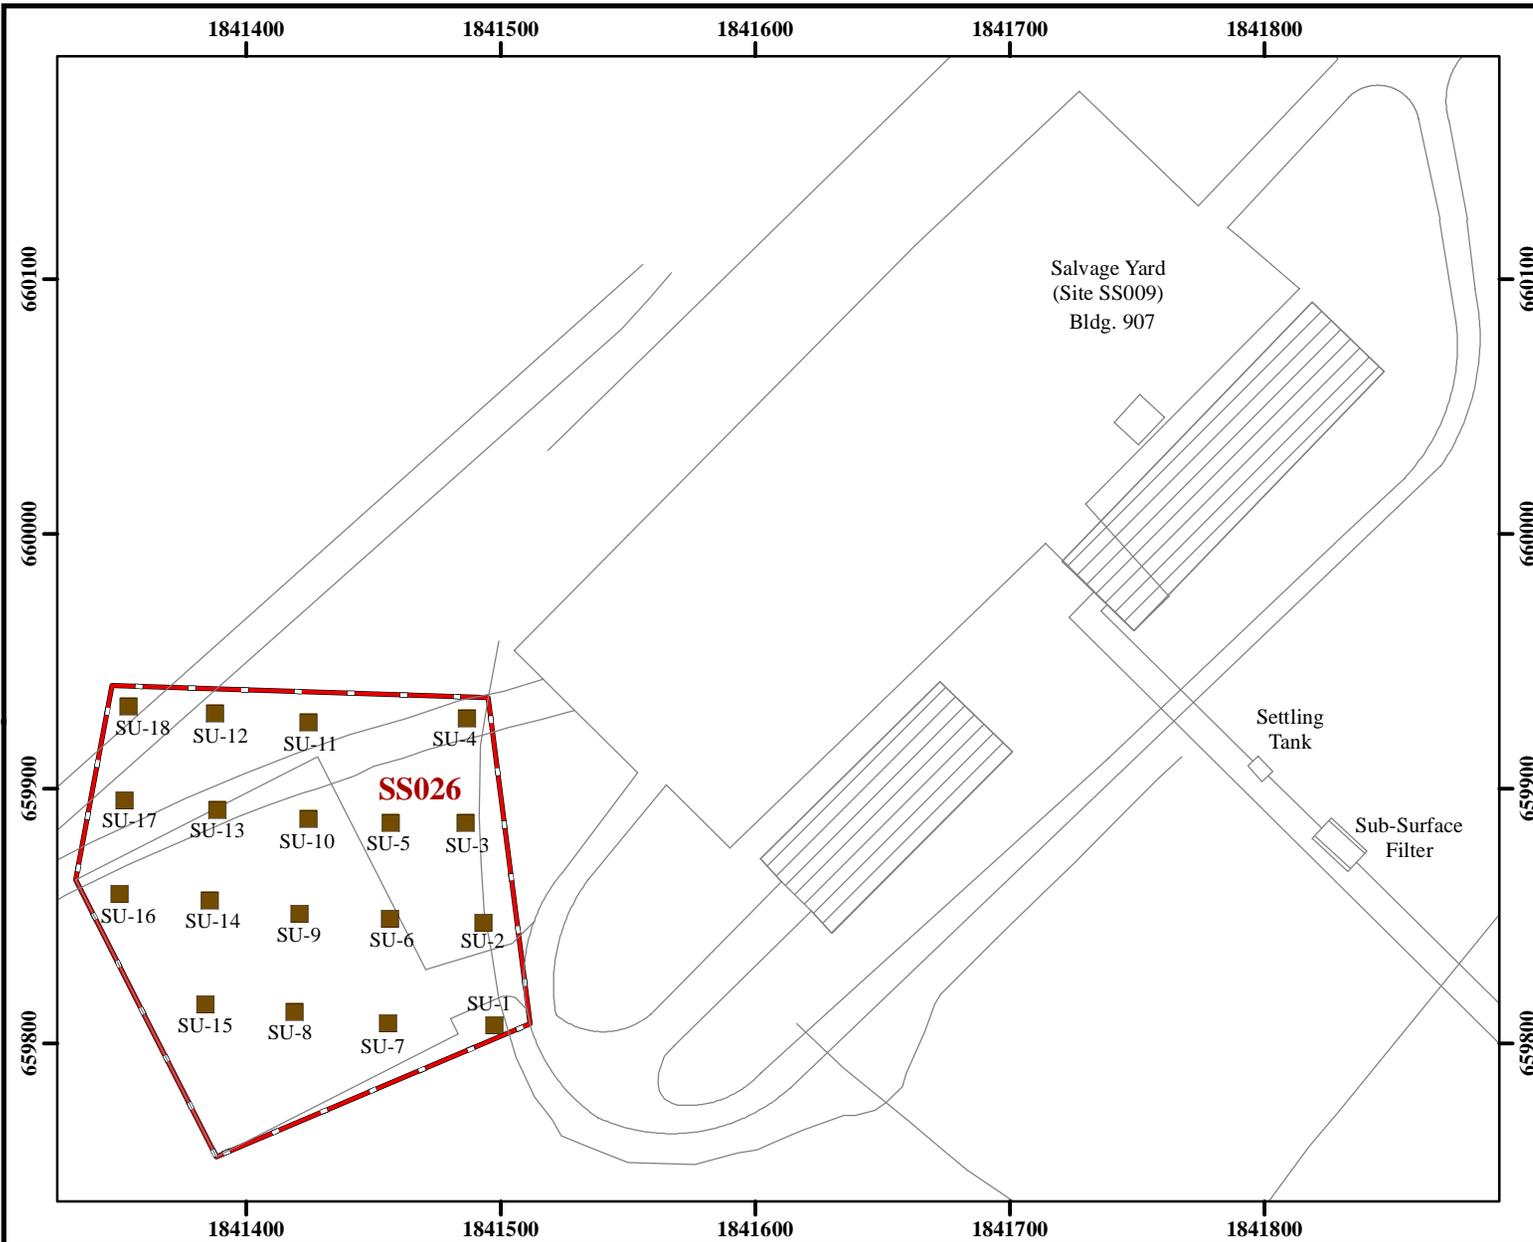
The Electric Transformer Storage Area was in use until 1975. The site is located at the southwest end of the Base Salvage Yard (Site 9), between Vause and South Perimeter Roads in Parcel D3.A. There are no records of whether the transformer dielectric fluids contained polychlorinated biphenyls (PCBs) and there are no records of fluid leaks. **Figure 1-8** shows the Site SS026 location.

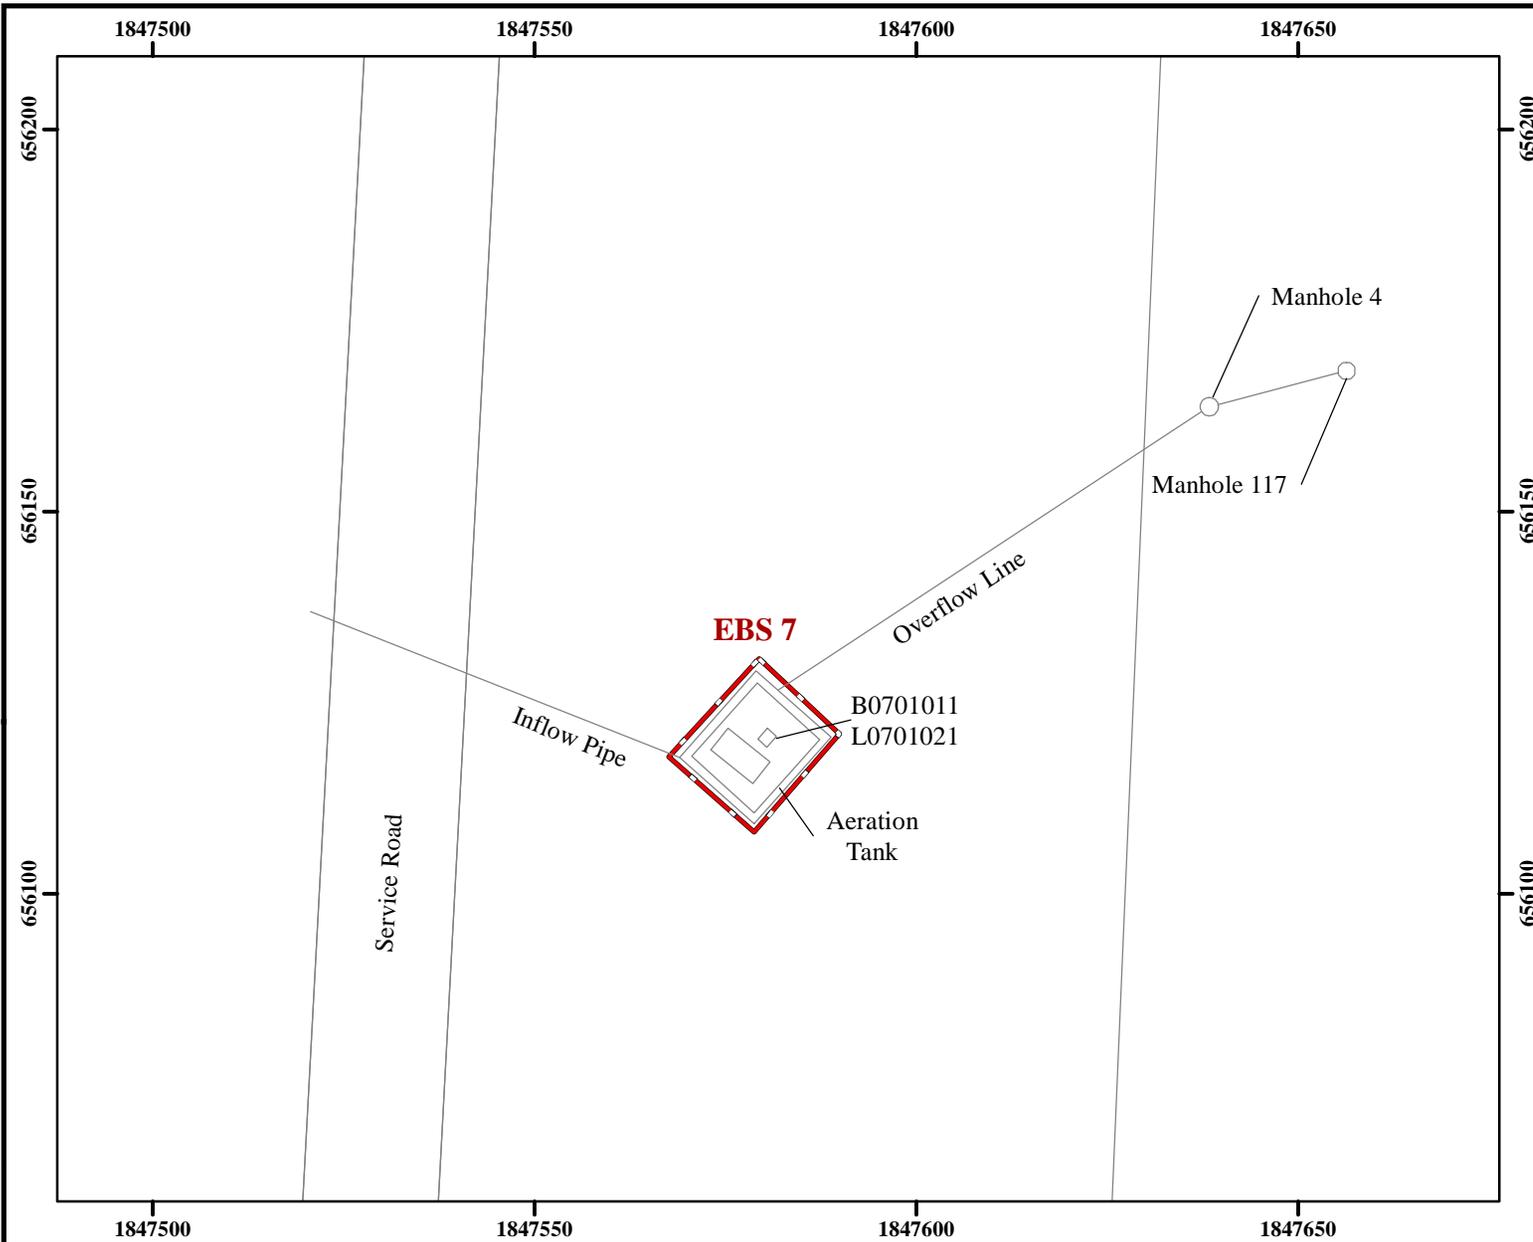
The package Sewage Treatment Plant (STP) located in Parcel D1.A was built in 1959 and serviced the guard house, check-out building, and missile maintenance building of the munitions storage area. The plant consisted of an approximately 225 ft³ below-grade aeration tank. The fenced concrete 11-foot-deep open-top tank was observed to contain at least 6 feet of rainwater on October 7, 1994. Effluent was discharged to a storm sewer at Manhole 117, which eventually discharged to Walnut Creek. **Figure 1-11** shows the Site EBS 7 location.

The 1996 SEBS concluded that the only analyte above method detection limit was barium (0.807 mg/L) in the Toxicity Characteristic Leaching Procedure (TCLP) analysis from the sludge, well below the TCLP toxicity limit (100 mg/L). The SEBS concluded that NFA was recommended for this site (IT, June 1996). The most recent USEPA tapwater screening level for barium is 7.3 mg/L and the MCL is 2 mg/L. The TCLP detection was well below the MCL and tapwater screening level (**Table 1-13**).

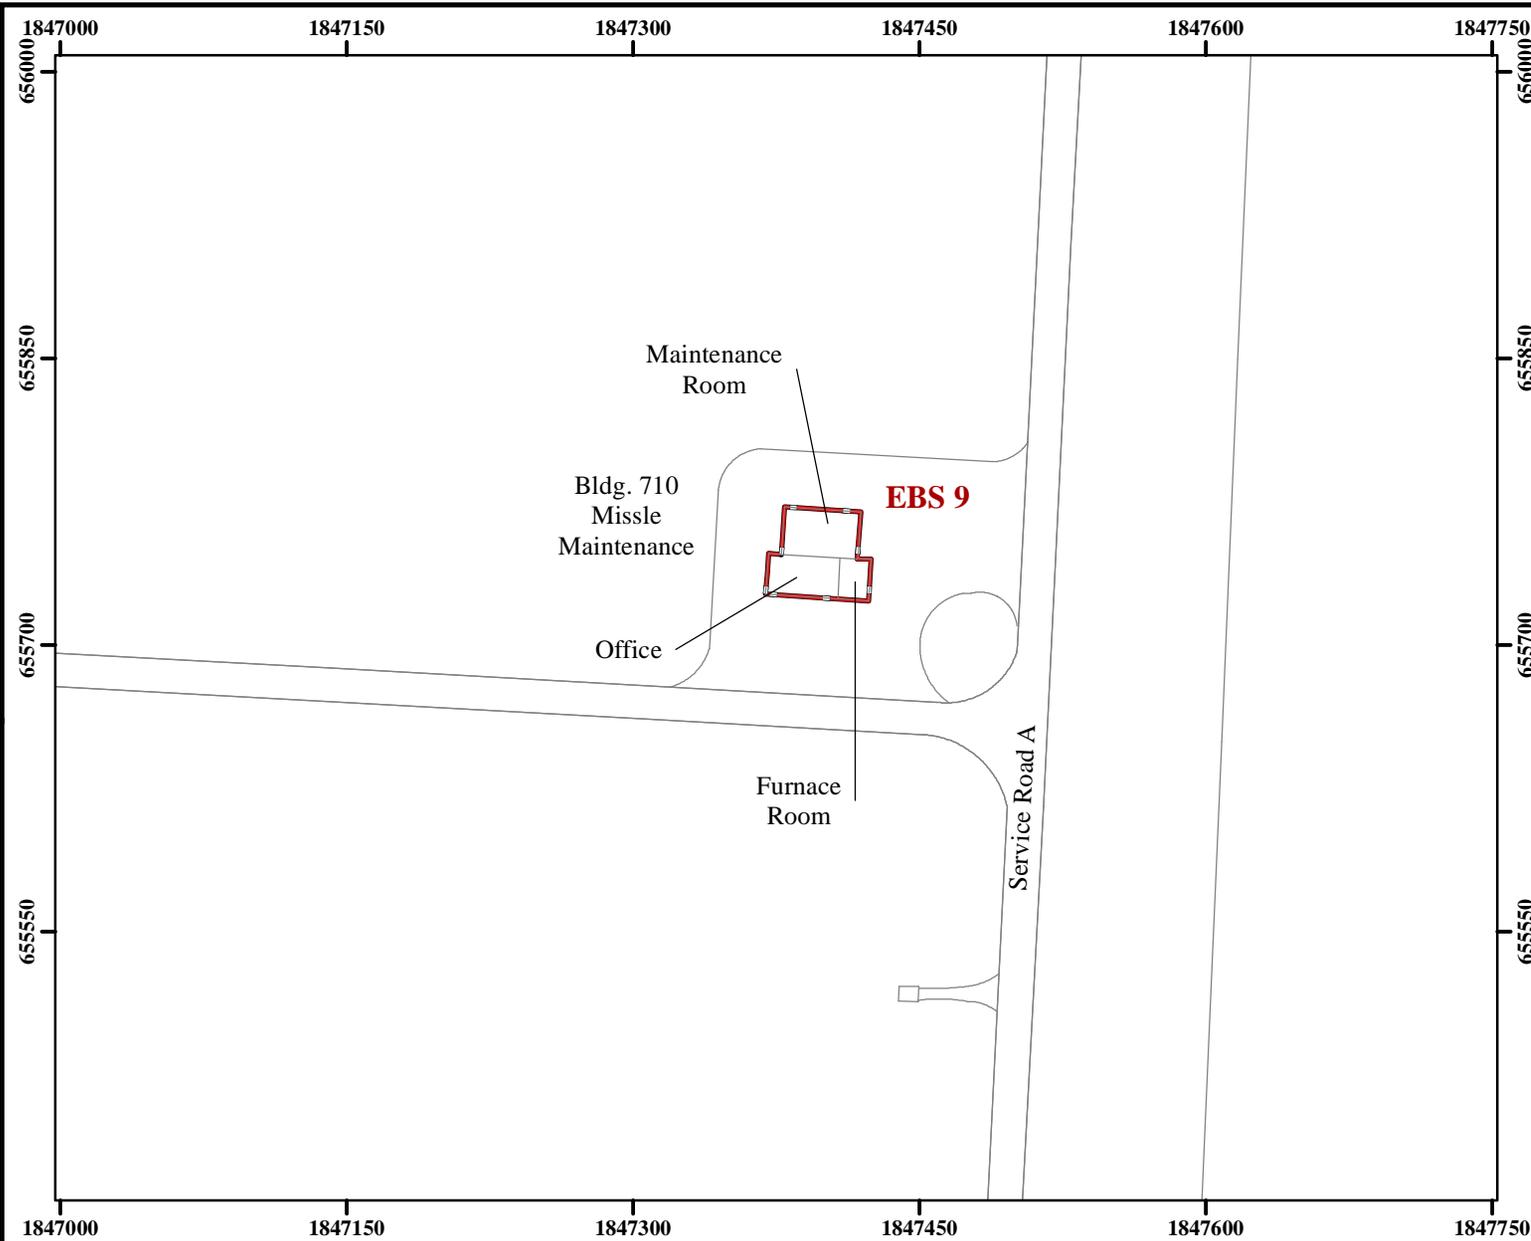
Building 710, located in Parcel D1.A, was a concrete block building, built in 1959 and was used for missile maintenance. The building had office space, storage area and a maintenance bay. The maintenance bay was approximately 40-by-20-foot high with a concrete floor, floor drains (believed to lead to the package STP) and overhead doors at either end. A VSI was conducted at Building 710 during the 1996 SEBS. The building was observed to be empty and the maintenance bay floor had a single stain (with an oil-like appearance) covering approximately 30 in². The furnace room had both an oil-burning furnace and an air conditioner. The floor around

the furnace was stained with what appeared to be petroleum (suspected to be diesel fuel), and the room had a diesel odor. The floor stain in the furnace room potentially had surface organic contamination. However, the stain had no build-up and a sample of the stain could not be collected. A UST, which was pulled under BUSTR, had once been located adjacent to the building. No incident report was ever filed for this tank and the tank was removed successfully in August 1994 (Ogden, 1995). The 1996 SEBS concluded that NFA was recommended for this site (IT, June 1996). **Figure 1-13** shows the Site EBS 9 location.

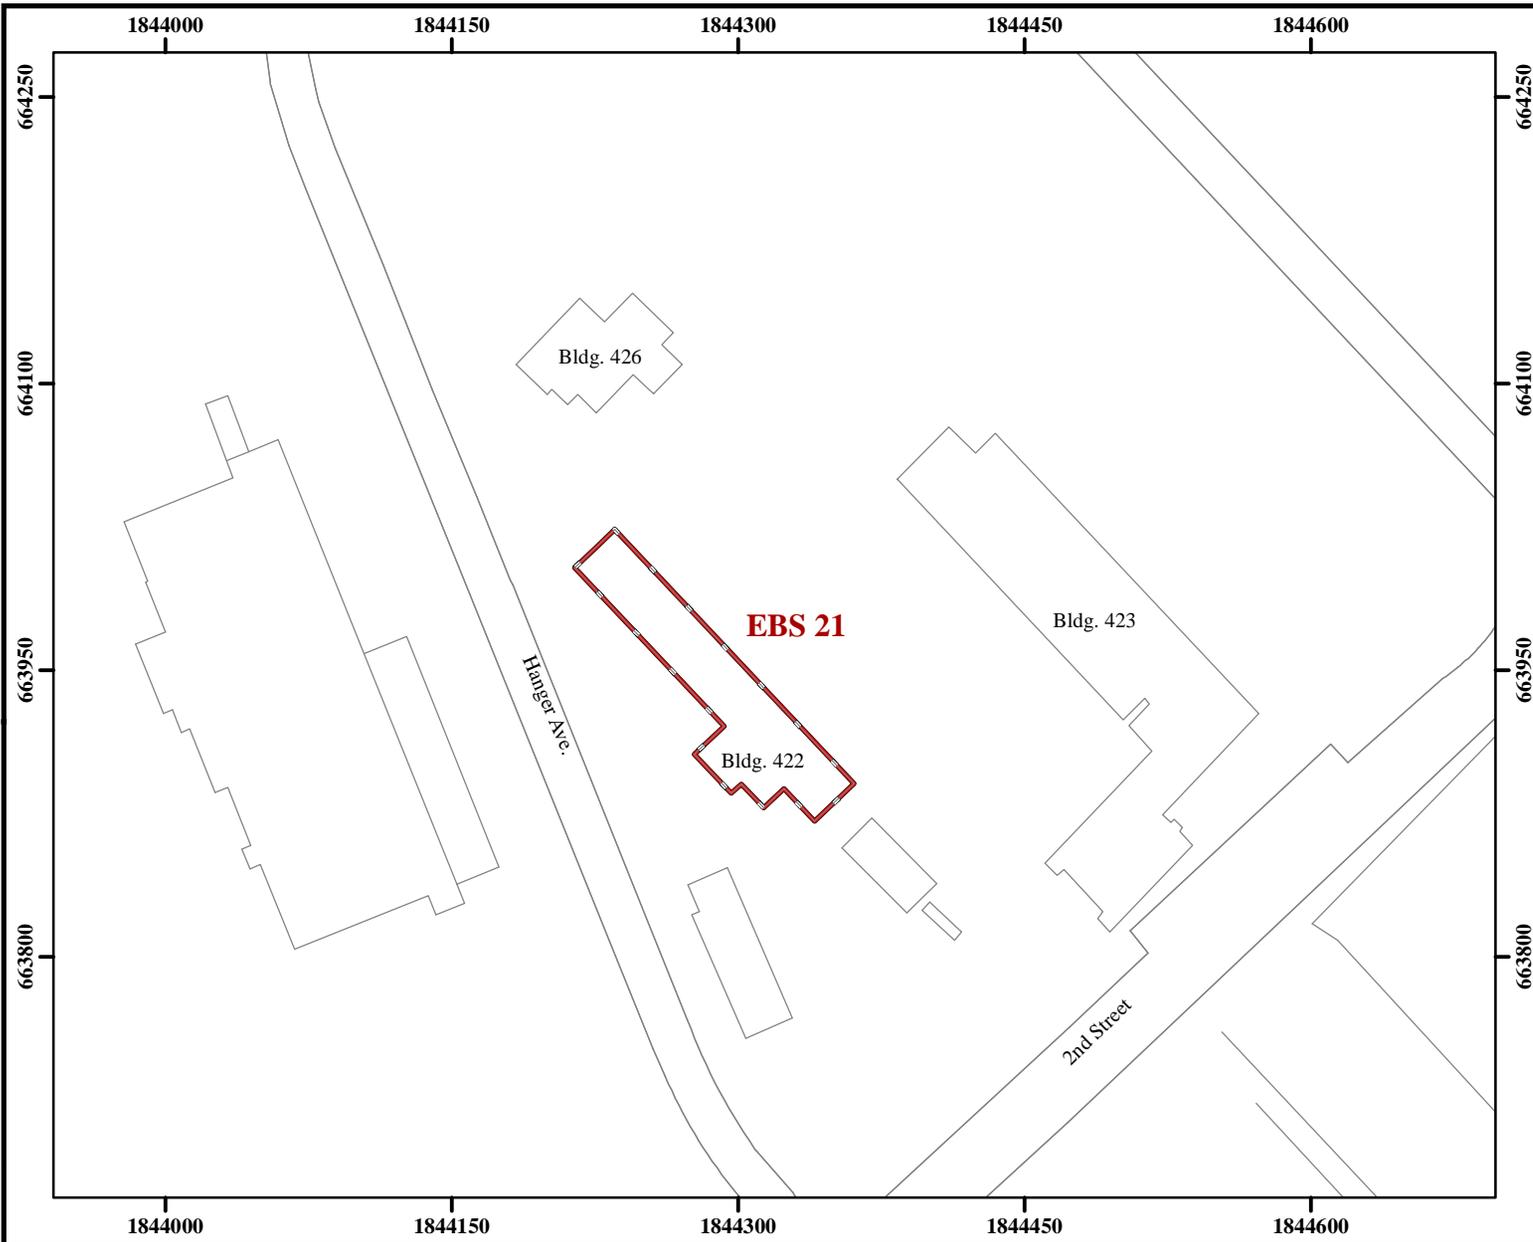
Building 422, the BCE Maintenance Shop, was a 7,500 ft² structure built in 1942 in the north-central portion of the Base in Parcel D2.A. The abandoned building was a single story wood frame constructed on a concrete slab at grade. The building housed the base's heating and air conditioning shop, welding shop, and offices of the 160 CEF entomology group. The entomology group vacated the building in 1980, and the other tenants vacated the building in 1992. A VSI of the building was conducted during the 1996 SEBS. The building was observed

to be in very poor condition, with broken windows, a collapsing roof, and having experienced vandalism. The building contained excess equipment from the former tenants, e.g. furniture, lockers, pipe racks, miscellaneous records and household waste. However, the 1996 SEBS determined that there was no evidence of any contaminant release associated with this building, and in accordance with SEBS recommendations the household wastes be removed and properly disposed of (IT, June 1996). **Figure 1-16** shows the Site EBS 21 location.

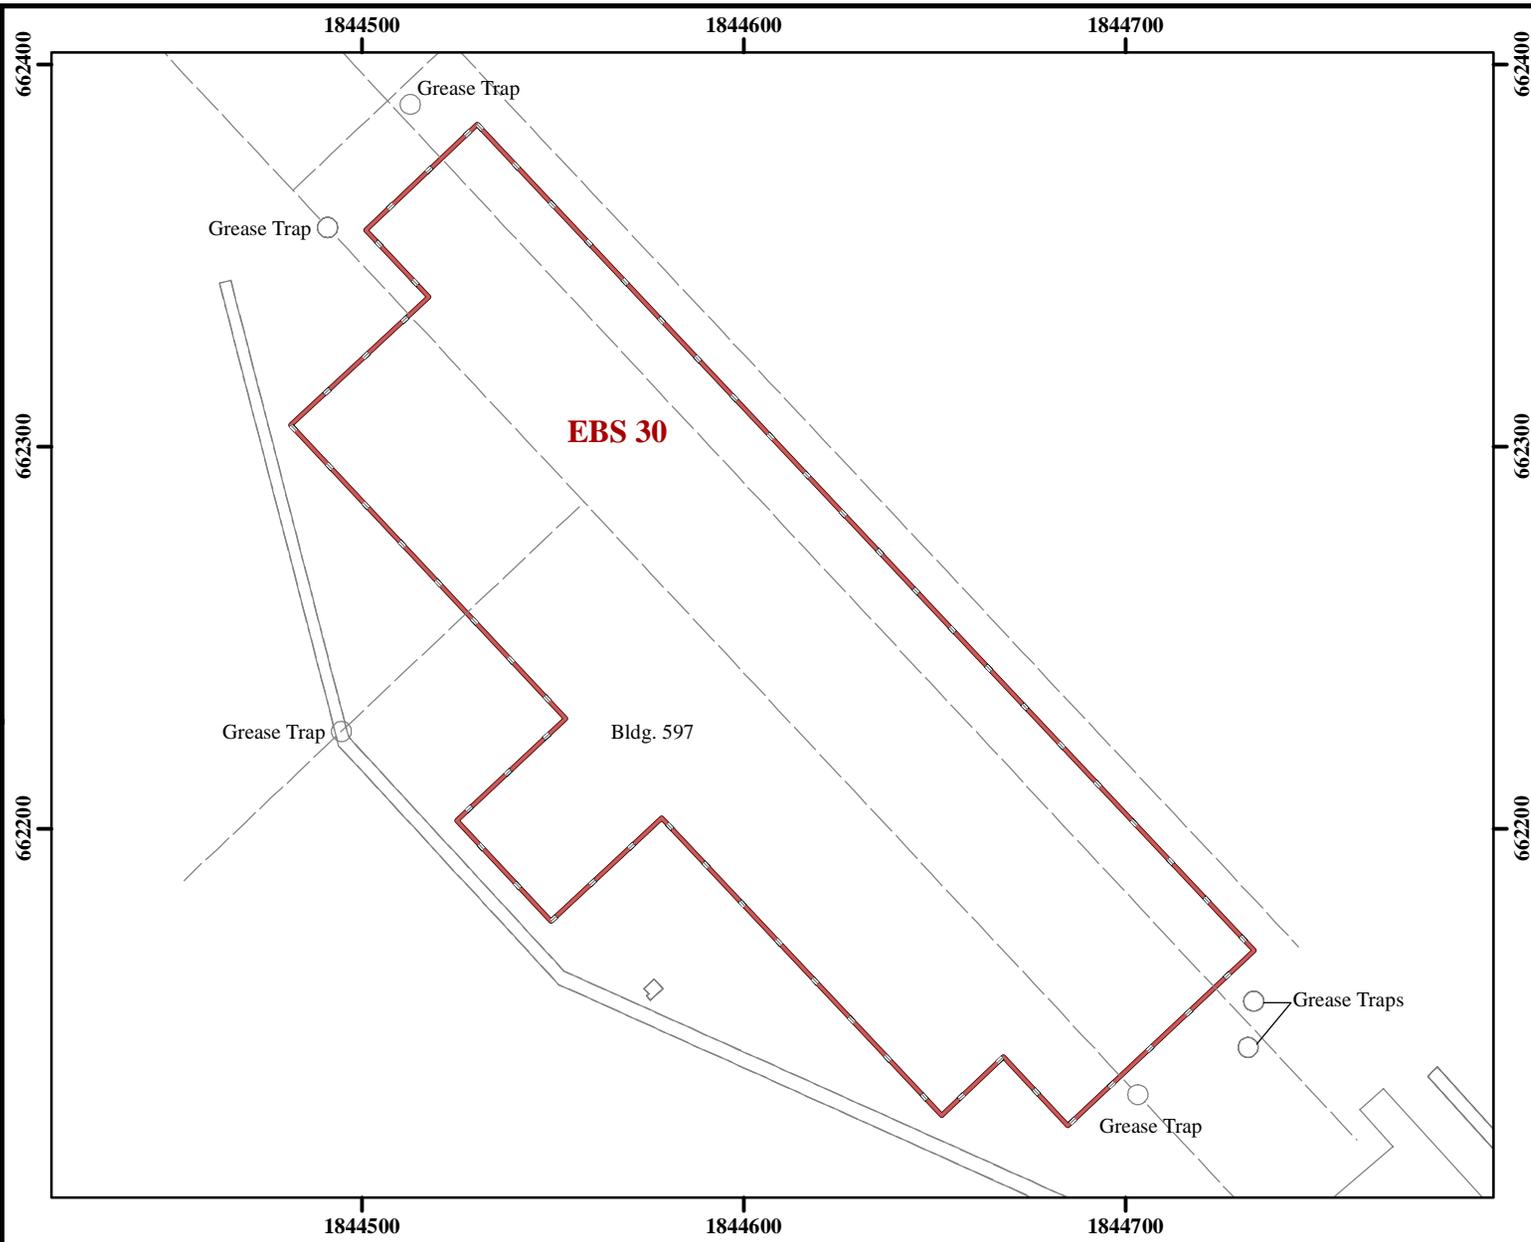
Built in 1954, Building 597 in Parcel D2.A is currently vacant but was used as a hangar where airplane fuel cells (the fuel bladders in airplane wings) were repaired. The building was constructed of steel frame and walls on a concrete slab at grade. The northwest end of the hangar was used to service A-7 fighter aircraft, and the southeast end was used to service C-130 aircraft. The building was used by the CRAA to store snow removal equipment and electrical supplies for servicing lights of the airfield. Oil Water Separators (OWSs) were located at each end of the building. The building likely contained lead-based paint because it was constructed prior to the 1978 DoD ban on the use of lead-based paint in residential buildings. No areas of concern were noted during the 1996 SEBS and the building was observed to be in good condition. The 1996 SEBS concluded that there was no evidence of any contaminant release associated with this site (IT, June 1996). **Figure 1-17** shows the Site EBS 30 location.

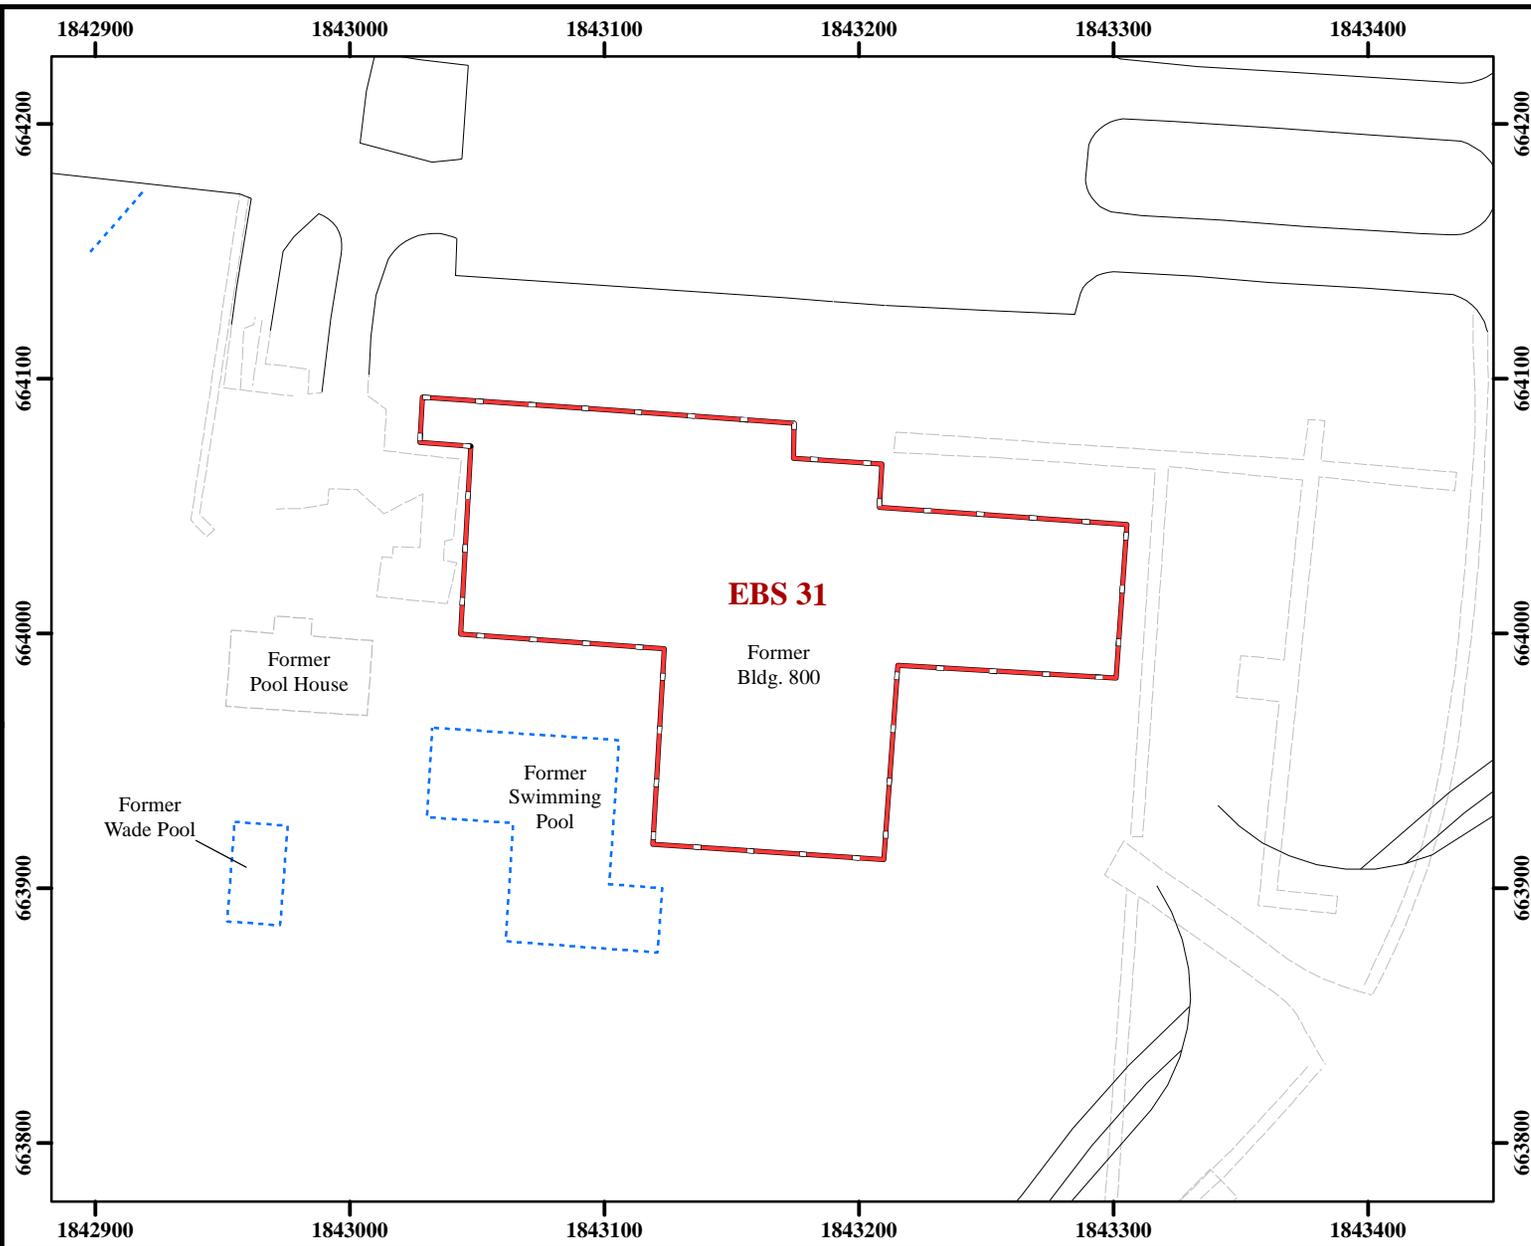
The former Consolidated Club Complex contained meeting facilities, a kitchen, a food service area, a swimming pool, and a wading pool in the northern portion of the base within parcel D2.A. The club also consisted of two outdoor pools, a bathhouse, several small support/storage buildings, and a main building. Portions of the complex were first built in 1958. The club was closed and the building was demolished at an unknown date. Since the facility was used for club-related activities only, it is not believed to contain hazardous material. The only hazardous chemicals that might have been stored in large quantities were those related to swimming pool maintenance. **Figure 1-18** shows the Site EBS 31 location.
