**Biological and Water Quality
Study of the Olentangy River,
Whetstone Creek and Select
Tributaries, 2003-2004**

**Crawford, Delaware, Franklin, Marion and Morrow
Counties**

EAS/2005-12-6

OHIO EPA Technical Report EAS/2005-12-6

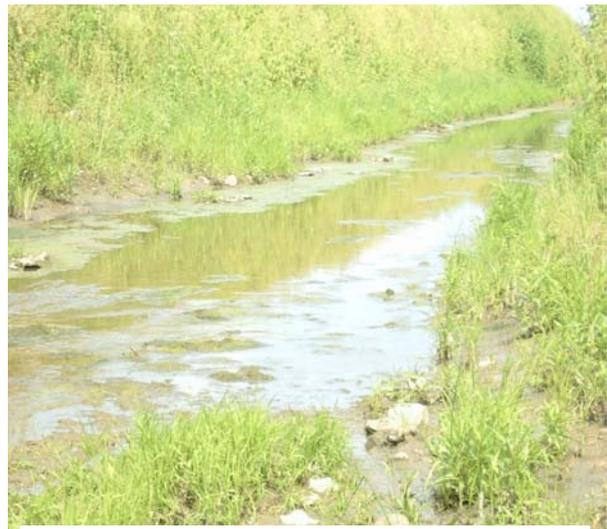
The results of these activities in QuQua Creek near Owens Road (RM 4.6) resulted in a channel with gravel and sand as the only substrate types present. Silt was present in normal to moderate amounts though substrates were moderately to extensively embedded, limiting the amount of interstitial spaces available for aquatic organisms. Instream cover was nearly absent with only sparse amounts of shallow areas providing any instream cover. The recent channelization activities left the stream with none to low sinuosity, poor development and low stability.

Figure 39. Algae present in QuQua Creek (RM 4.6).

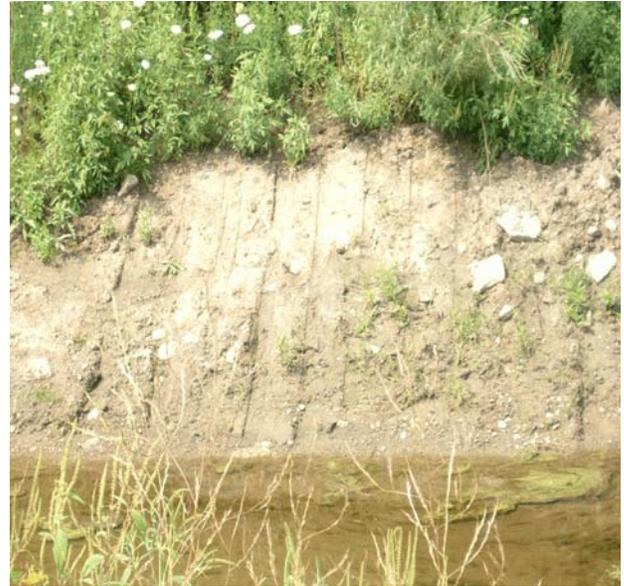
The stream was very uniform in cross-section, and nearly trapezoidal in configuration. Channelization techniques including bank shaping, dredging, canopy removal, relocation and snagging were all evident. No buffers were present adjacent to the high intensity row cropping along the stream, increasing the amount of sunlight available to the excessive nutrients in the stream. This resulted in excessive algal production (Figure 39). Removal of vegetation and reshaping of the stream resulted in increased erosion as moderate bank erosion was noted throughout the upper reach (Figure 40).

Figure 40. Evidence of recent channelization activities increasing bank erosion in QuQua Creek (RM 4.6).

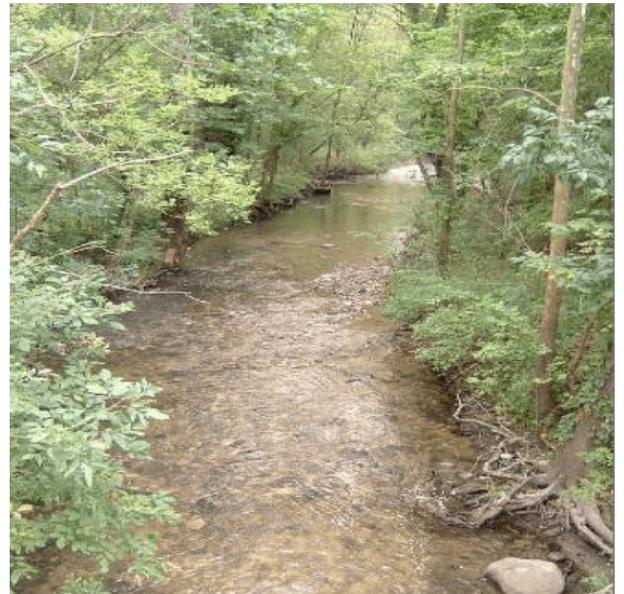
In contrast to the upper reach, the lower portion of QuQua Creek, near State Route 98 (RM 0.1), is restricted from development as part of the controlled floodway for Delaware reservoir, which is under national Federal Emergency Management and Agency (FEMA) control (Figure 41). According to Marion county officials, this is the only reason the lower portion of QuQua Creek was not channelized along with the upper reach. The lower portion of the stream was last channelized in 1946 according to Marion County Officials.

Figure 41. Intact riparian corridor and natural appearance of QuQua Creek near State Route 98 (RM 0.12).

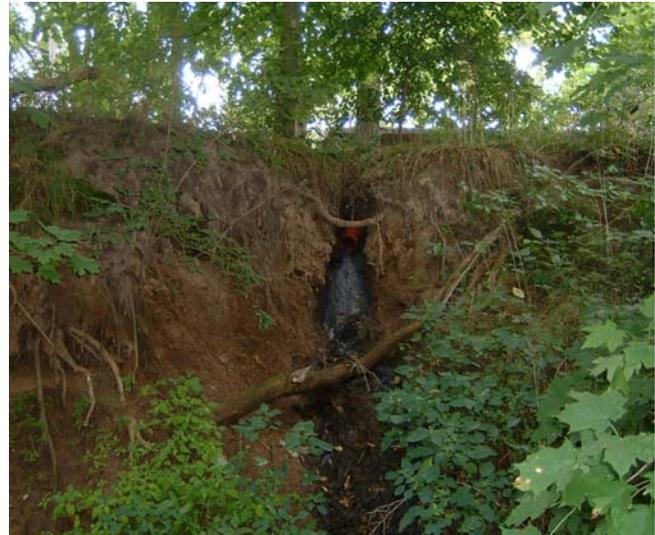
Figure 43. Failing septic system along Grave Creek RM 0.8.

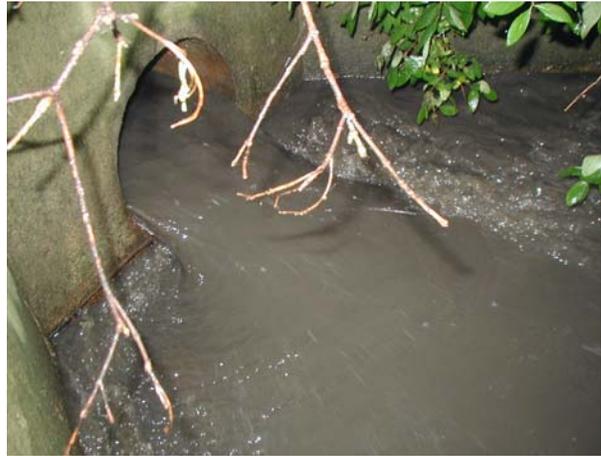
Figure 62. Mt. Gilead wet weather discharge.

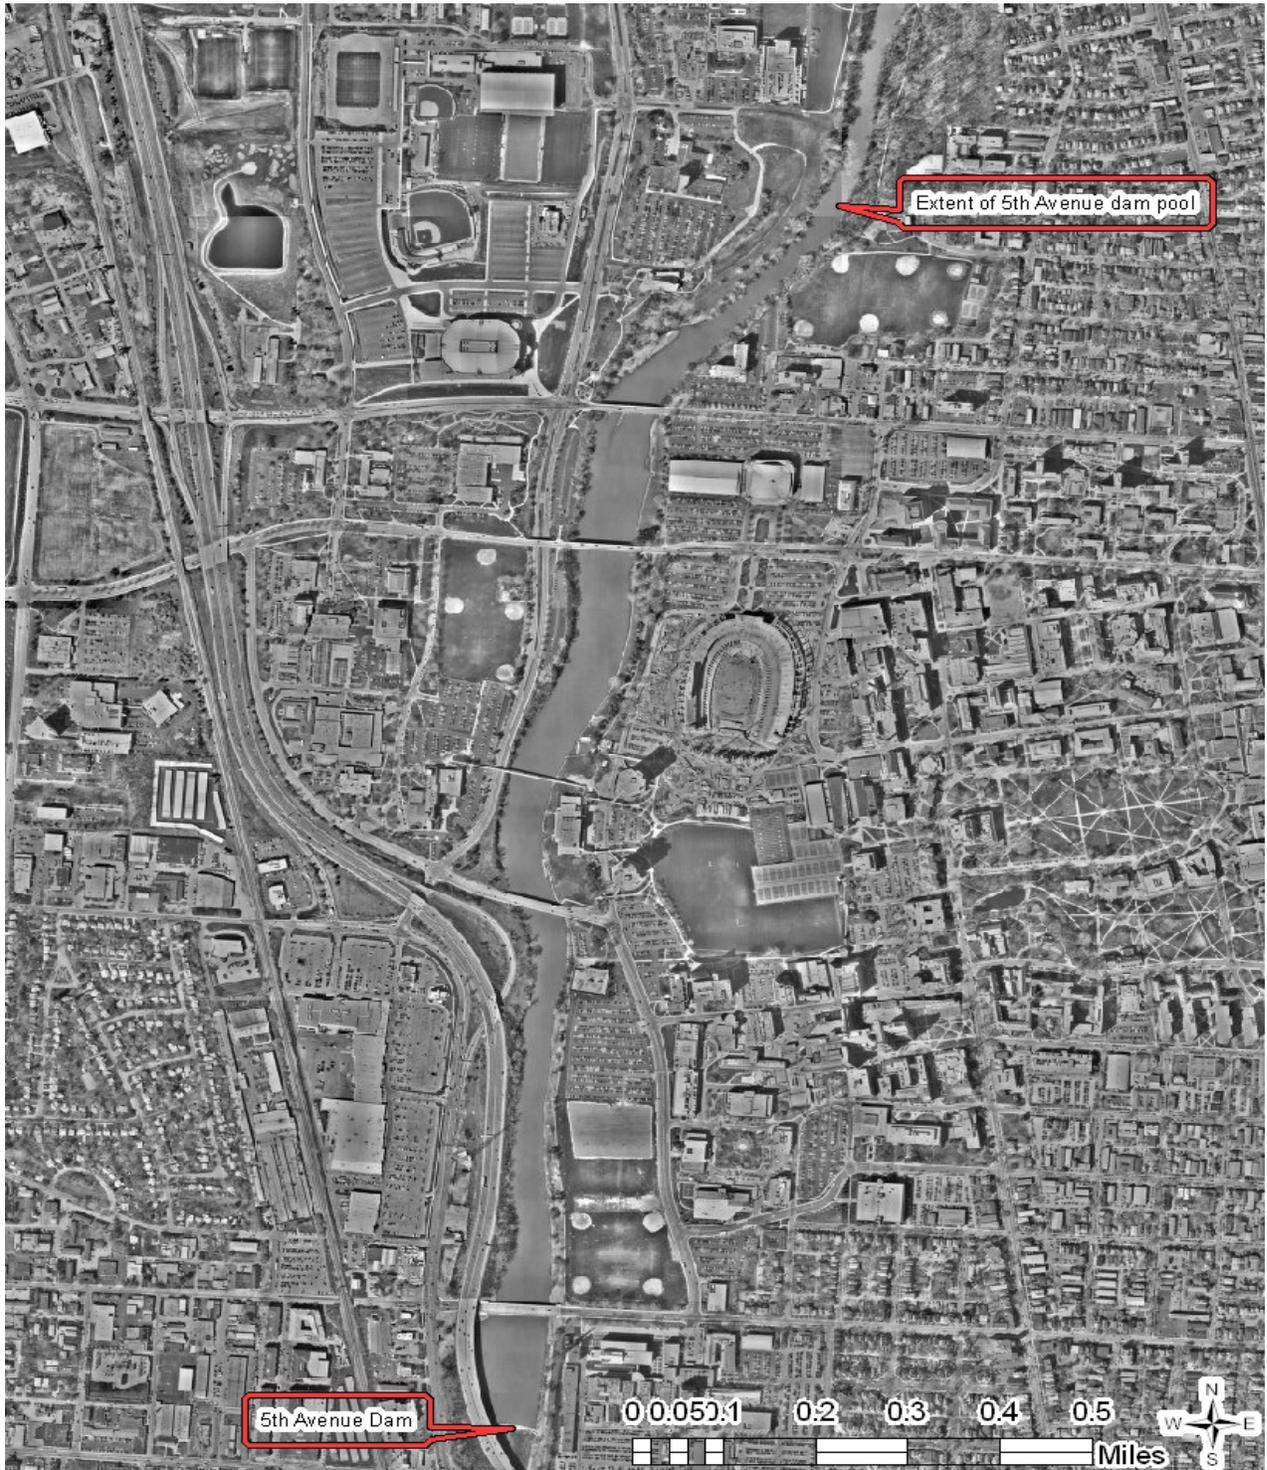
Figure 94. Orthophoto of the Fifth Avenue dam pool. Notice the straight, monotonous form of the river, poor riparian buffers and high intensity urbanized landscape.

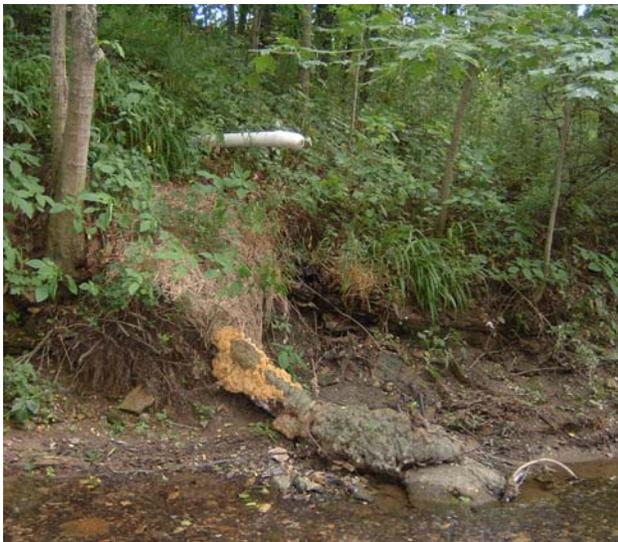
Figure 113. Sewage fungus along septic system outfall.
