# Biological and Water Quality Study of the Sandusky Bay Tributaries, 2009

Watershed Assessment Units 0410001 101, 102, 112, 113,  
and 114

Erie, Sandusky, and Seneca Counties

OHIO EPA Technical Report EAS/2010-4-6

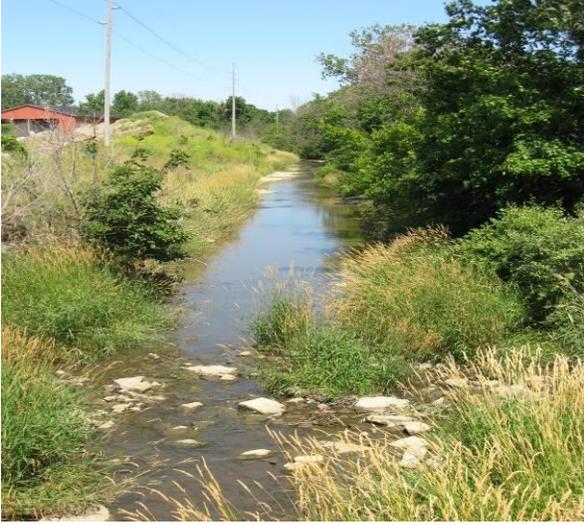
Figure 15. The poor habitat quality of Pipe Creek RM 2.32 due to siltation, poor channel development and lack of adequate instream cover from channelization activities.

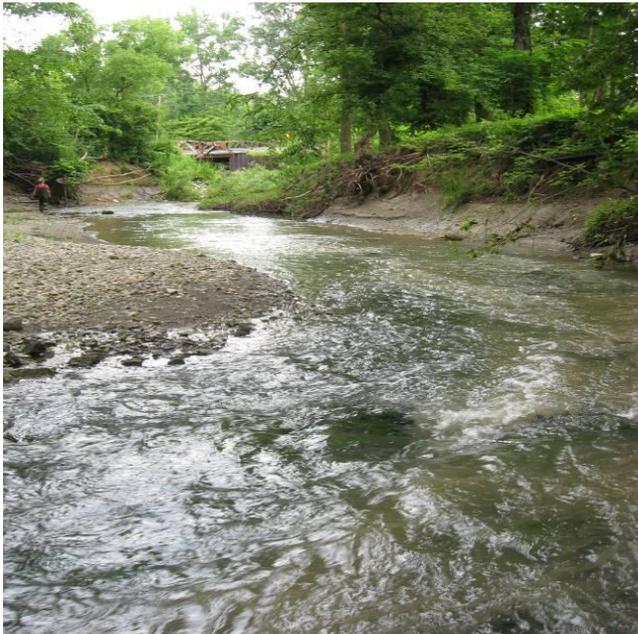
Figure 16. Good habitat quality is present at sites such as Green Creek RM 18.8. Diverse substrates and abundant instream cover with good channel development provide habitat for aquatic organisms and the dense riparian corridor assists with nutrient assimilation within the stream.
