Division of Surface Water

Total Maximum Daily Loads for the Chagrin River Watershed

**Final Report
May 15, 2007**

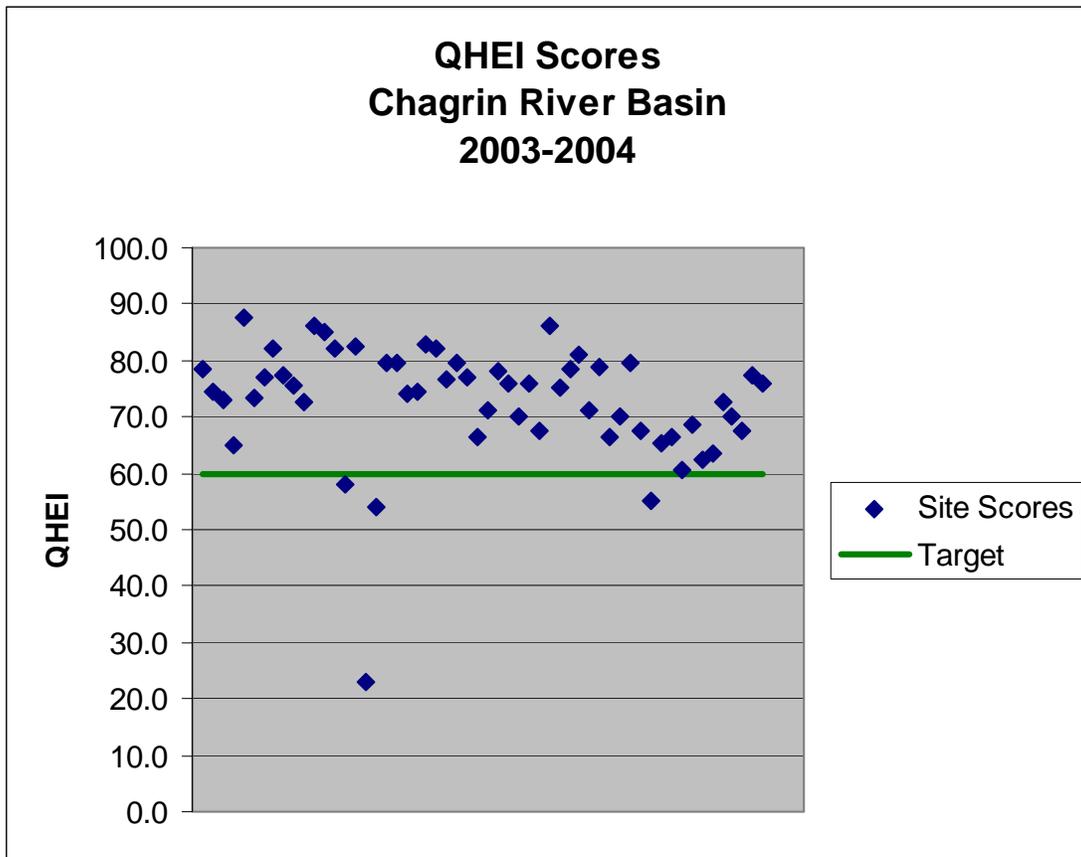
Figure 3-1. Chagrin River watershed QHEI Scores

Deviations from habitat goals are those QHEI values less than 60 for WWH streams. Figure 3-1 shows Chagrin River basin QHEI scores. Of the 56 sites assessed, only 4 failed to meet the QHEI target of 60. These sites were:

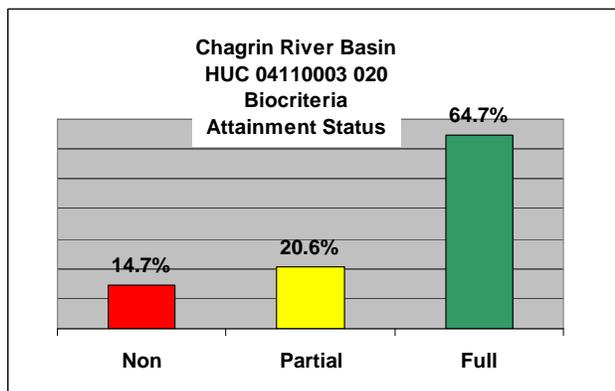
Figure 3-2. HUC 020 Attainment

previously described in Table 3-1. A more detailed description of Ohio EPA’s biocriteria can be found in Ohio EPA’s *Biological Criteria for the Protection of Aquatic Life*, web link at: <http://www.epa.state.oh.us/dsw/bioassess/BioCriteriaProtAqLife.html>. Biological assessment scores are found in Appendix A. Figures 3-2 and 3-3 depict biological attainment status for each HUC.

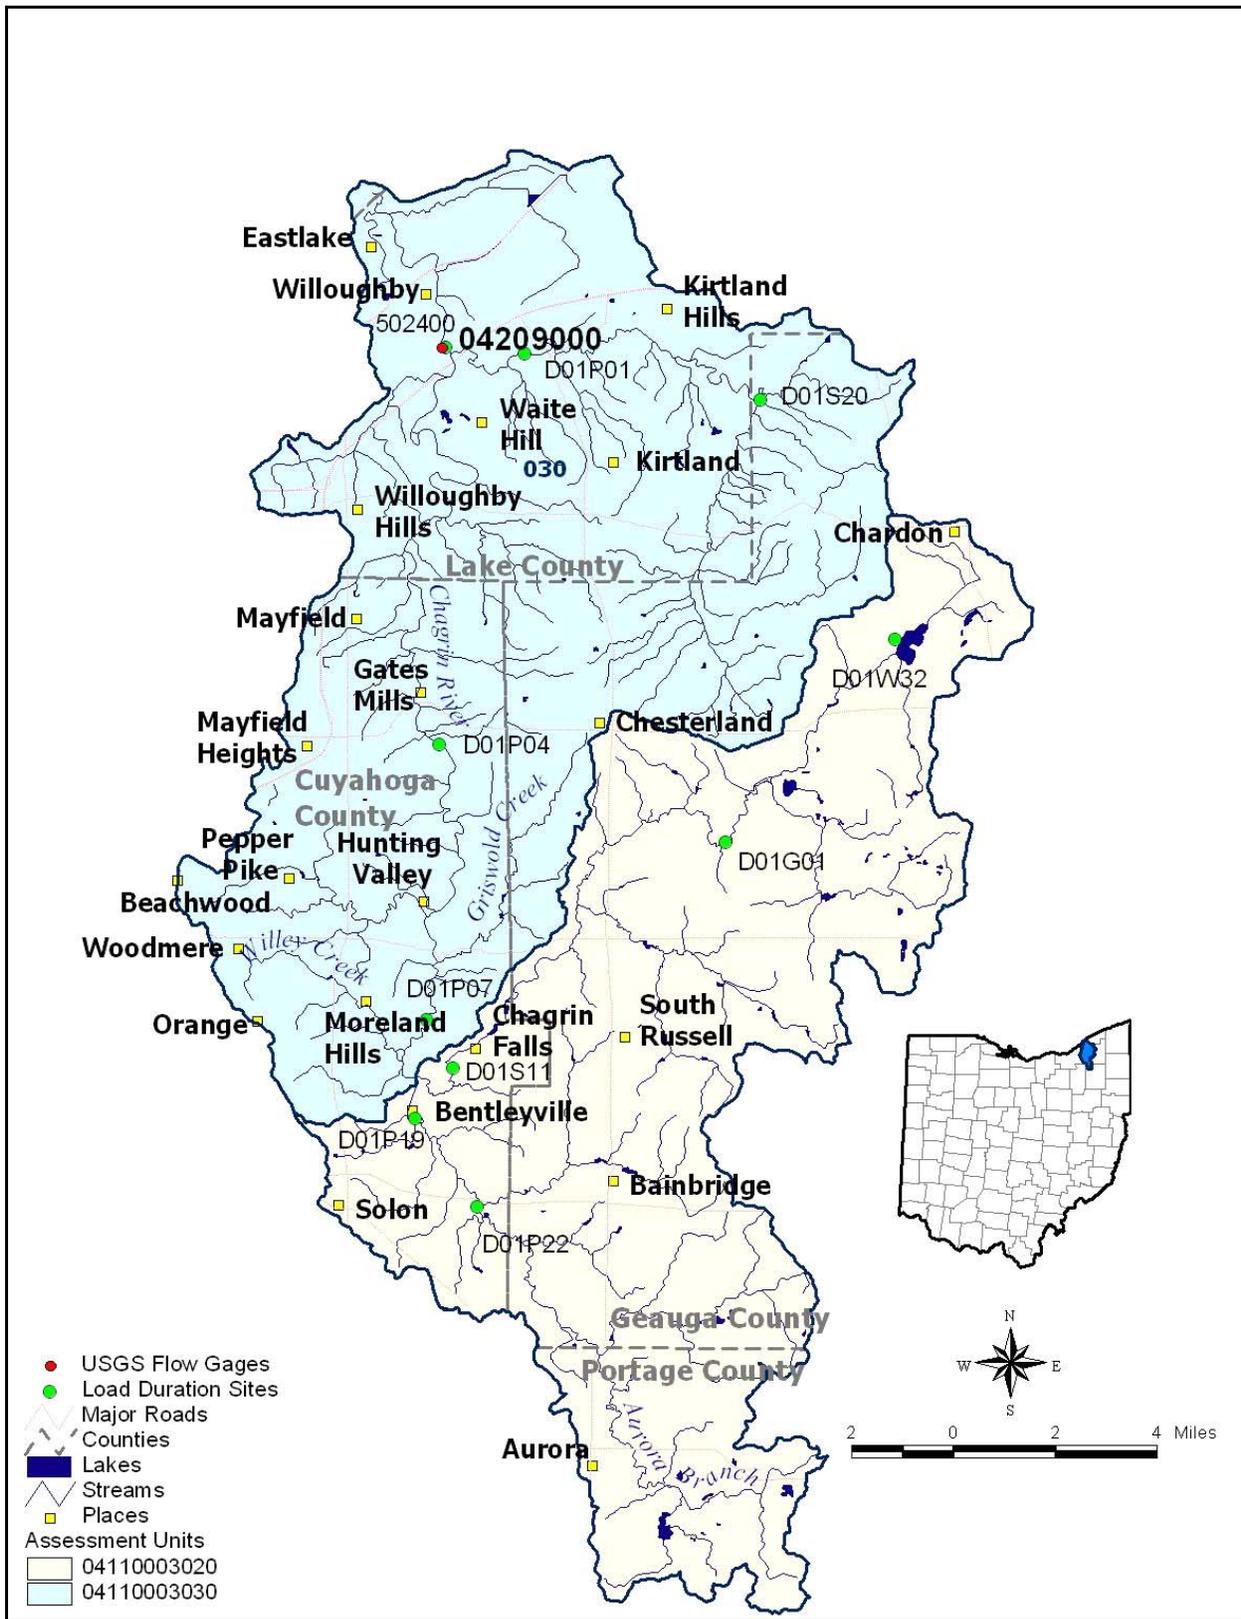
Figure 4-1. Load duration Sites

- * Two sites are located on the mainstem of the Chagrin River at Sperry Road (D01G01) and at Miles Road (D01S11).
- * Two sites are located on the Aurora Branch at Bainbridge Road (D01P22) and at Solon Road (D01P19). One station is located on Spring Brook at the old railroad grade (D01W32).

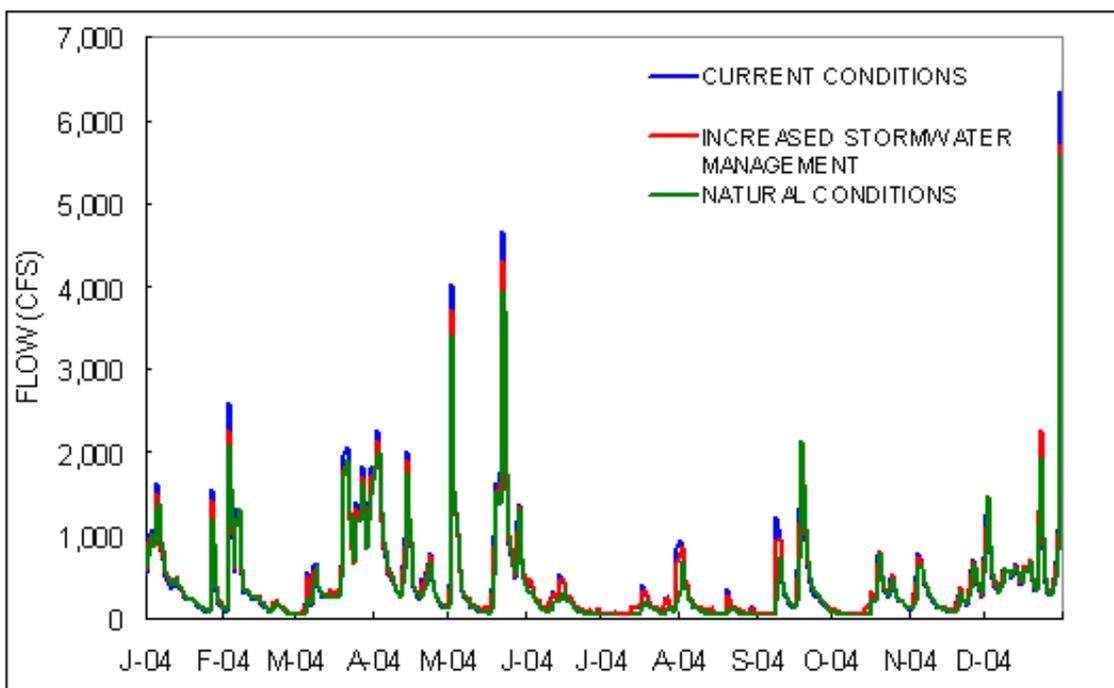
Figure 5-1. Comparison of full-year model scenario results at the Chagrin River at the USGS gage at Daniels Park.

Metric	Chagrin River at Daniels Park			Unnamed Tributary Draining the Pepper Pike Area		
	Current Condition	Natural Condition	Increased Storm Water Management	Current Condition	Natural Condition	Increased Storm Water Management
Flashiness	0.44	0.38	0.39	0.64	0.42	0.51
% Change from Current	0.0%	-12.9%	-10.6%	0.0%	-33.8%	-21.1%
Total Runoff (trillion cubic feet)	30.00	27.10	29.95	1.34	1.09	1.29
% Change from Current	0.0%	-9.6%	-0.2%	0.0%	-18.5%	-3.2%
Peak Flow (cfs)	6,345	5,993	5,776	311	253	262
% Change from Current	0.0%	-5.6%	-9.0%	0.0%	-18.7%	-15.9%

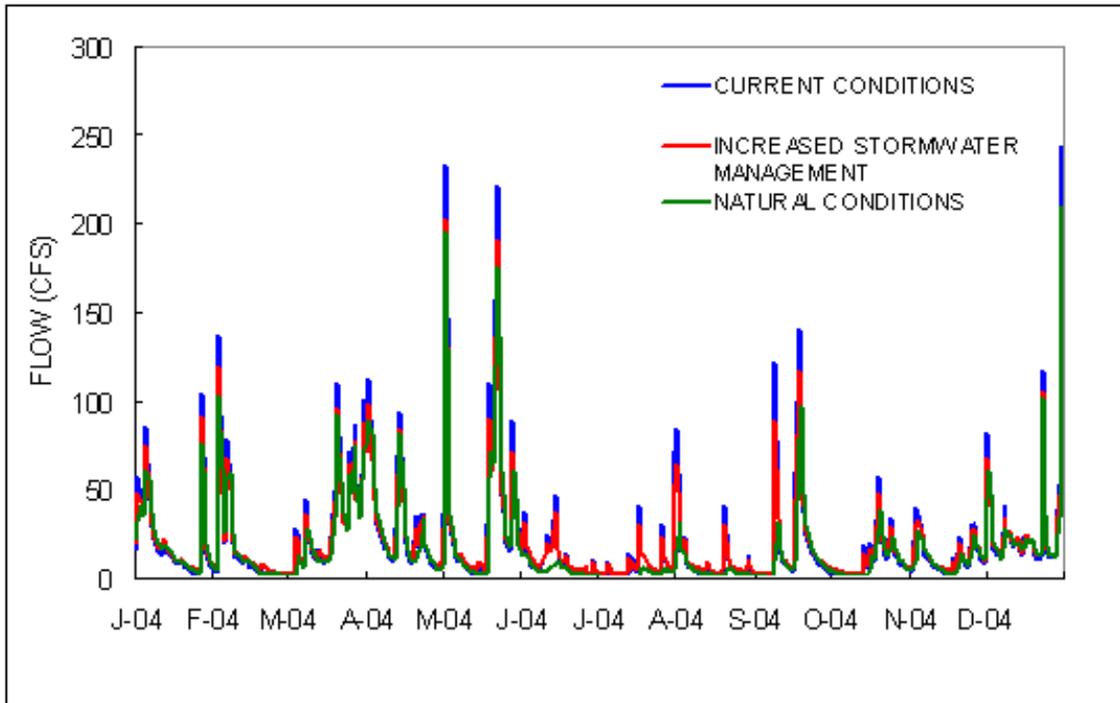
Figure 5-2. Comparison of full-year model scenario results at unnamed tributary draining the Pepper Pike area.

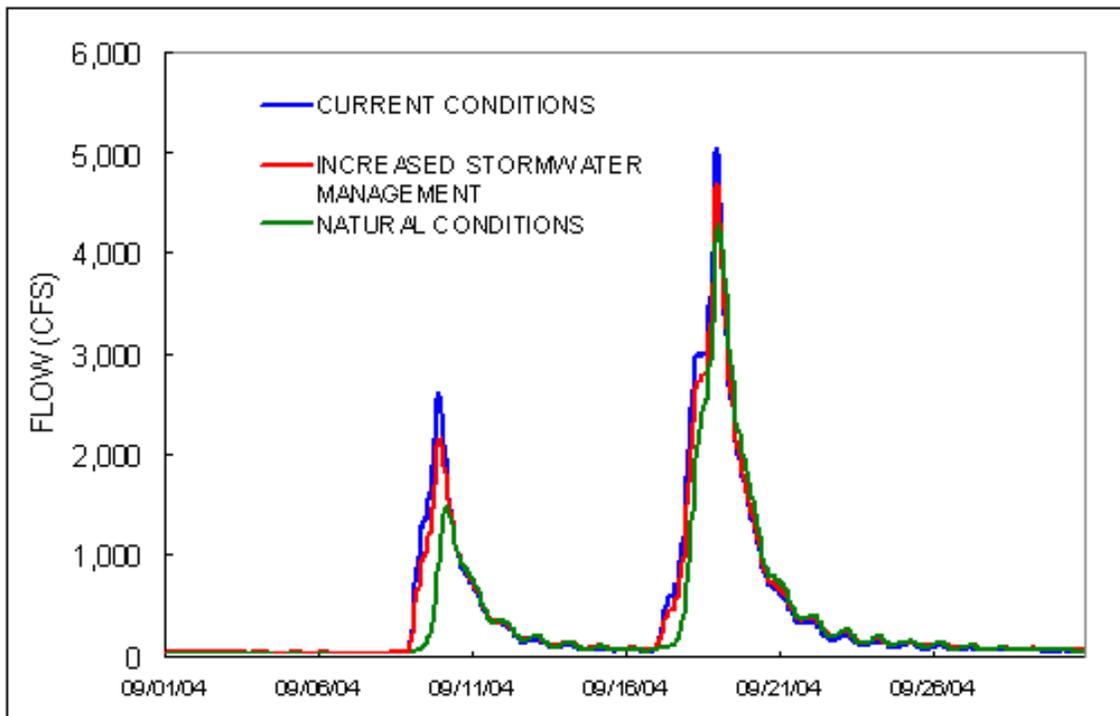
Figure 5-3. Comparison of model results for two storms at the Chagrin River at the USGS gage at Daniels Park.

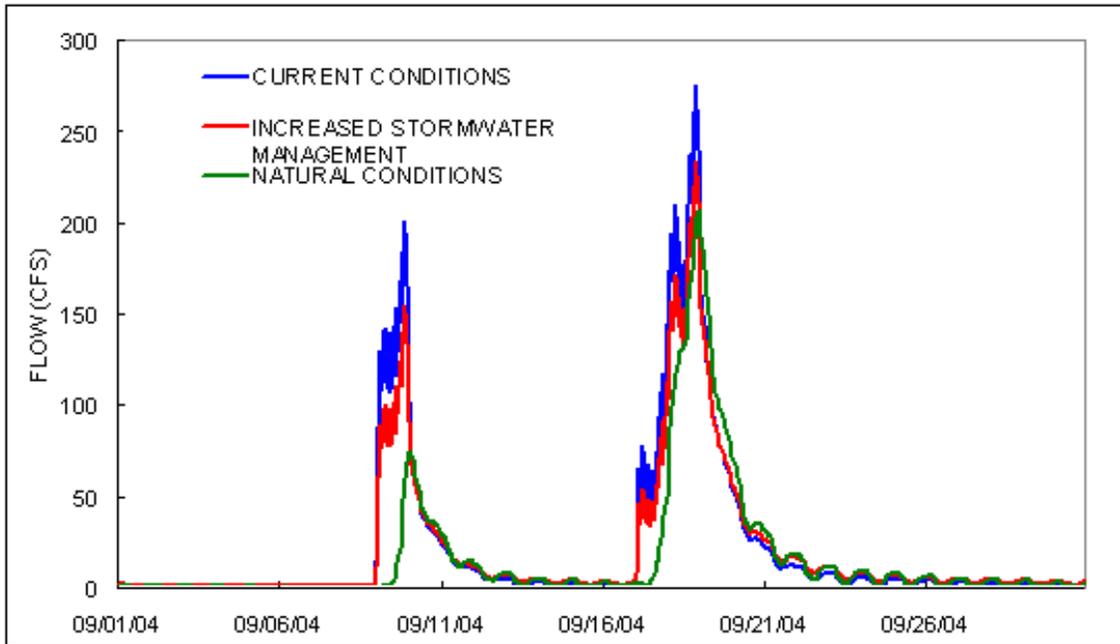
Figure 5-4. Comparison of model scenario results for two storms at unnamed tributary draining the Pepper Pike area.

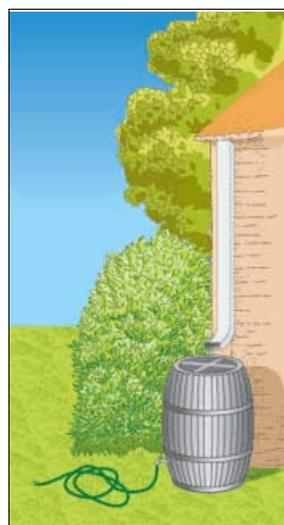
Figure 7-1. Rain Barrel

Rain barrels are low-cost, effective, and easily maintainable retention devices applicable to both residential and commercial/industrial sites. Rain barrels operate by retaining a predetermined volume of rooftop runoff (i.e., they provide permanent storage for a design volume); an overflow pipe provides some detention beyond the retention capacity of the rain barrel. Rain barrels also can be used to store runoff for later reuse in lawn and garden watering.

Rainwater from any type of roofing material can be directed to rain barrels. To be aesthetically acceptable, rain barrels can be incorporated into a landscaping plan, patio or decking design. Rain barrels placed at each corner of the front side of the house should be landscaped for visual screening. Gutters and down spouts are used to convey water from rooftops to rain barrels. Filtration screens should be used on gutters to prevent clogging of debris. Rain barrels should also be equipped with a drain spigot that has garden hose threading, suitable for connection to a drip irrigation

system. An overflow outlet must be provided to bypass runoff from large storm events. Rain barrels must be designed with removable, child-resistant covers and mosquito screening on water entry holes. The size of the rain barrel is a function of the rooftop surface area that drains to the barrel, as well as the inches of rainfall to be stored. For example, one 42-gallon barrel provides 0.5 inch of runoff storage for a rooftop area of approximately 133 square feet. This method is most useful for small runoff events and will help to reduce peak flows. Large storm events will generate runoff volumes greater than the available capacity of rain barrels.

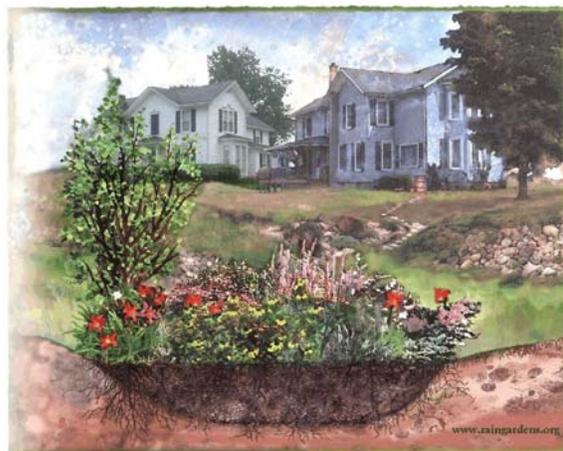
Figure 7-2. Rain Garden (courtesy of Rain Gardens of Western Michigan)

Bioretention (rain gardens) is possibly one of the most recognized alternative storm water management practices. Used in residential, commercial, and certain industrial settings, bioretention has the potential to offer developers significant cost savings and environmental benefits over conventional storm water management systems. Significant design differences exist between a bioretention basin used for storm water permit compliance and a rain garden commonly utilized for residences. Bioretention areas (Figure 7-2) are shallow, topographic depressions filled with engineered soils and vegetation that retain, treat, and infiltrate water.

Bioretention systems are designed for the temporary storage of rainwater. They successfully remove pollutants through increased contact time with soils and plant materials. As compared with conventional storm water management systems, bioretention areas more closely mimic the natural hydrologic cycle, allowing soils and plants to filter pollutants from storm water and permitting the processes of infiltration, evaporation, and transpiration to occur. The systems can also create wildlife habitat, minimize erosion, and recharge local groundwater supplies.

In parking lots, storm water should be conveyed directly to the bioretention area through a system of grassed swales. For residential applications, treatment areas are generally located some distance away from houses to increase flow paths and treat runoff from rooftops and driveways. In either case, bioretention systems route storm water to bioretention areas that are designed to accumulate water to depths not exceeding six to 12 inches. In the event that storm water volumes exceed treatment capacities, bioretention areas are usually equipped with overflow drop inlets routed to municipal storm water systems. In certain industrial and commercial areas, pollutant loadings may be too concentrated for the successful use of bioretention areas. In such areas, termed “hotspots,” the use of structural practices to infiltrate storm water may be deleterious to groundwater supplies. In these instances, designers are advised to use alternative practices, such as exfiltration trenches, to convey filtered water into a conventional storm water management system for proper treatment. A manual for home rain garden installation may be found on the internet at:
