ACID MINE DRAINAGE ABATEMENT AND TREATMENT (AMDAT)  
PLAN FOR THE LEADING CREEK WATERSHED

Cynthia Bauers  
Michael Gosnell  
Raina Ooten

Meigs County Soil and Water Conservation District

May 2006

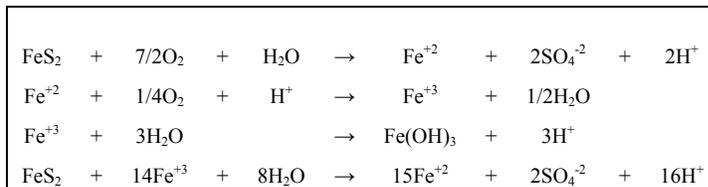
**Figure 2. Formation of Acid Mine Drainage**

The production of acid mine drainage consists of several reactions beginning with the exposure of pyrite ( $\text{FeS}_2$ ) to water and oxygen (Figure 2). Pyrite is typically found within the coal seams or surrounding shale and sandstone. The oxidation of pyritic minerals results in the production of sulfuric acid, which lowers the pH. As this highly acidic, sulfate-rich drainage passes over the surrounding rock strata, coal overburden, or the streambed, heavy metals such as iron, manganese and aluminum are mobilized.

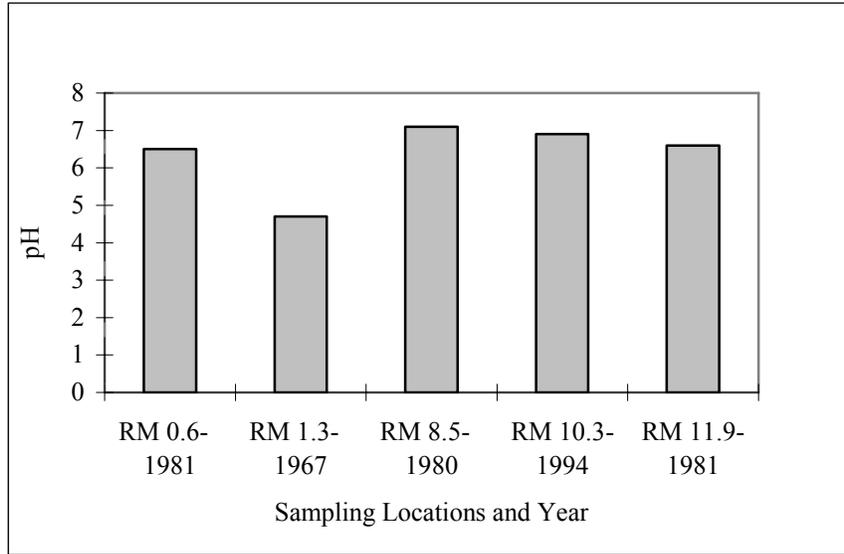
**Figure 5. Most severe historical pH values at sites along Leading Creek**

Compared to historical information, the water chemistry along the mainstem of Leading Creek does not show significant changes (United States EPA, 2003; Figure 5). Except at site RM 1.3 in 1967, this site is located downstream of the confluence with Thomas Fork. In general, Leading Creek seems to exhibit few, if any, impairments from acid mine drainage except downstream of Thomas Fork. Compared to historical information, Thomas Fork continues to maintain poor water chemistry, but the severity of impairments does fluctuate with different flow regimes (US Geological Survey, 2003; Table 8).

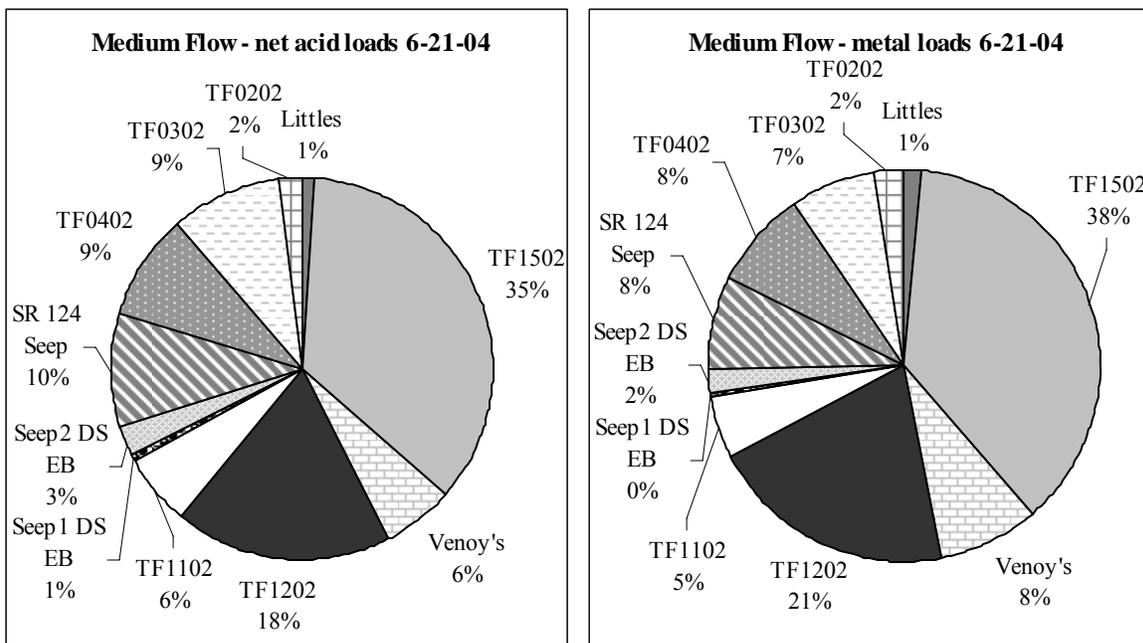
**Figure 11. Percent contribution of acid and metal loads from tributaries and sources in Thomas Fork**

Figure 11 shows a comprehensive look at percent contribution of acid loads from all measured sources and tributaries in the Thomas Fork Subwatershed during one medium flow regime (6-21-04). Figure 11 shows a pie chart of the highest acid loaders in Thomas Fork. Consistently the number one highest loader is the Unnamed Tributary TF1502, followed by Kinzel TF1202.

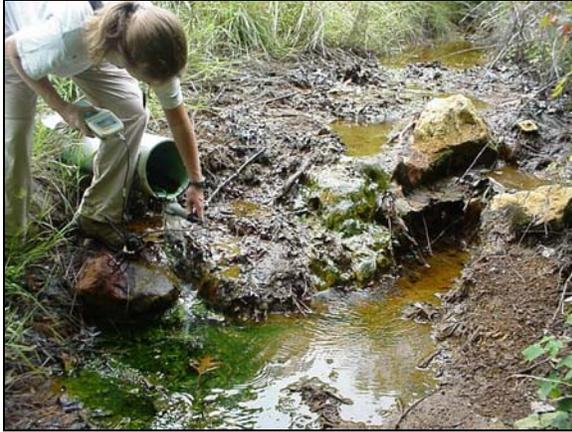
**Photo 3: TF15 Pipe #1**

Site Description: Historically, the area was deep-mined, surface-mined, and auger-mined. The land was reclaimed in the 1980s at which time a series of surface and subsurface drains were installed to localize the movement of water from the area and to stabilize saturated reclaimed hillsides below the mines drains. The source of AMD in this tributary comes from seven functioning above drainage, sub-surface mine drains, 2 buried/clogged drains, and 2 seeps. The 8" under drains yield highly acidic, metal-laden water at an almost constant rate of flow.

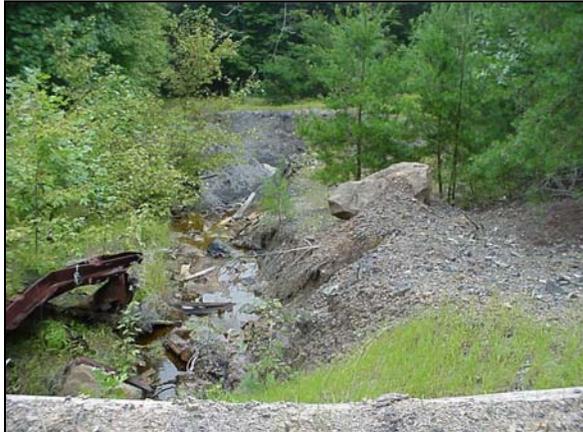
Photo 8: Casto Seep #3

AMD is produced in a very diffuse manner leaking from strip mine pits, or entering the stream as base flow. Four sources have been identified: a small stream that flows in a rock-lined channel through the reclaimed area (TF1100-1), a seep where the water fans out and diffusely enters the stream (TF1100-2), a small stream draining a strip pit flowing through sharp-angled spoil banks and gob pile (TF1100-3), and surface mining impoundments in the headwaters (TF1180).

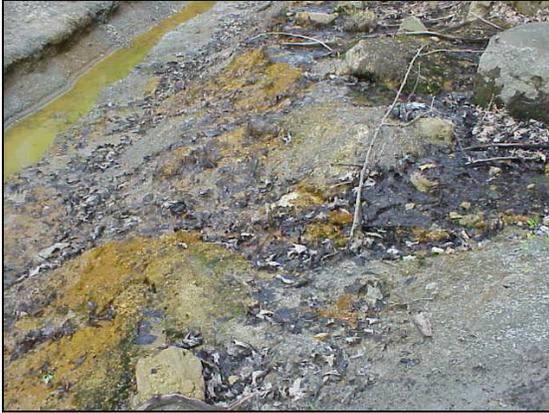
**Photo 11: Seepage in Hysell Hollow #11**

Hollow #11 – All previously mined areas are producing AMD in a very diffuse manner. No mine entrances are visible, and there are diffuse seeps along the bank of the stream. There are several pits along the highwall, but none are connected by surface flow to tributary #11. Most of the hollow is forested, but there is exposed gob on the north side of the hollow. The topography of the drainage area is degraded (*i.e.* much of the valley is filled and/or altered).

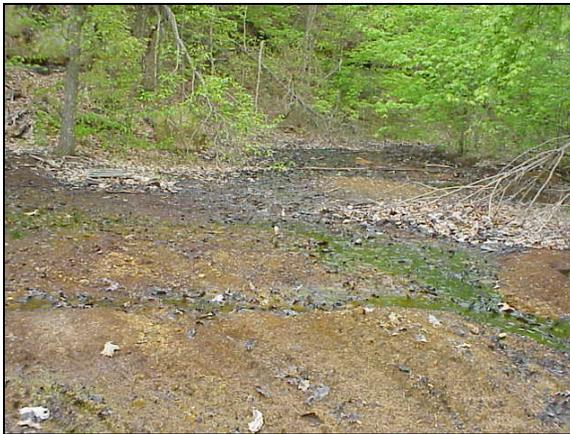
**Photo 13: Seepage along highwall in Hysell Hollow #8**

Hollow #8 – AMD production is caused by sub-surface drainage from leaking strip mine and auger mine pits. During higher flow, two additional sources are a seep on the north side of the hollow and a pit apparently fed by an underground mine on the south side. The landscape is characterized by modest tree growth, areas with unreclaimed coal refuse piles, exposed auger holes, and large pits of water along the highwall.

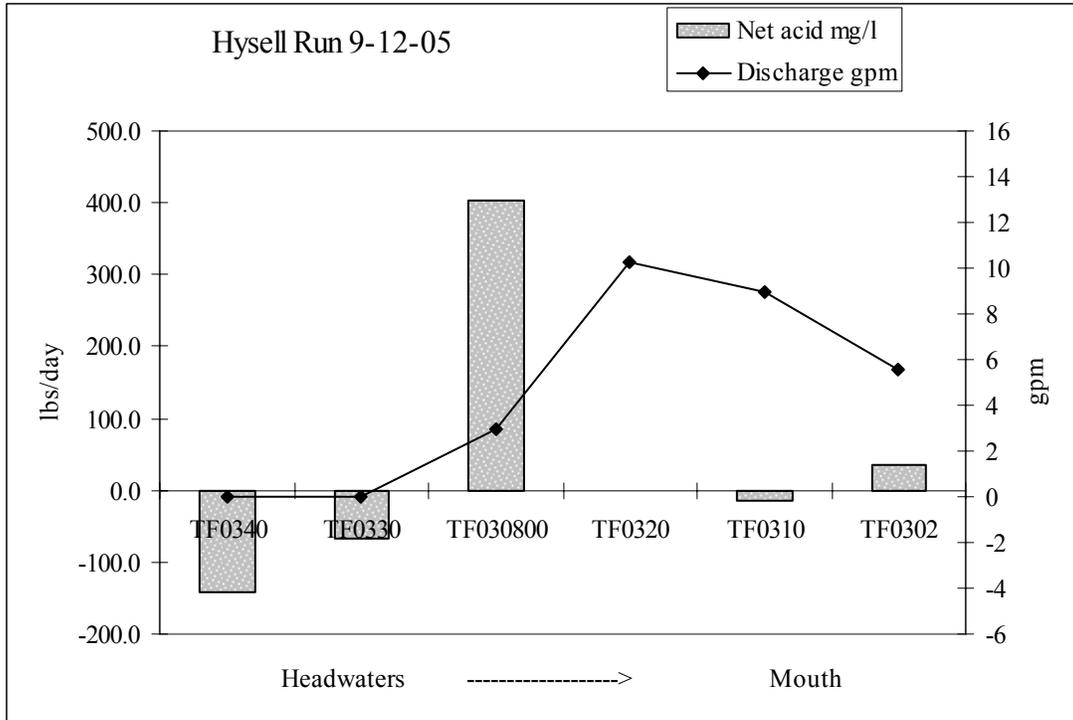
**Figure 14. Hysell Run acidity and discharge measured on 9-12-05**

During the extreme low flow sampling event (9/12/05) most tributaries and sources in Hysell Run were dry. Hollow #8 was the only tributary that continued to discharge (Figure 14).

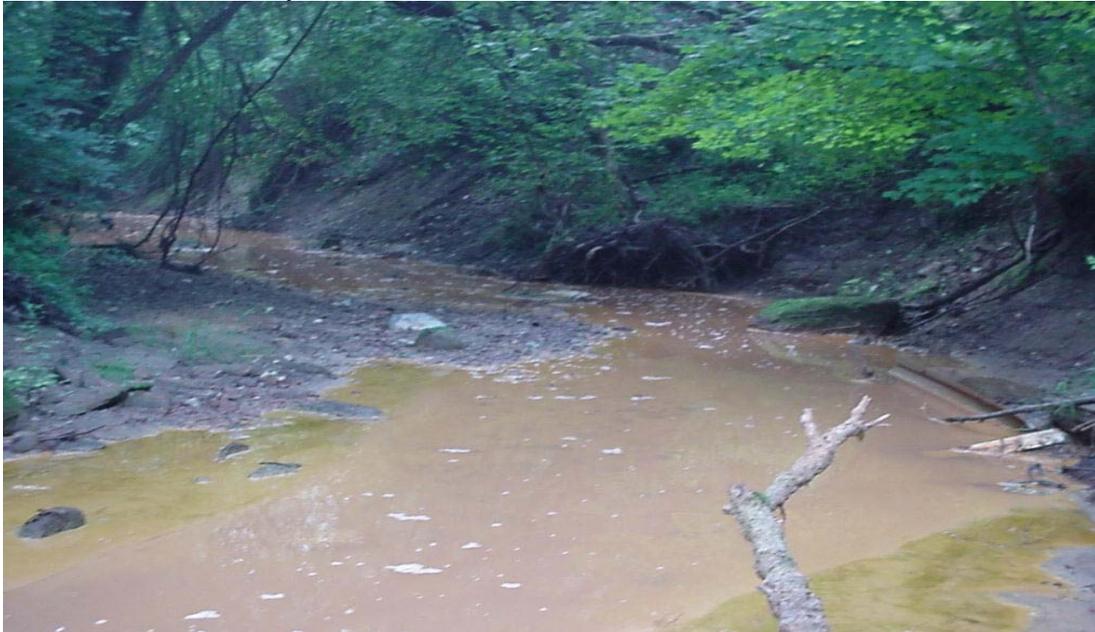
TF 0070: Downstream of TF 15 confluence  
RM 7.4  
Accessible from Bailey Run Road

Photo taken just downstream of TF 15. No fish ever noticed, poor water quality.  
(7-22-04)

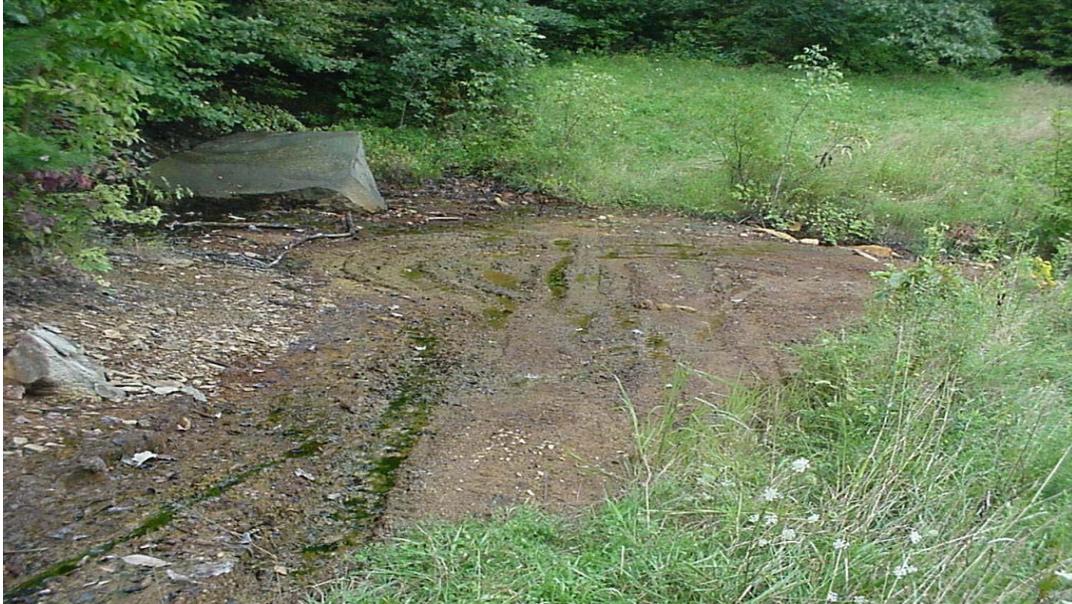
TF 15 Seep 1: Seep which combines with pipe 1, drains into the Unnamed Tributary on Bailey Run Road  
Accessible by entrance through gates and up hill, just upstream of the first bridge on Bailey Run Road (Township Road 165).

Photo taken near the top of the hill at the base of the highwall  
(8-23-04)

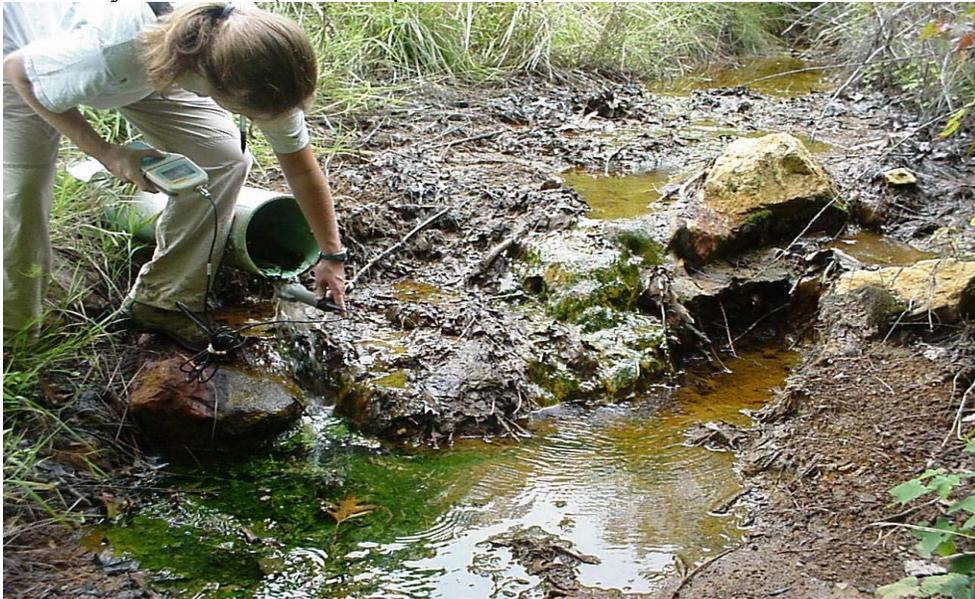
Pipe 1: Drains into the Unnamed Tributary on Bailey Run Road  
Accessible by entrance through gates and up hill, just upstream of the first bridge  
on Bailey Run Road (Township Road 165).

Photo taken just below highwall at first pipe  
(8-23-04)
