# Leachate Collection System Investigation for Countywide Recycling & Disposal Facility

**LEACHATE COLLECTION SYSTEM INVESTIGATION  
FOR COUNTYWIDE RECYCLING  
& DISPOSAL FACILITY**

**EAST SPARTA, STARK COUNTY, OHIO**

Prepared to  
Address Orders 12 and 13 of  
Director's November 7, 2007 Orders

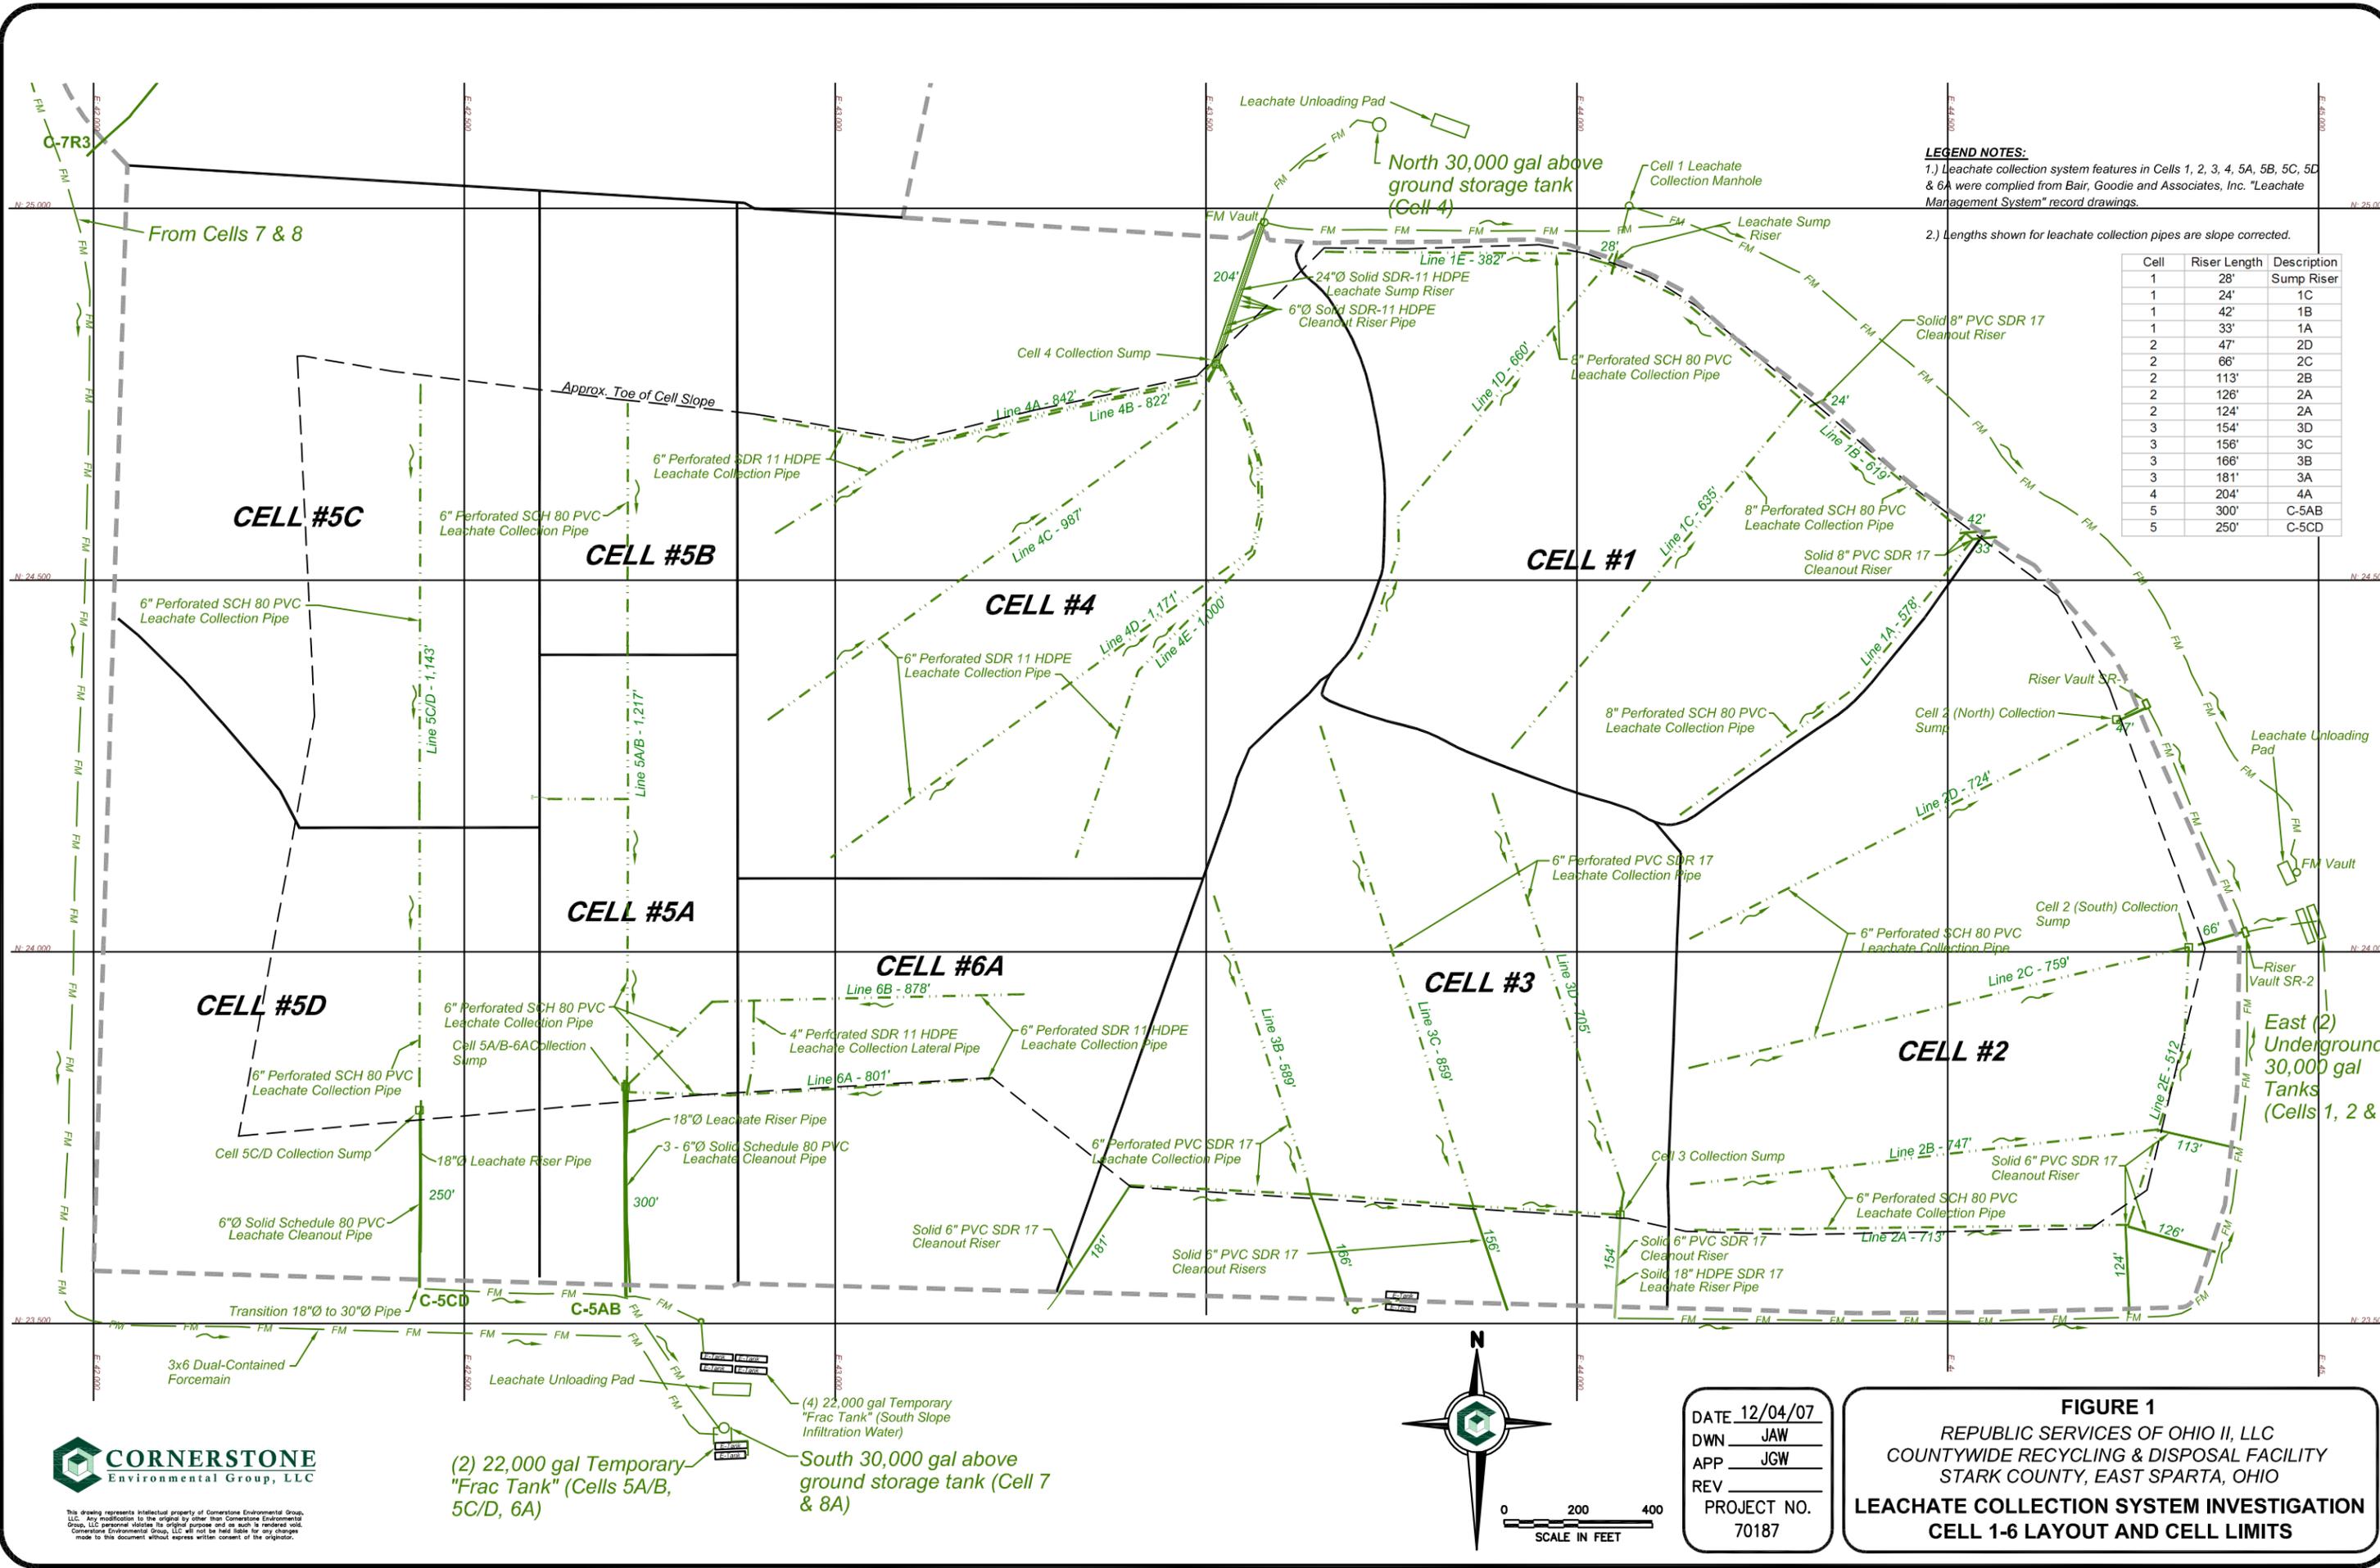
**FIGURE 1**  
 REPUBLIC SERVICES OF OHIO II, LLC  
 COUNTYWIDE RECYCLING & DISPOSAL FACILITY  
 STARK COUNTY, EAST SPARTA, OHIO  
**LEACHATE COLLECTION SYSTEM INVESTIGATION  
 CELL 1-6 LAYOUT AND CELL LIMITS**

Figure 1 – Leachate collection system investigation cells 1 – 6 layout and cell limits

Pipe 3A was noted to cross pipes 3B, 3C and 3D as shown in Figure 1. The certification report was reviewed to determine if a cross pipe fitting was constructed at these locations however no information could be found. Therefore a video inspection of the 3B, 3C and 3D cleanout riser pipes was conducted to determine if a cross fitting with pipe 3A could be observed and if so cleaned. The video was inconclusive, as dark liquids were encountered prior to the location where the pipes would have intersected.

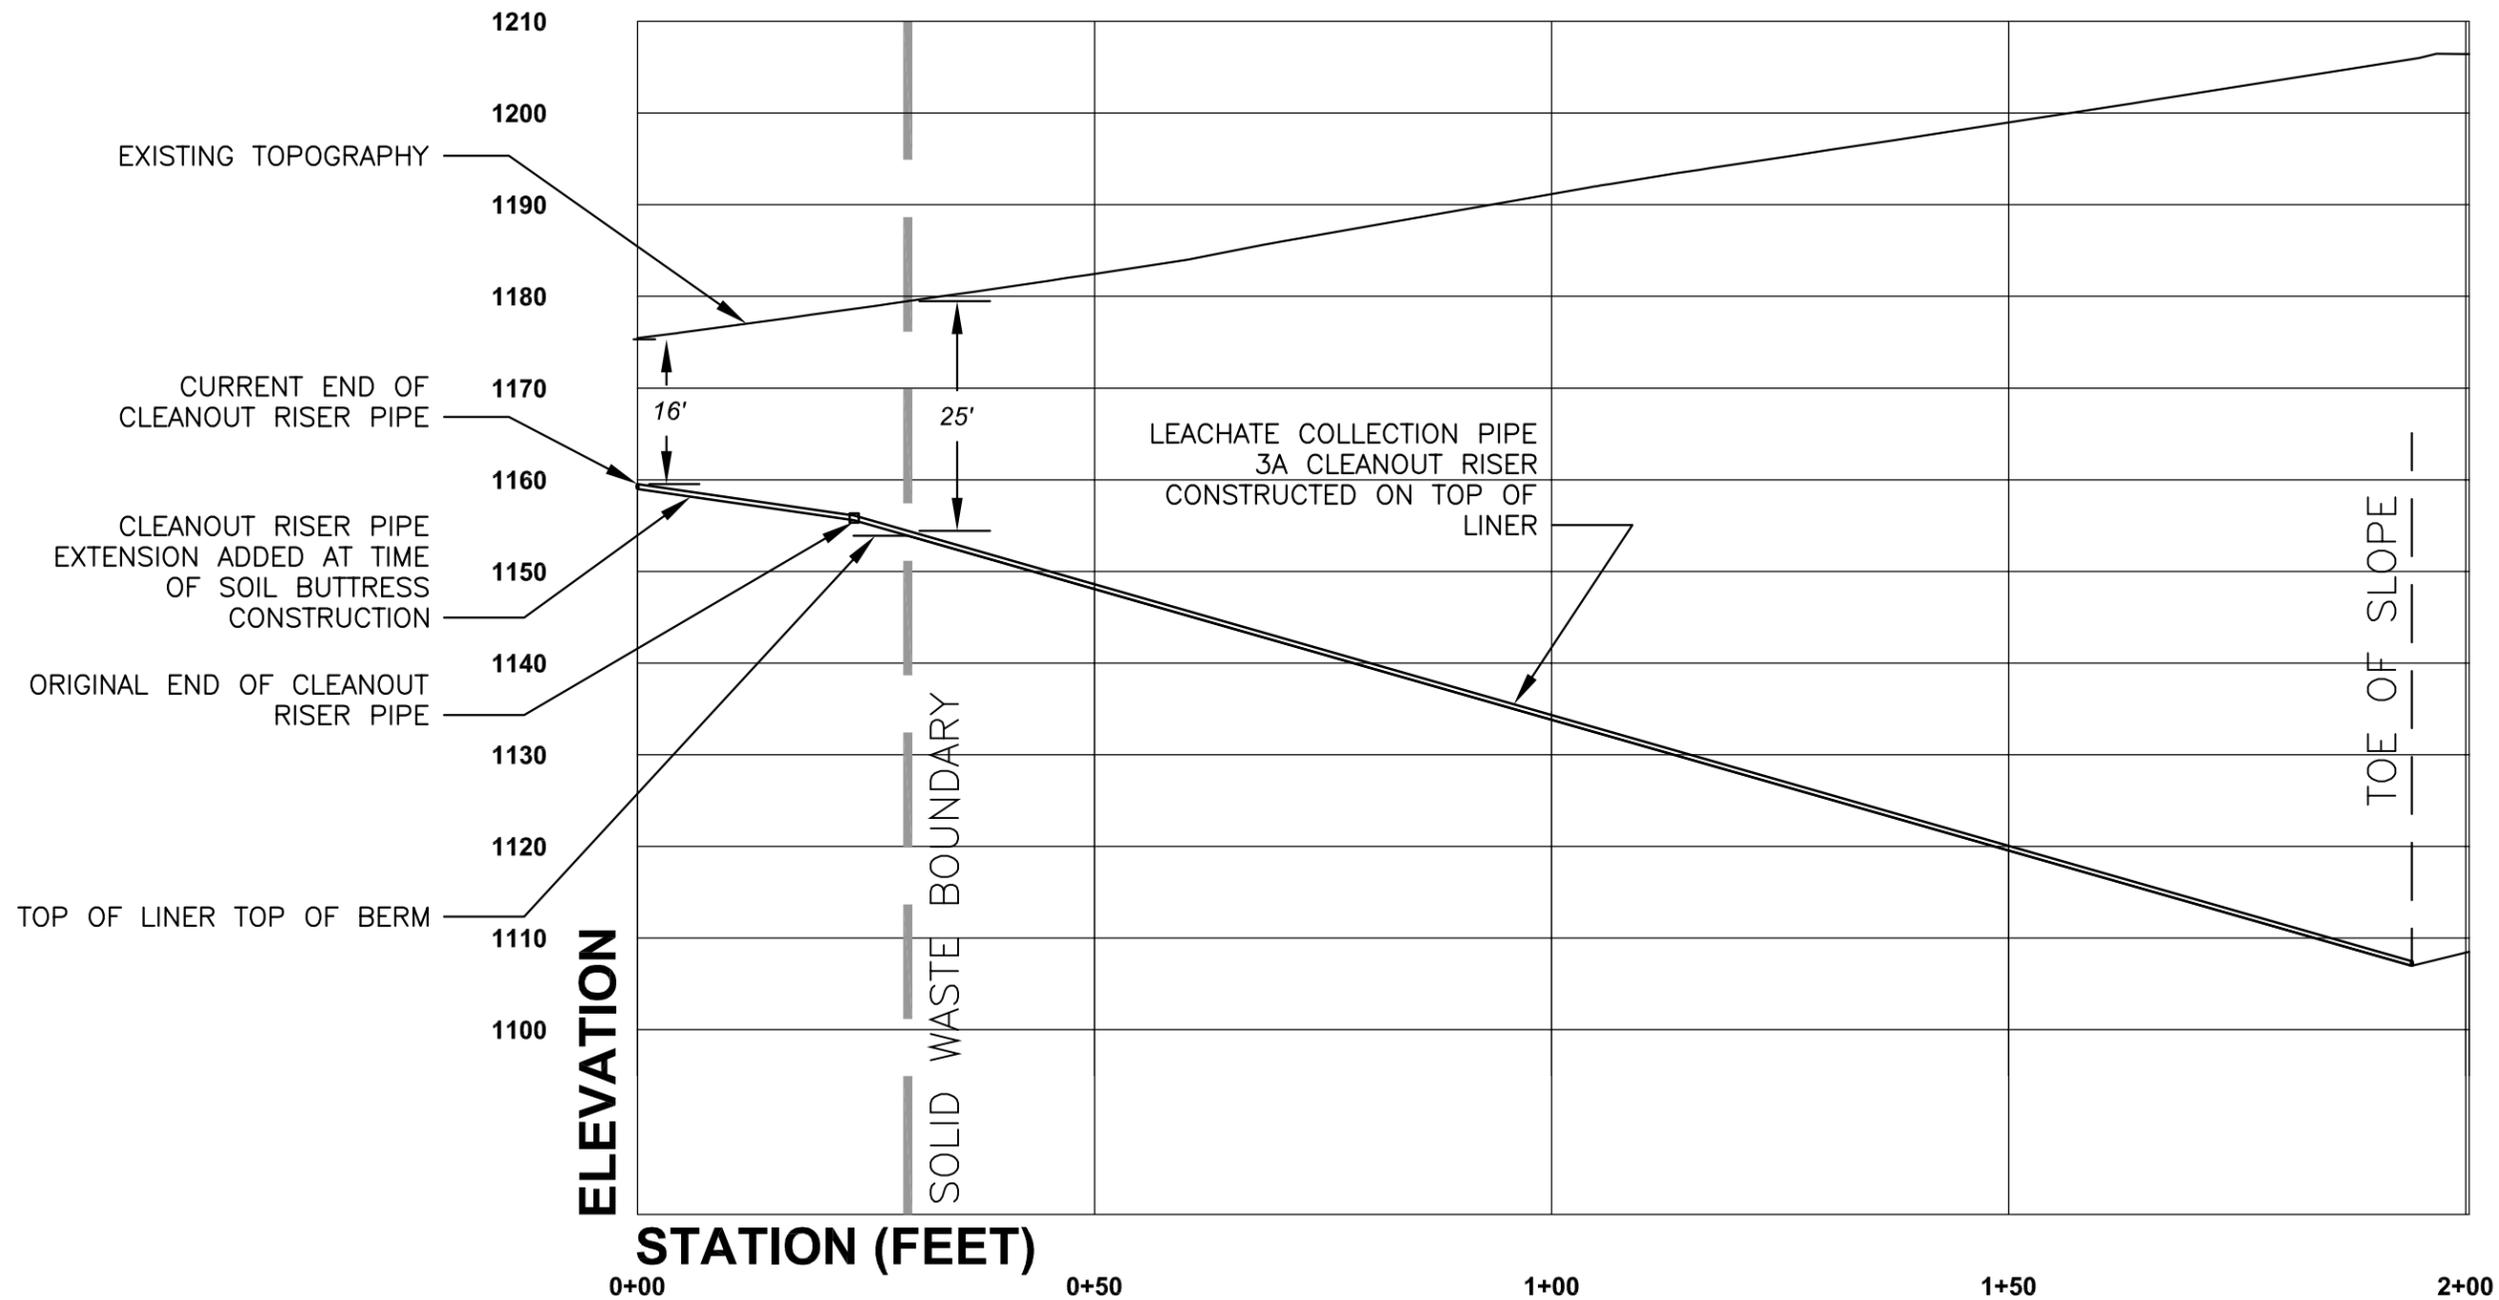
Figure 3 – Cross section of existing grades & location of leachate collection pipe 3A cleanout riser

The end of the cell 3A leachate cleanout riser pipe was extended approximately 25 feet from the original location at the top of slope as shown in Figure 3. During the temporary capping of the south slope in late May 2006, it is presumed to have been damaged during maintenance of the temporary cap or the installation of seepage control measures at and below the southerly anchorage of the temporary cap during June and July of 2006. Subsequent slope deformations have also likely compromised the upper southernmost section of the cell 3A cleanout riser. Once this riser was extended upward through the toe fill it was subjected to significant lateral loading a tension that exceeded the ability of the pvc pipe to remain intact. This, rather than some indication of deep seated liner movement is the likely explanation for the reason why the cell 3A cleanout riser pipe was impassible at a depth of 30 feet during the 2006 leachate pipe cleaning. Section 9 of this report addresses proposed corrective actions for the cell 3A leachate pipe.

Once the symptoms of the reaction in the waste in the vicinity of the south slope buttress have subsided (elevated odor, temperature, gas and liquid) the upper portion of the cell 3A cleanout riser pipe can be investigated and repaired so that inspection and cleanout access to pipe 3A is restored.

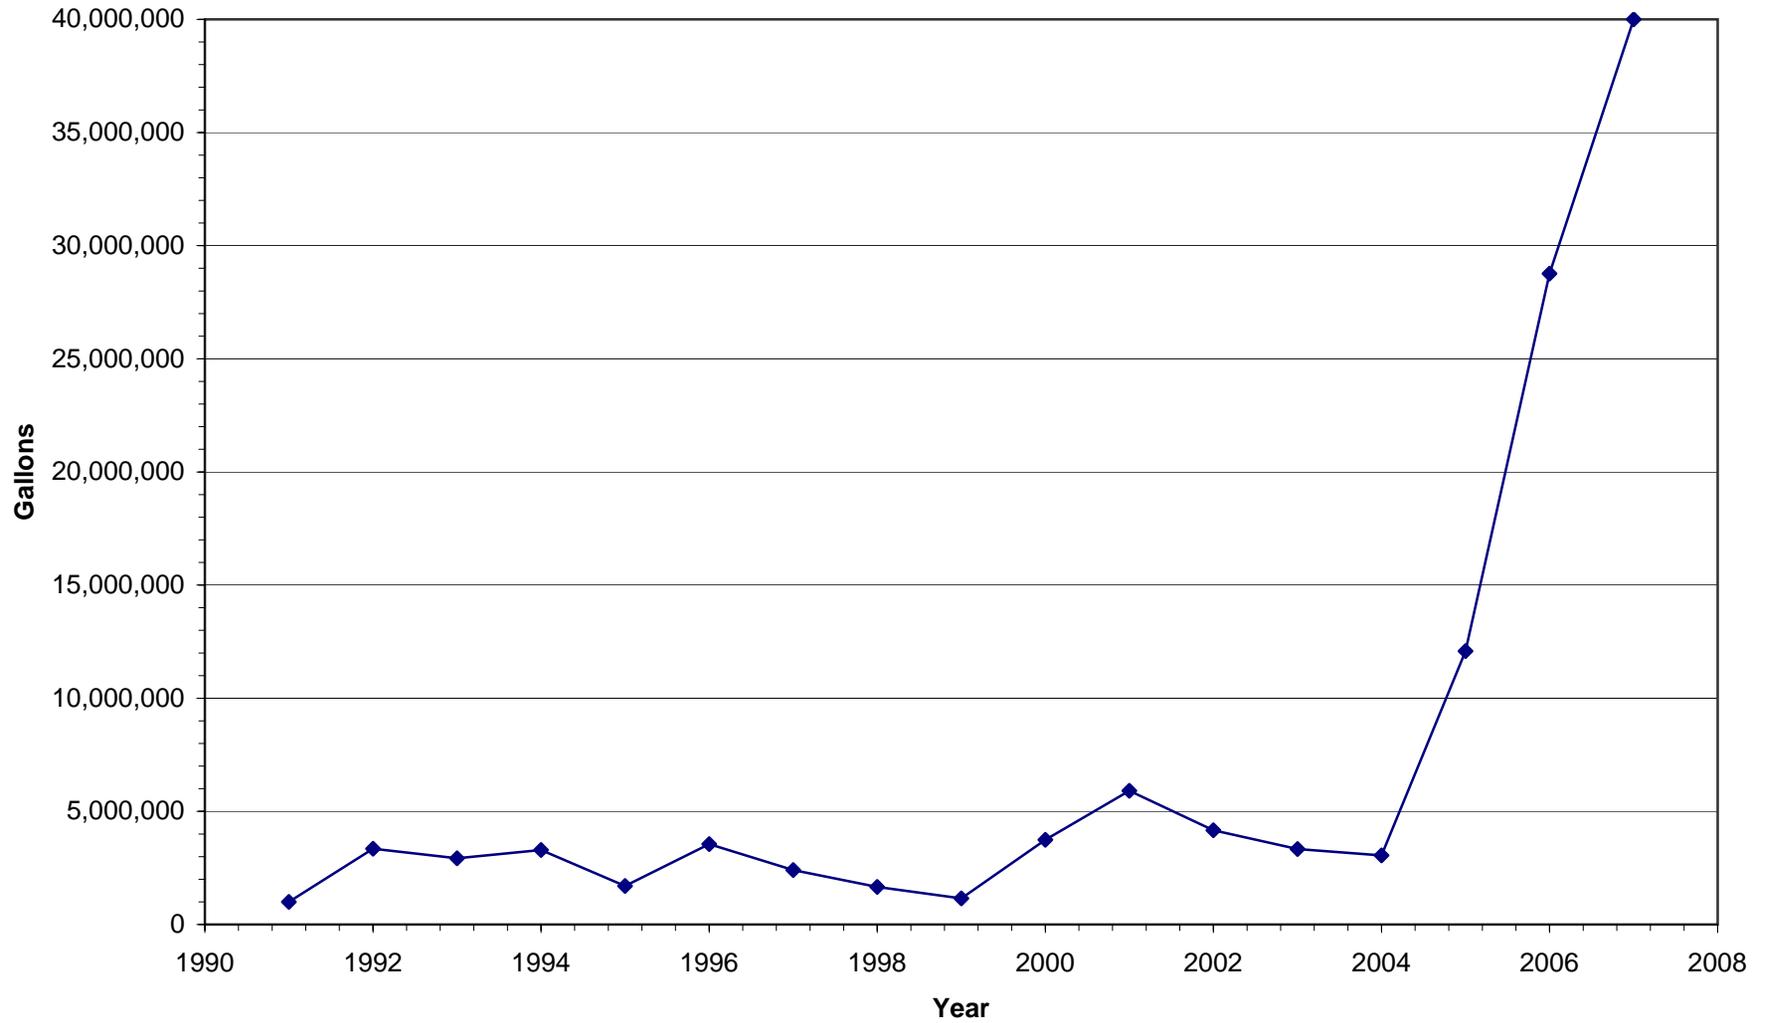
**Figure B.1 - Annual Collected Leachate Volumes 1991 - 2007  
Countywide Recycling & Disposal Facility**

Leachate collection volume data is presented in Appendix C. The data is broken down by source of where the leachate is pumped to (i.e. storage tank). From 1991 to 2004, the annual leachate collected at Countywide averaged about 3 million gallons per year. In 2005, the volume increased to 12 million gallons. This was followed by 29 million gallons collected in 2006 and 37 million gallons collected through November 2007 (which is projected to be 40 million gallons for the year). Of the 37 million gallons collected for 2007 to date, 26 million gallons have been pumped from the bottom LCS while 11 million gallons are from upper collection sources such as toe drains, gas wells and gas condensate.

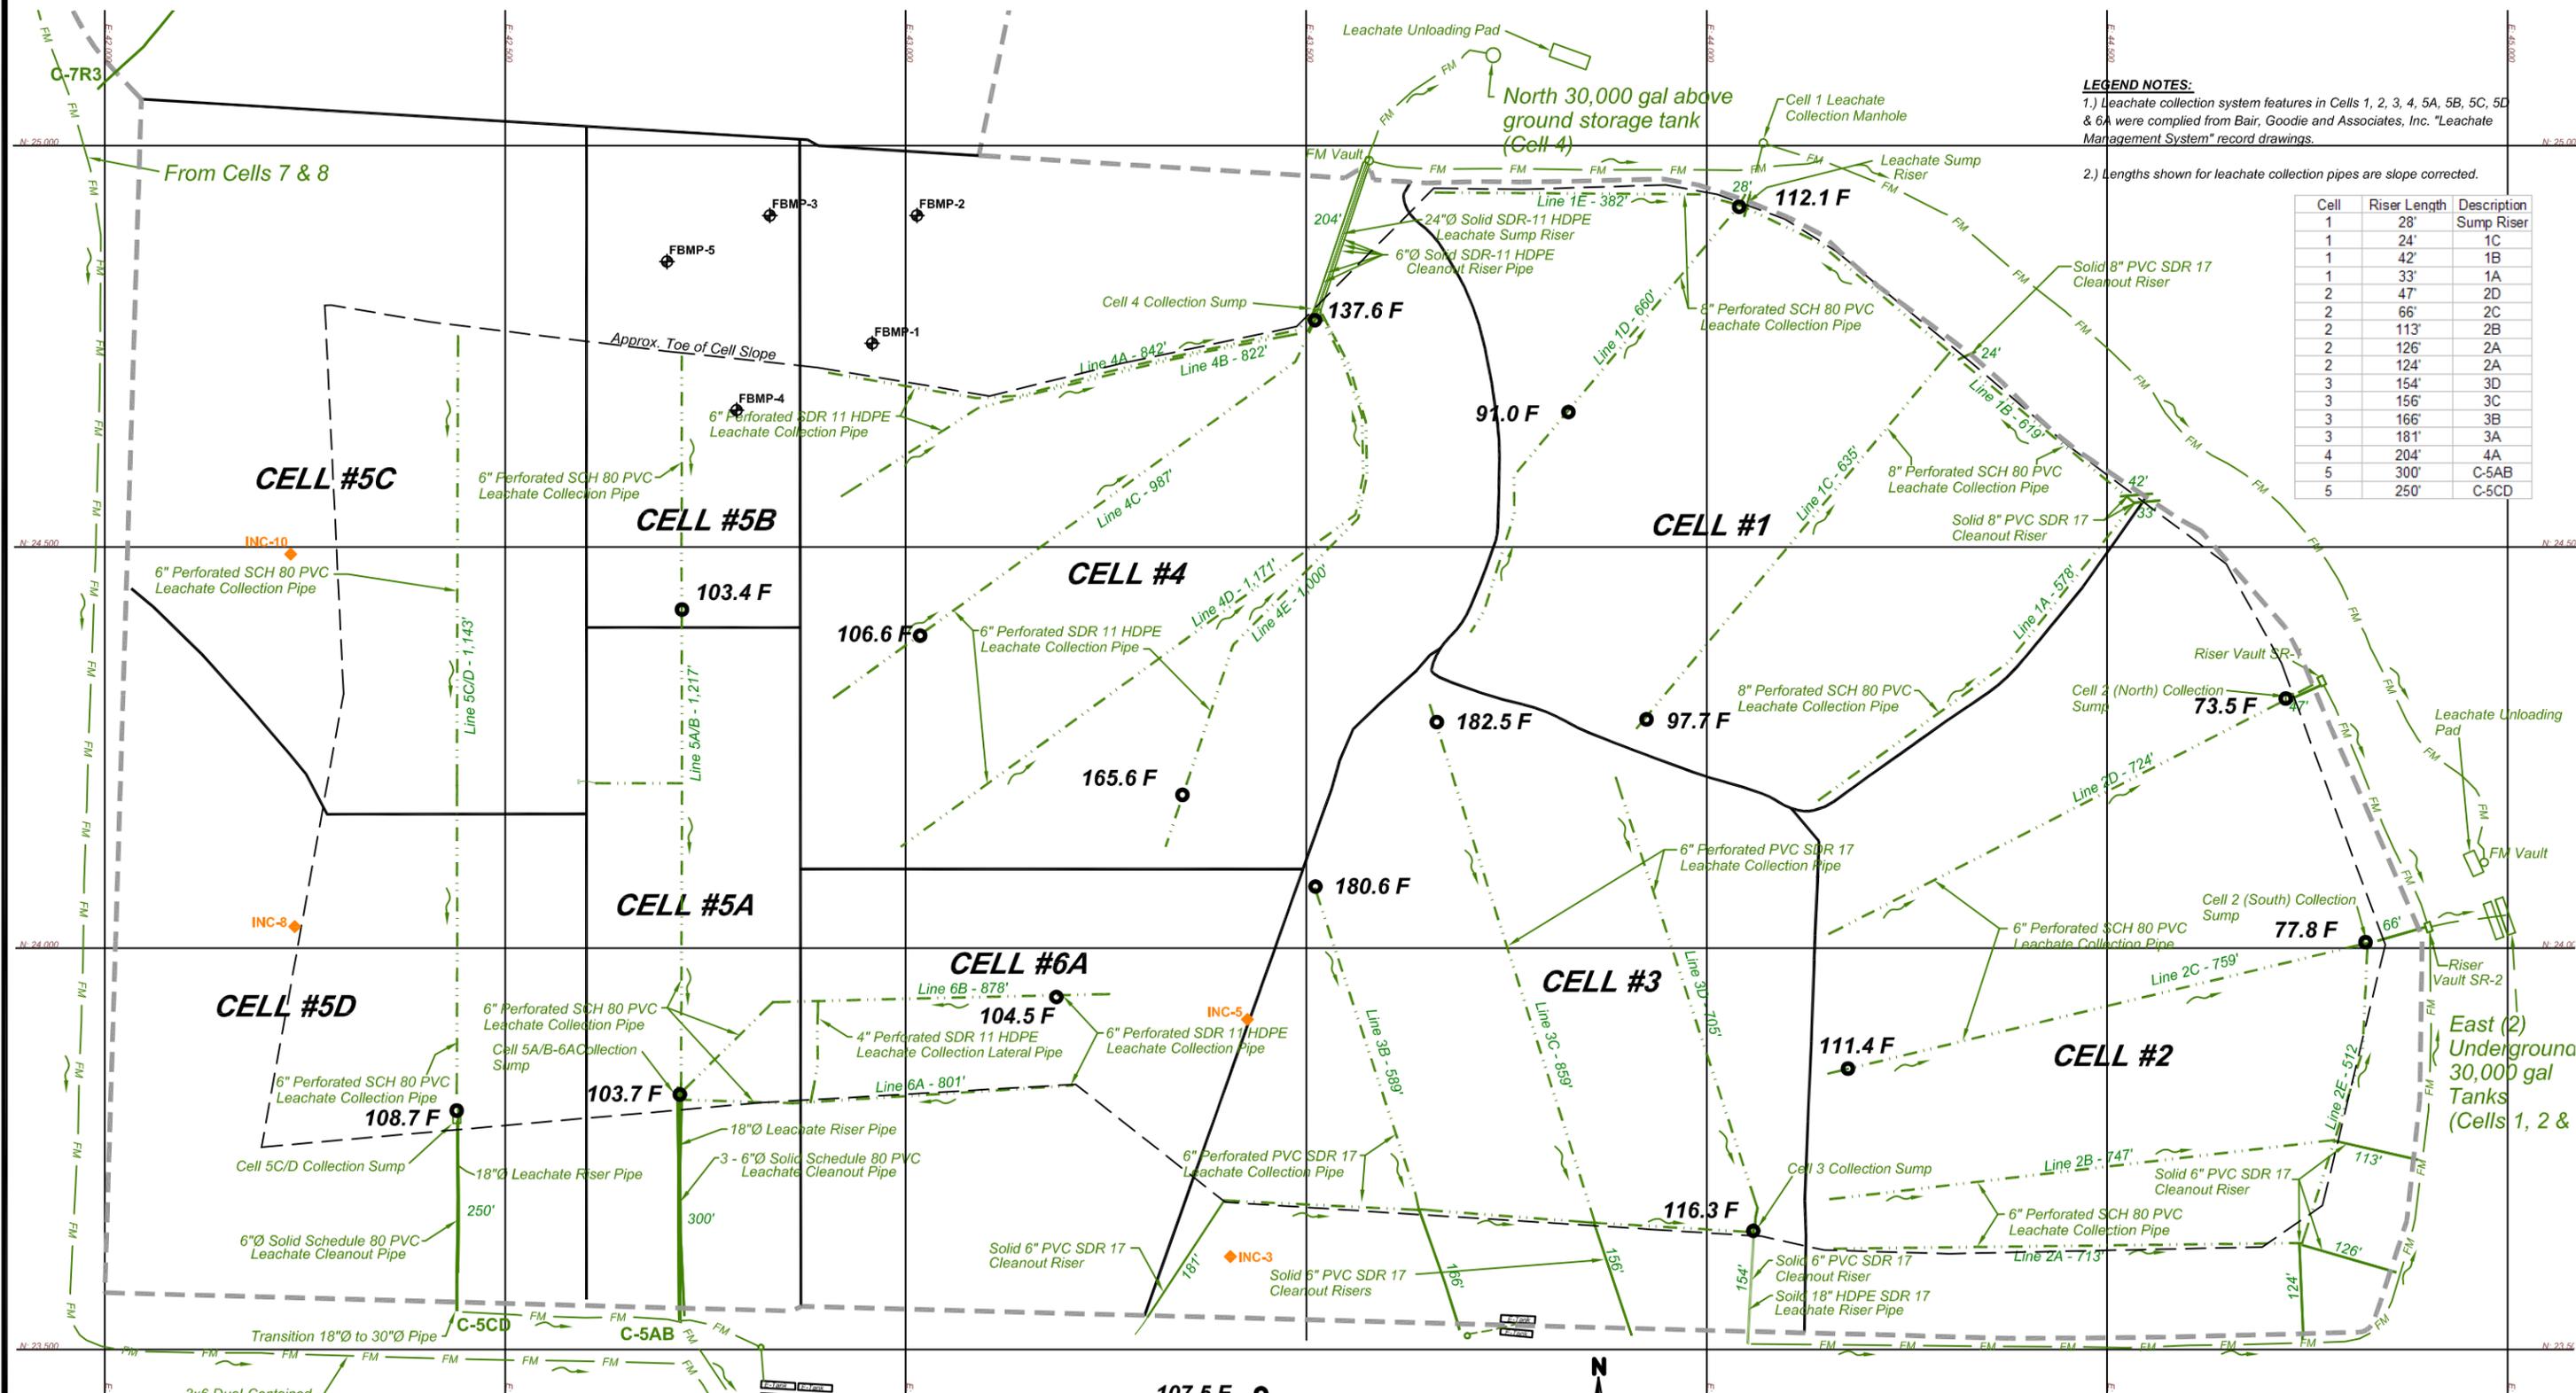
**FIGURE C.1**  
REPUBLIC SERVICES OF OHIO II, LLC  
COUNTYWIDE RECYCLING & DISPOSAL FACILITY  
STARK COUNTY, EAST SPARTA, OHIO  
**LEACHATE COLLECTION SYSTEM INVESTIGATION**  
NOV. 1, 2007 THERMOCOUPLE UPDATES

Temperatures from thermocouples installed in leachate collection sumps and leachate collection pipes have been observed approximately weekly since April. Figure C.1 in Appendix C shows the locations of the thermocouples. Results of the thermocouple temperature measurements are shown graphically in Figures C.2 and C.3.

shown in Figure C.1 in Appendix C. Temperature data from the inclinometers and FBMPs is summarized in Table C.1 in Appendix C. Figures showing monthly temperature measurements observed in the gas wells are presented in Appendix C.

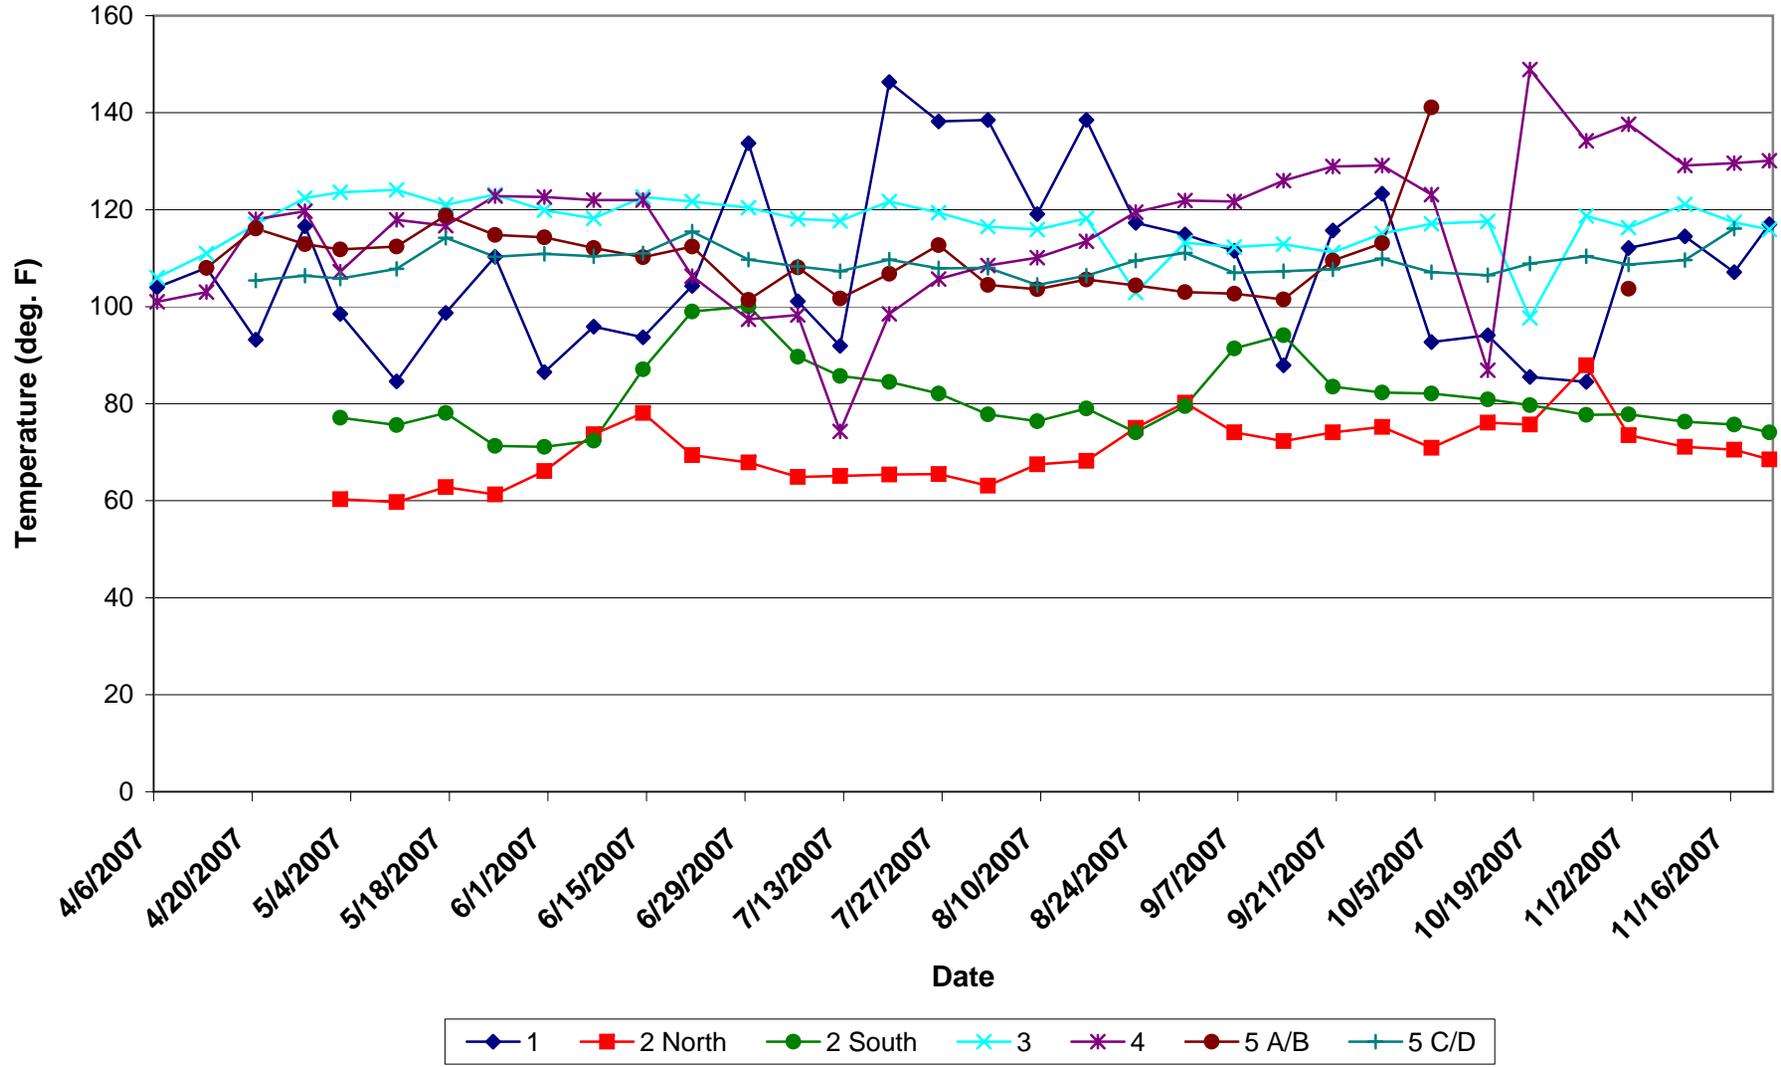
Figure C.2 - Weekly Leachate Temperatures in Cell Sump  
Countywide RDF - East Sparta, OH

Review of the thermocouple data located in the leachate collection sumps shows temperatures of sumps that are somewhat elevated above levels of those in similarly constructed cells. This can be seen in Figure C.2. The temperatures within the leachate collection pipes show elevated temperatures in the leachate collection pipes 3B type K, 3B type T, 3C, and 4E. These lines are located within the reaction zone and show temperatures significantly above those lines located outside of the reaction. The observed average temperatures within these lines remains around or less than 180°F, well below the melting point of HDPE. These temperatures do not appear to be increasing with time. At this time there is still significant leachate production from these portions of the landfill and all lines have been jetted and cleaned. Therefore the pipes remain open and continuing to function properly.

at temperatures above 482°F. Pyrolysis is the break down of any substance into its basic components in an anaerobic environment. With tire chips this process will produce three byproducts; carbon char, a liquid (pyrolytic oil), and a gas. The average melting point of the rubber in tire chips ranges from 257°F – 284°F. The temperatures that are observed in the cell 5A riser and leachate cleanout pipes within the cell show temperatures averaging around 110°F, approximately half the temperature at which the rubber within the tire chips will begin to melt. Temperature data can be seen on Figures C.2 and C.3 in Appendix C.
