Big Creek

Nonpoint Source Implementation Strategy

May 27, 2017

Tetra Tech, Inc.

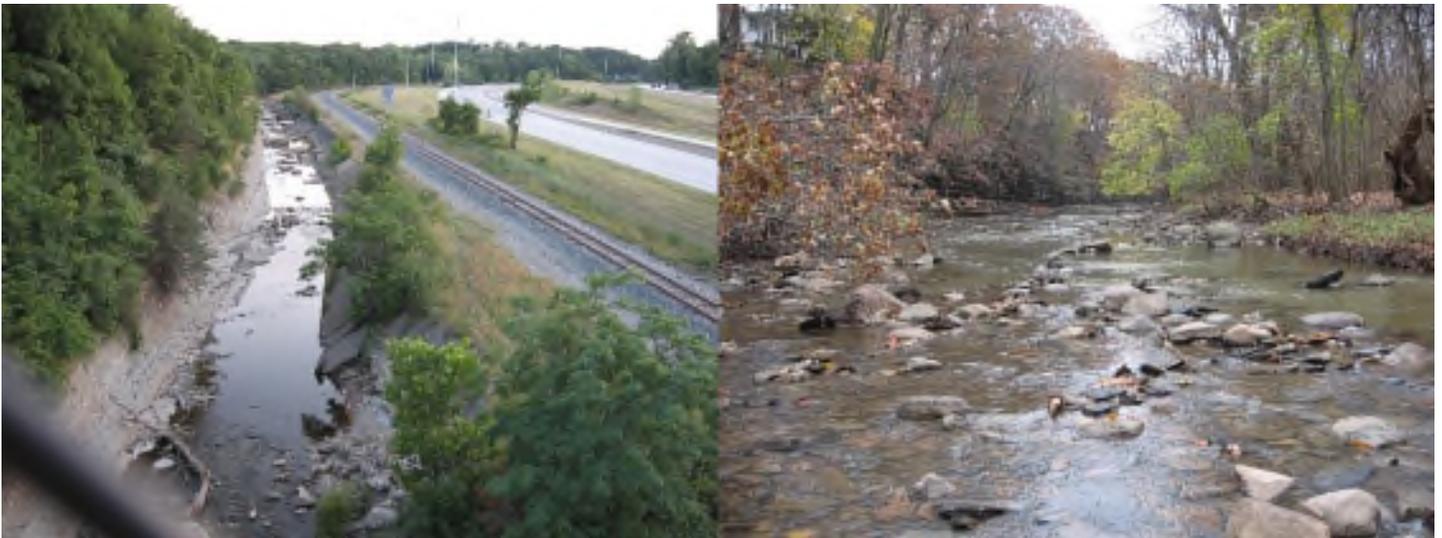
Figure 9. Big Creek along I-71 (left) with poor fish habitat and East Branch (right) with good habitat.

As measured by the QHEI, fish habitat has been assessed at several locations along Big Creek and its tributaries. Fish habitat is generally *good* in Big Creek and its tributaries (Figure 9), as measured by the QHEI. However, a few locations have *excellent* or *fair* habitat. QHEI scores from the past decade are summarized in Table 9 in Section 2.4

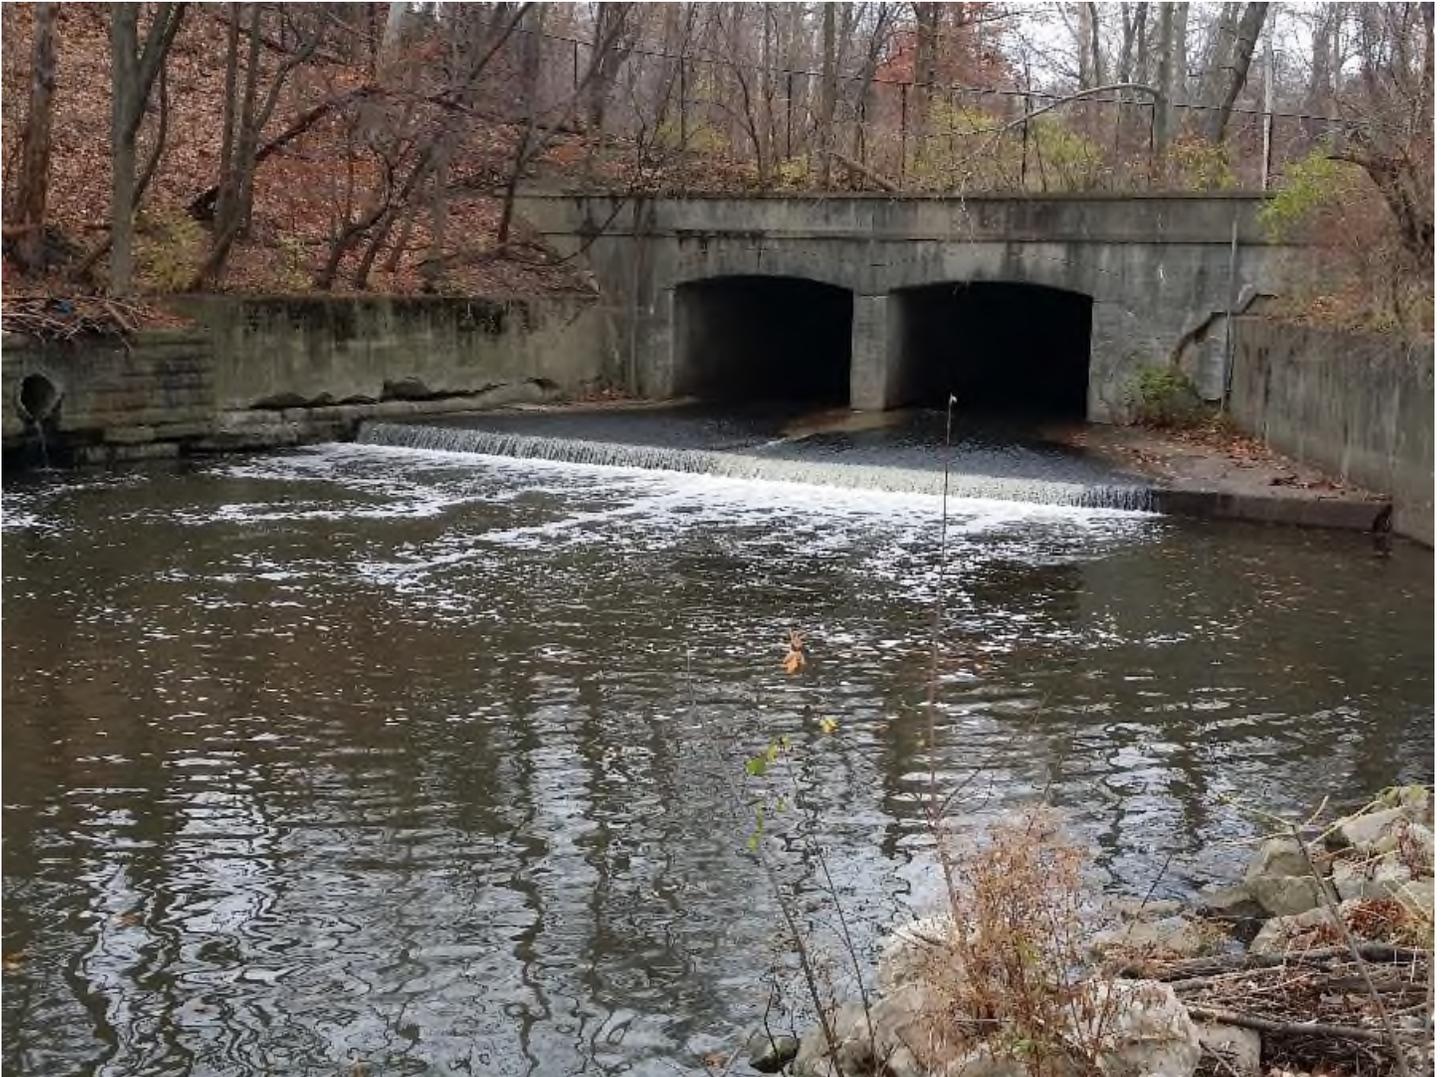
Figure 11. Double barrel culvert of Big Creek at the Cleveland Metroparks Zoo.

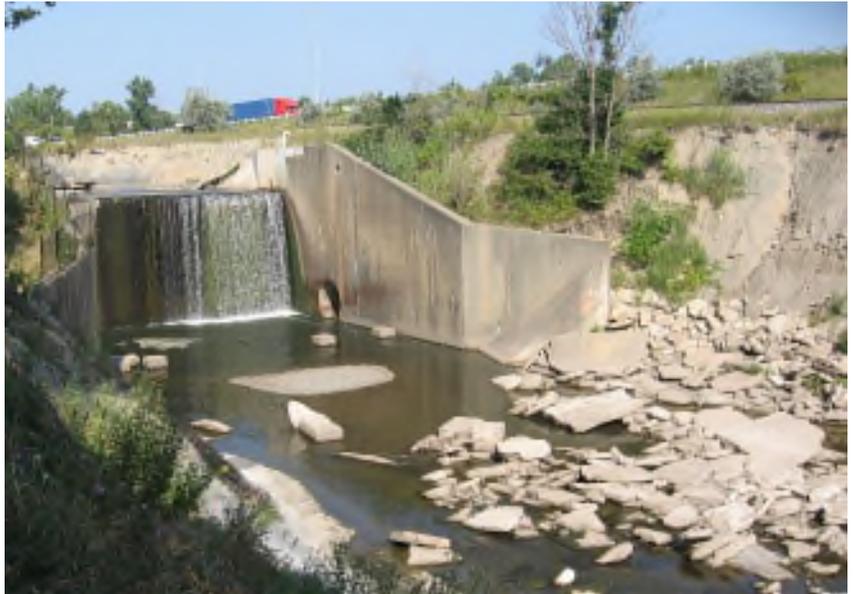
Figure 14. Big Creek drop structure along I-71.

- Objective 2** Restore 5,800 lineal feet of bank habitat along lower Big Creek
 - Along I-71, Big Creek is a concrete channel. However, many concrete panels have begun to fail, exposing underlying shale.

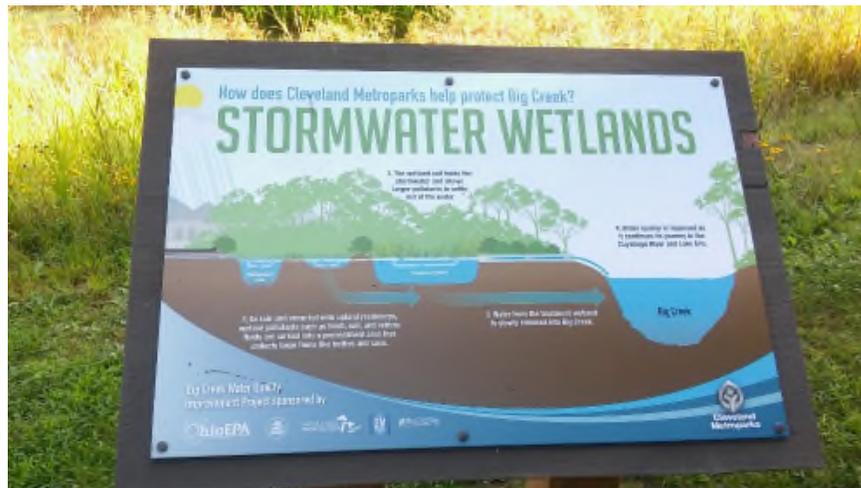
Figure 25. Completed stormwater project in the Big Creek Reservation.

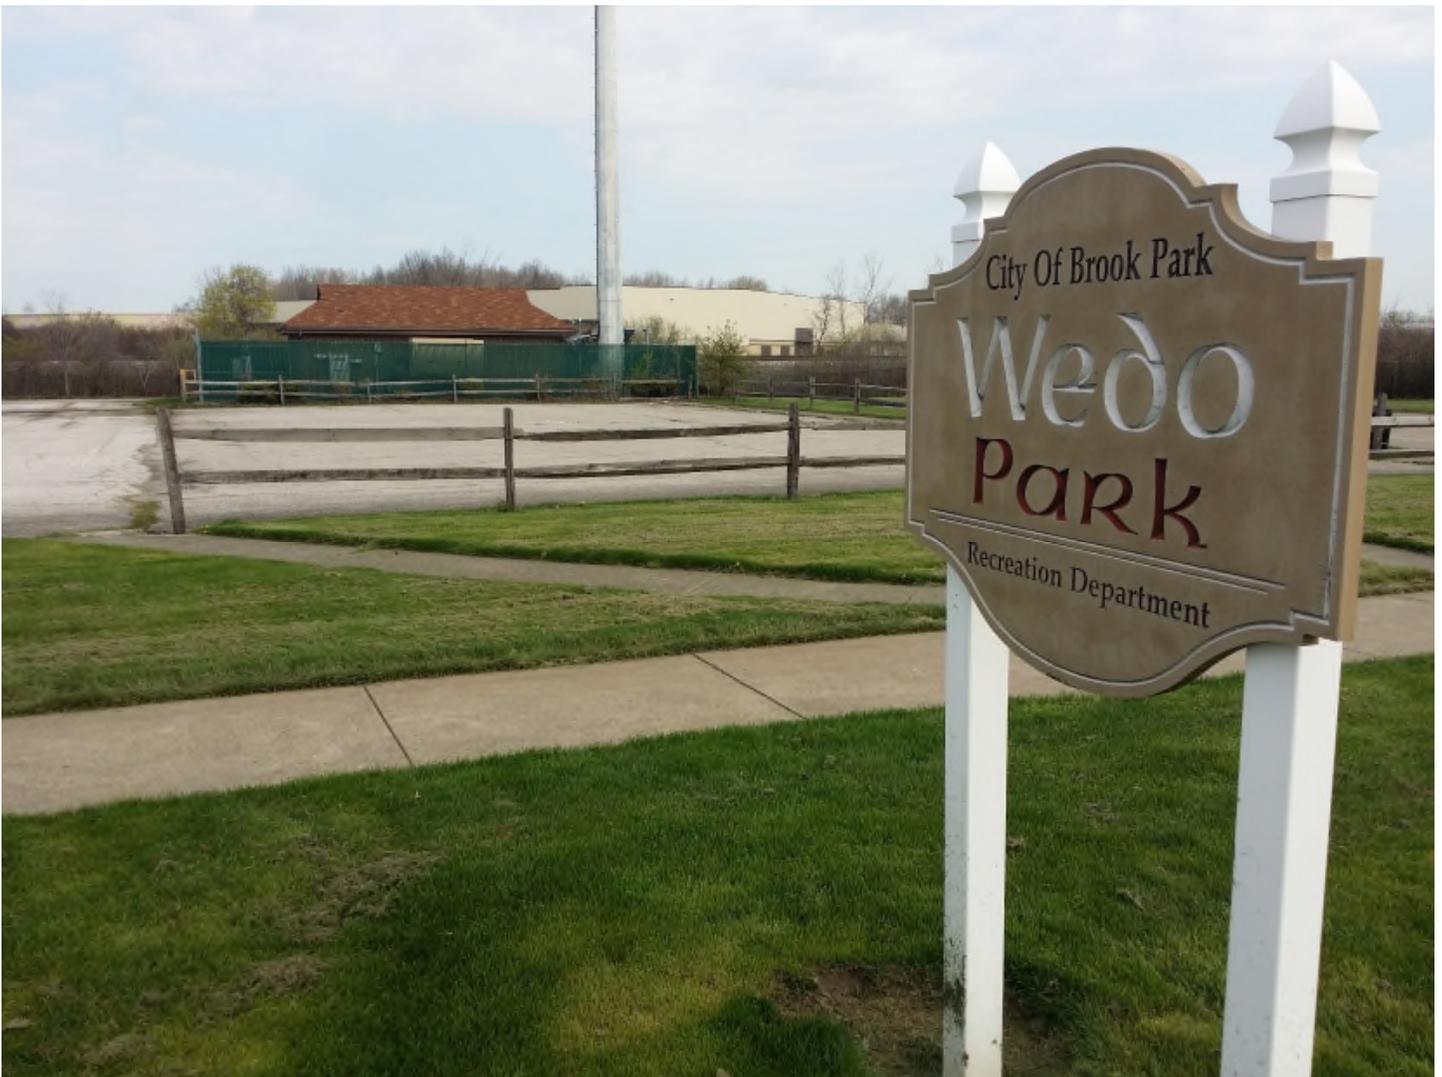
Figure 28. Project #6 in Table 23 propose to install a detention basin in Wedo Park.
