Loading Analysis Plan and Supporting Data Acquisition Needed for the Big Darby Creek Basin

Total Maximum Daily Load Development

Ohio EPA Technical Report AMS/2014-DARBY-3

Division of Surface Water
Assessment and Modeling Section
February 2021

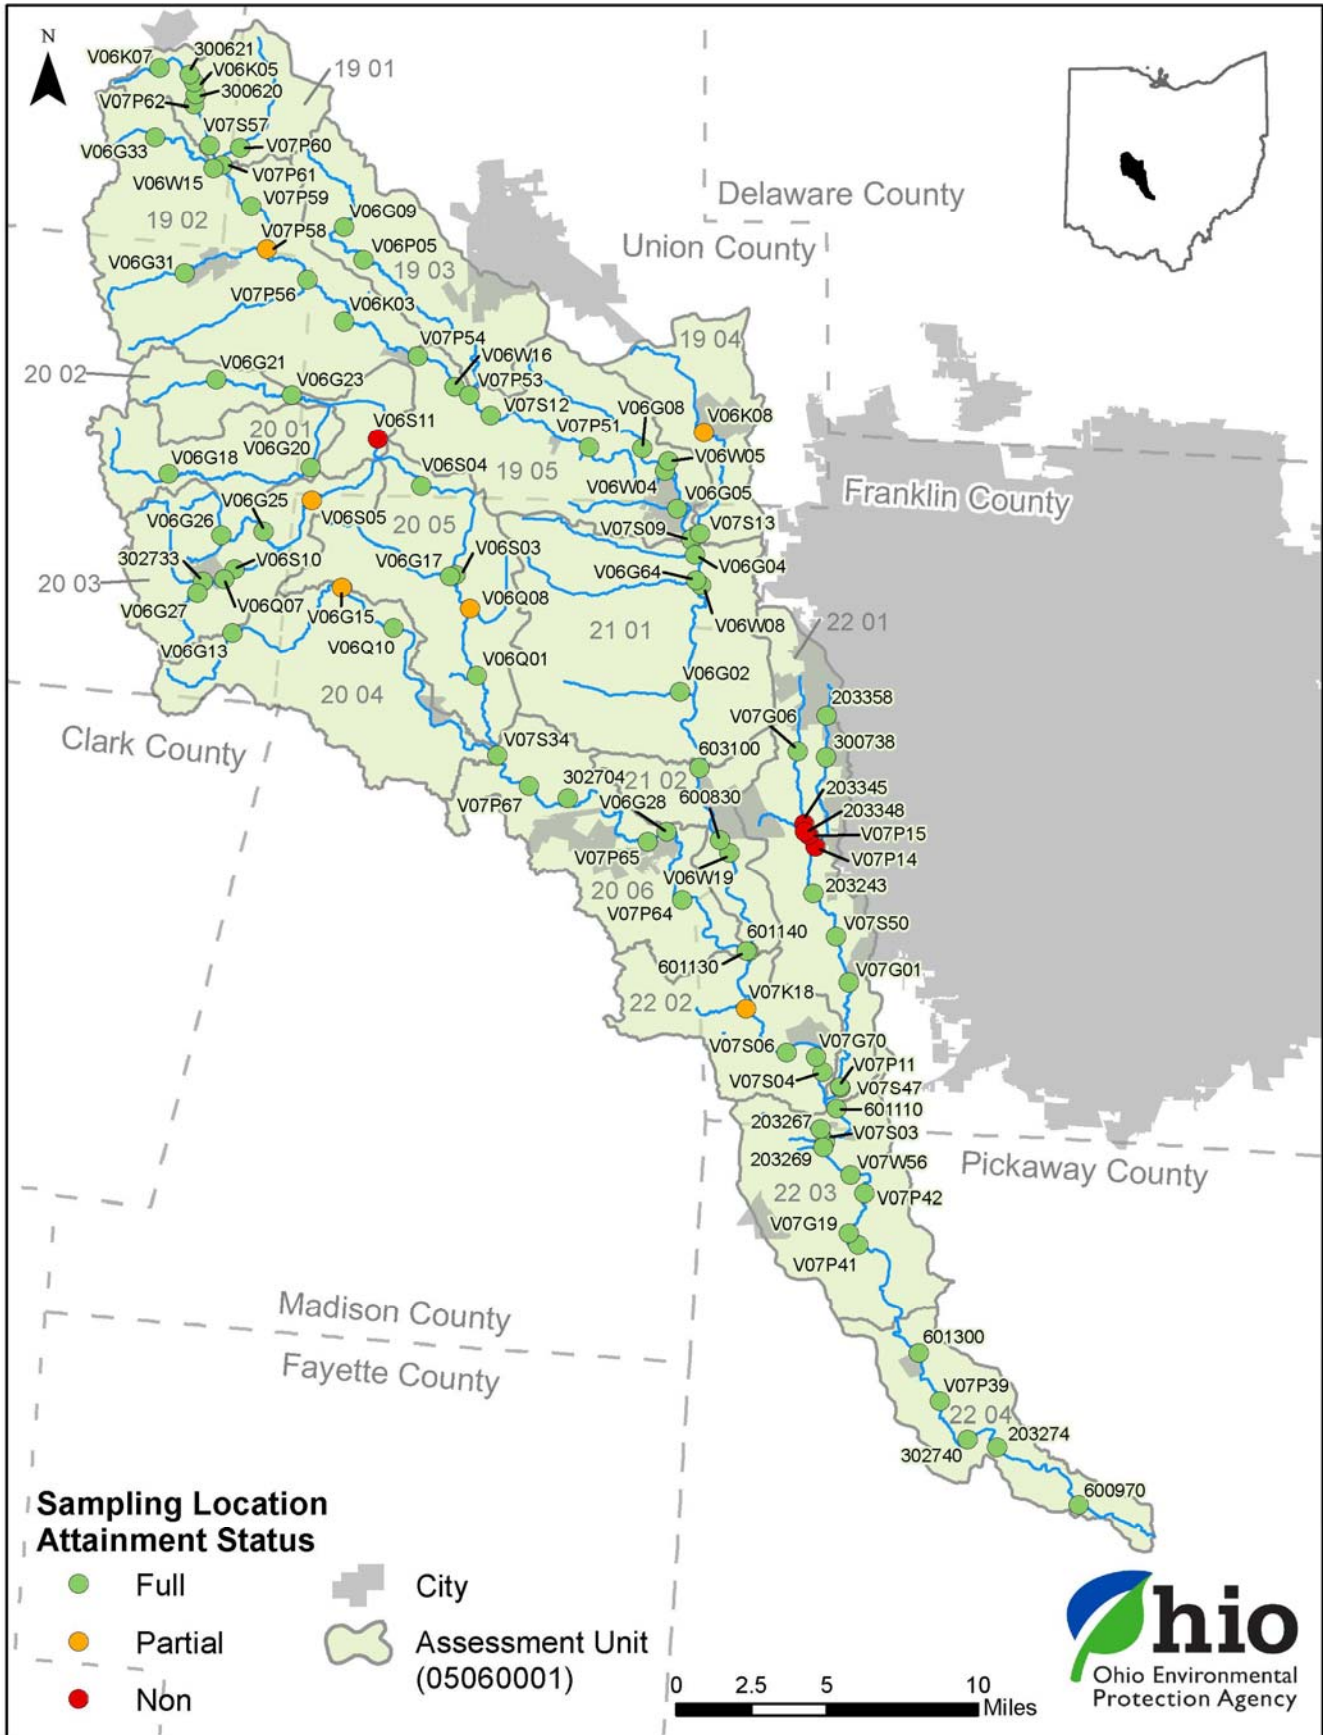
Figure 1 — Map summarizing ALU attainment status in the Big Darby Creek watershed in 2014.

Attainment of Ohio EPA's biocriteria are based on fish and macroinvertebrate scores, as measured by the Index of Biotic Integrity (IBI), Modified Index of well-being (MIwb) and Invertebrate Community Index (ICI). Numeric goals for those indices are codified in rule (Ohio Administrative Code (OAC) 3745-1-07, Table 7-1) for exceptional warm water habitat (EWH), warm water habitat (WWH) and modified warmwater habitat (MWH). Coldwater habitat (CWH) does not have associated biocriteria. The numeric criteria that apply to the Big Darby Creek watershed is shown in Table 1. The attainment status for each site is shown in Figure 1 and the scores for impaired sites are shown in Table 2.

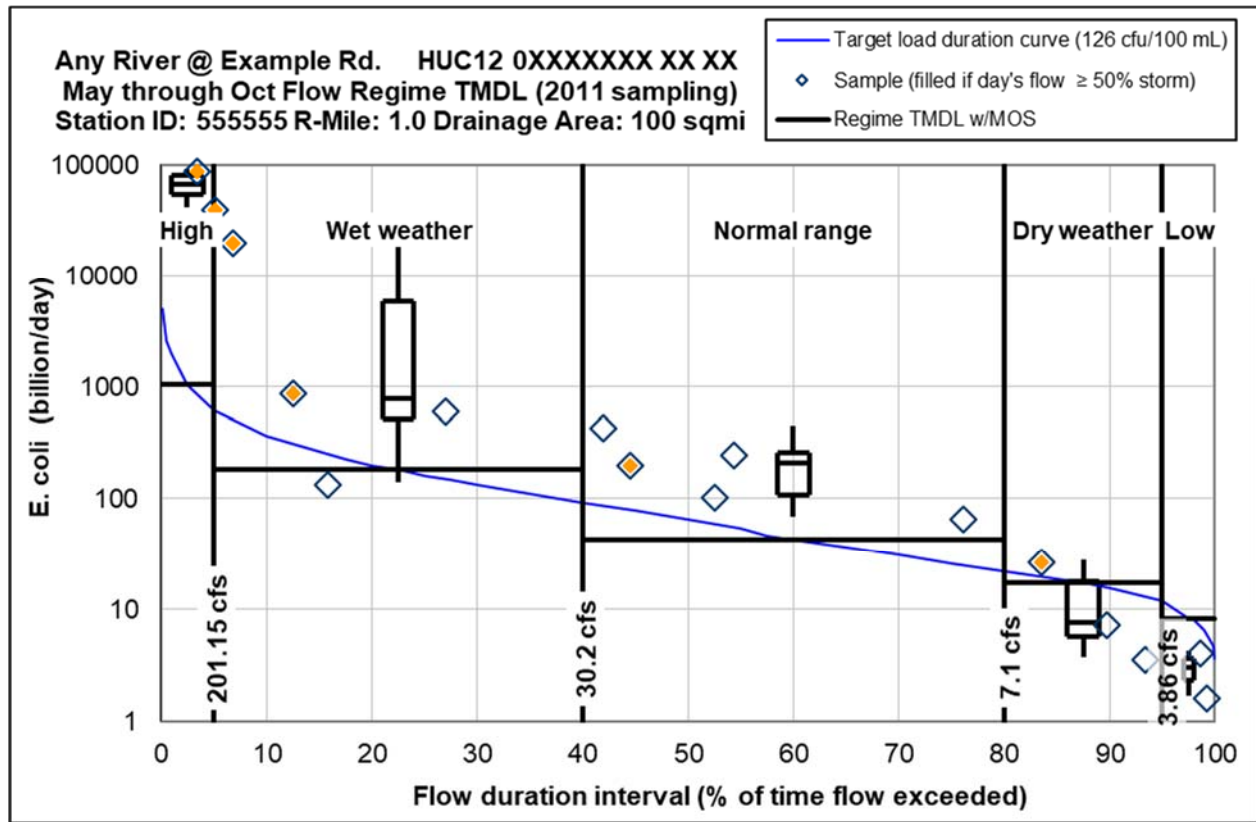
Figure 3 – Example load duration curve.

Due to these mechanisms of delivery, the sources of pathogens in surface waters can be determined to a certain extent via the level of stream flow observed. Therefore, Ohio EPA proposes using the load duration curve (LDC) framework for recreation use TMDLs. LDCs are an empirical method of determining TMDL pollutant loading and needed reductions. The main advantage of the use of LDCs is in this method's ability to differentiate loads from various types of sources based on stream flow regime. While this is a fairly simple modeling method, relationships between bacteria source contributions and flow regimes are straight forward. In-stream processes and interactions between sources are simplified, mitigating the major weaknesses of the technique. Figure 3 shows an example LDC with corresponding TMDL calculations represented in Table 11. Ohio EPA will handle recreation use impairment via LDC TMDLs.

Table 11 – Example TMDL table calculations (from above load duration curve).
