PRELIMINARY ASSESSMENT NARRATIVE

Manville Forest Products Corporation
10600 Evendale Drive
Sharonville, OH 45241
USEPA #OHD037493707

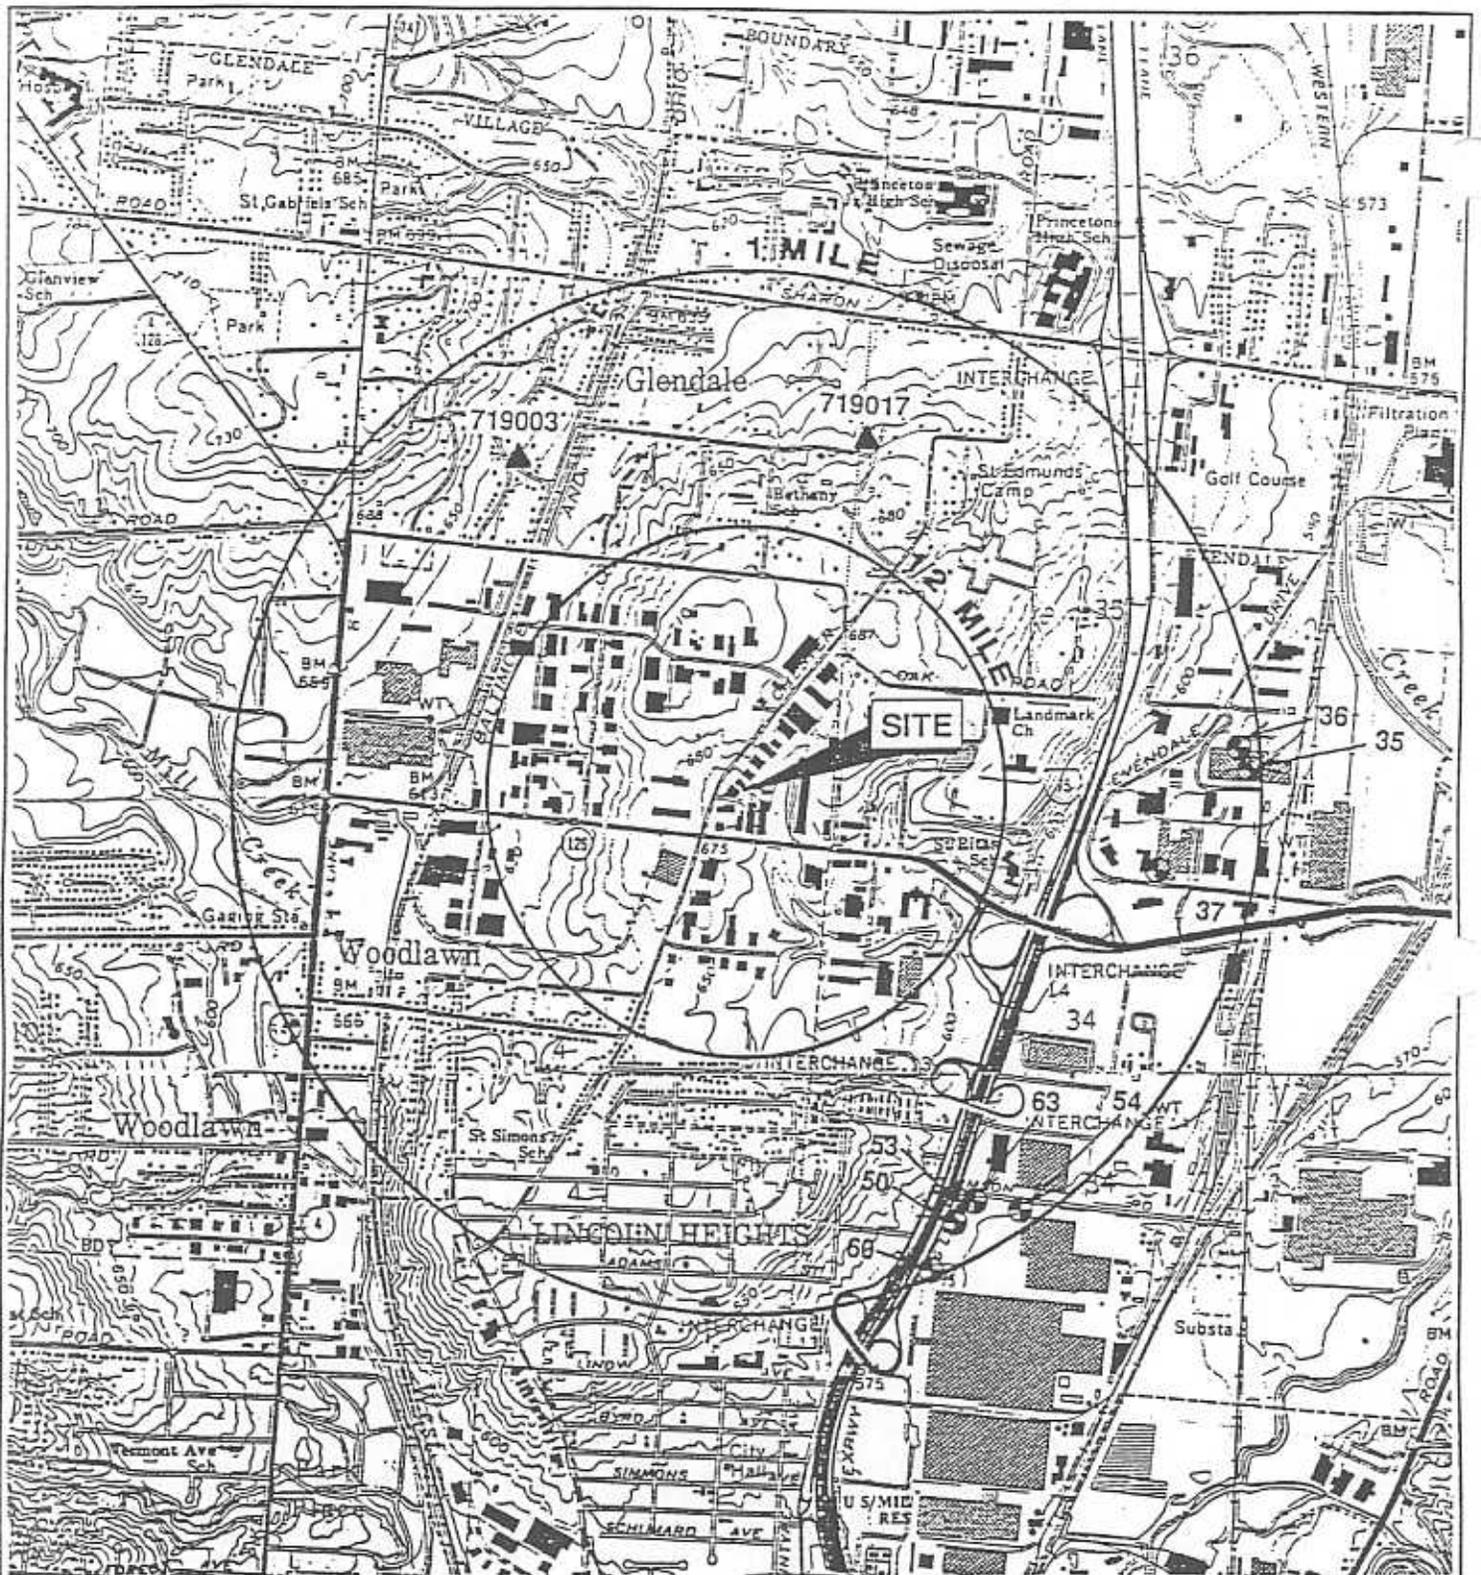
FIGURE
 4

WATER WELLS WITHIN 1 MILE RADIUS*
 HUNTING SPECIALTY PRODUCTS, INC.
 PFI-CINCINNATI, OHIO
