**RE: RESPONSE TO JANUARY 14, 2008 NOV LETTER  
COUNTYWIDE RECYCLING AND DISPOSAL FACILITY**

# EXHIBIT D

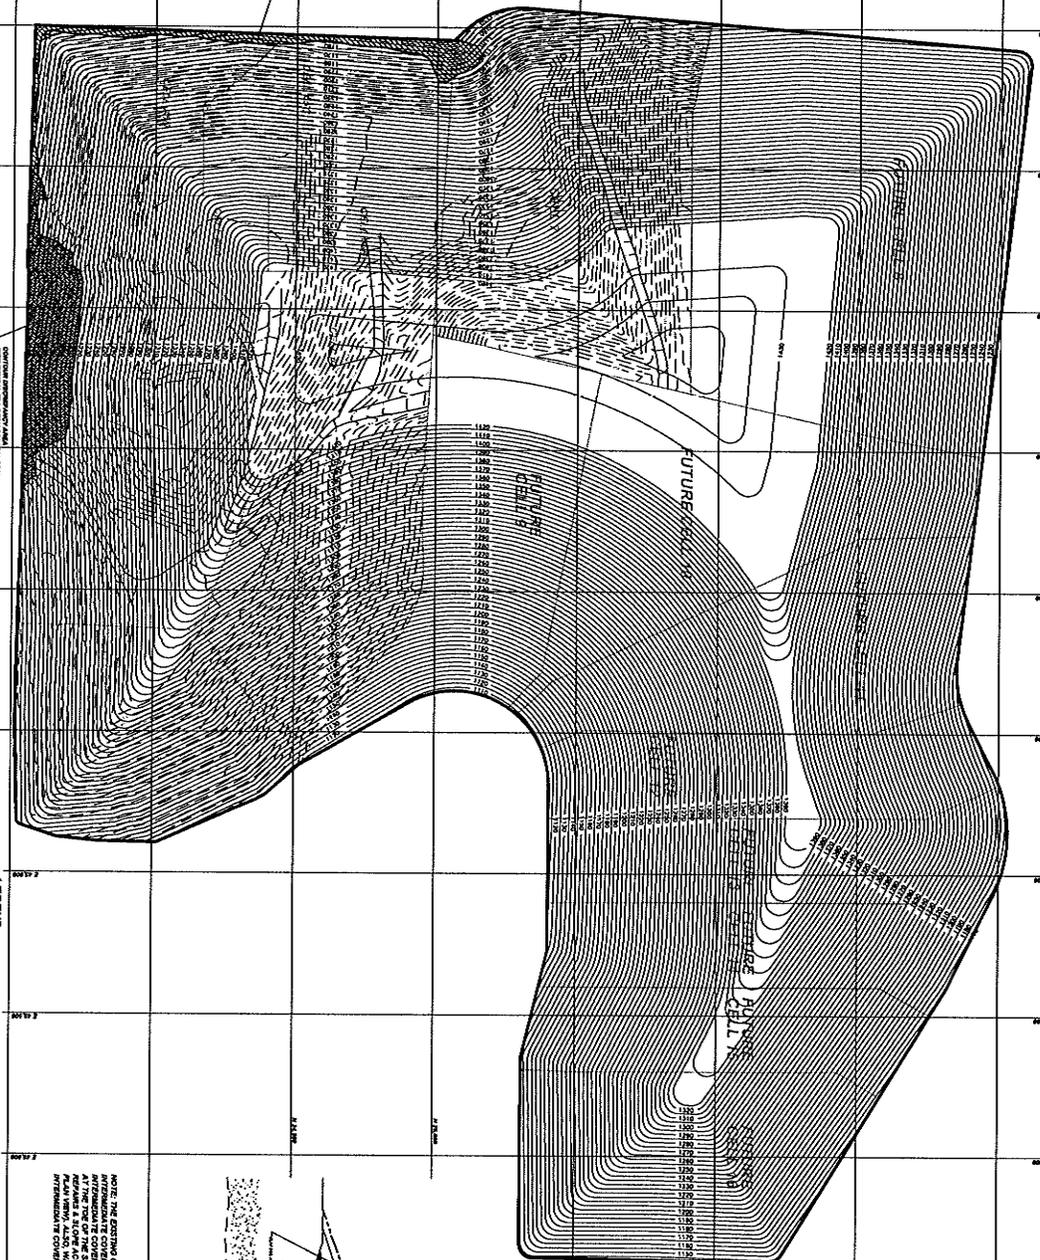
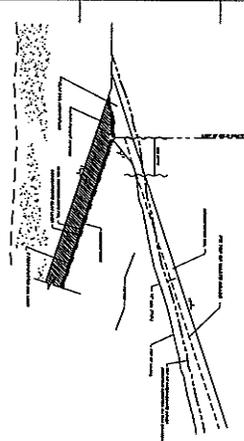
NOTE: THE EXISTING GROUND CONTAINS WITHIN SOLID WASTE PLACEMENT AREA AND ADJUSTMENT TO COVER INDICATED IS ONE FOOT THICK DIRT TO BE PLACED AT THE TOP OF THE SLOPE. ADJUSTMENT TO BE PLACED FOR SECTION A-A AND PLAN VIEW. ALSO, WASTE COILS ARE VERIFIED IN THE FIELD FROM DUAL COVER & ADJUSTMENT TO COVER SOIL PLACEMENT.
