Down-Hole Cameras and Video Inspection Services

Capabilities of the Site Investigation Field Unit (SIFU)

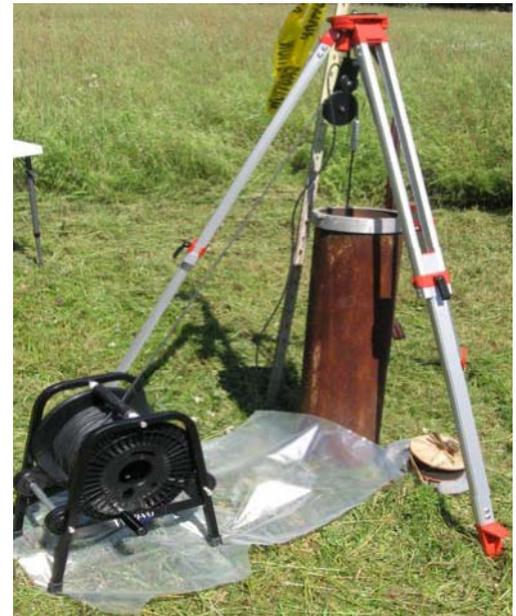
Well camera and tripod assembly.

Ohio EPA's Site Investigation Field Unit (SIFU) provides down-hole video inspection services of wells and open boreholes using a Well-Vu™ Down-hole Camera to support environmental site investigations. The cylindrical, waterproof camera is connected to a spool of coaxial cable and produces real-time recordable video as it is lowered into a well or borehole.

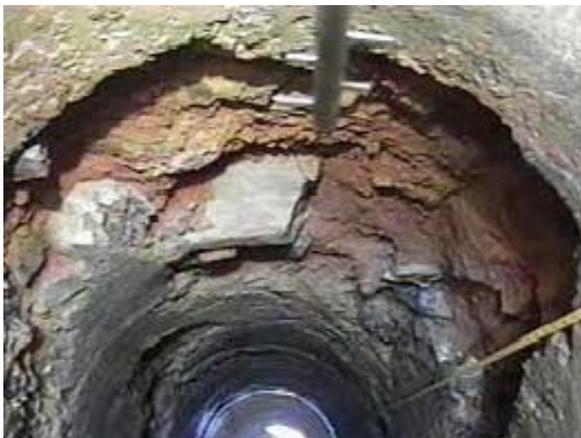
View of an open borehole using the down-hole well camera.
