State of Ohio Environmental Protection Agency

RE: Countywide RDF, Stark County; Notice of Violation (NOV)

On May 20, 2008, Ohio EPA and an Ohio EPA expert consultant observed violations of Ohio's regulations at Countywide RDF, located at 3619 Gracemont Street S.W., East Sparta in Stark County. Ed Gortner of Ohio EPA's Central Office and Dr. Timothy D. Stark of Stark Consultants, Inc. conducted a field walk over of the west slope of the 88 acres, Cell 7, and the north side of Cells 1 and 4. Weather conditions were mild with temperatures in the mid-60s, partly sunny, slightly breezy from the NW, and no precipitation.

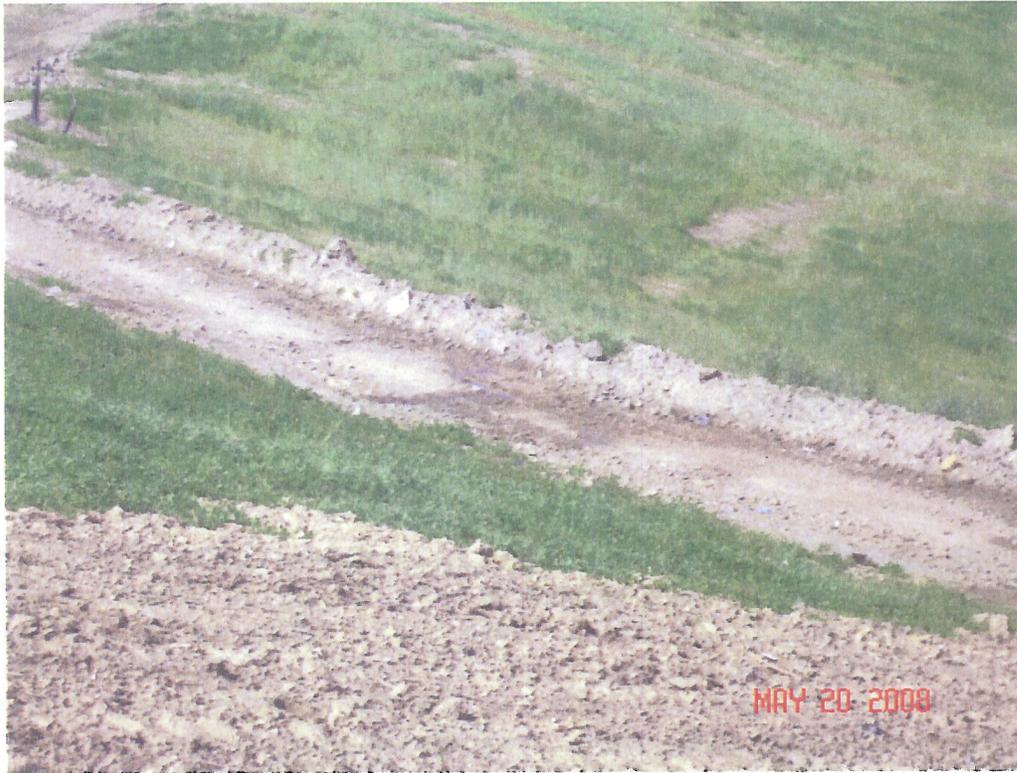
In the course of conducting the field walk over, Ohio EPA and Dr. Stark observed several small leachate outbreaks originating down slope of PW-314 in Cell 7 and flowing into small leachate pools on the ground surface along the bench down-slope of PW-314. Based upon the recent slope regrading activities in certain areas, it appears that the operator attempted to address the outbreaks. Unfortunately, based on these observations, the previous corrective efforts proved unsuccessful.

From top to bottom: (a) leachate flowing onto slope bench, (b) leachate outbreak pools along bench, (c) gas and leachate exiting slope in Cell 7.

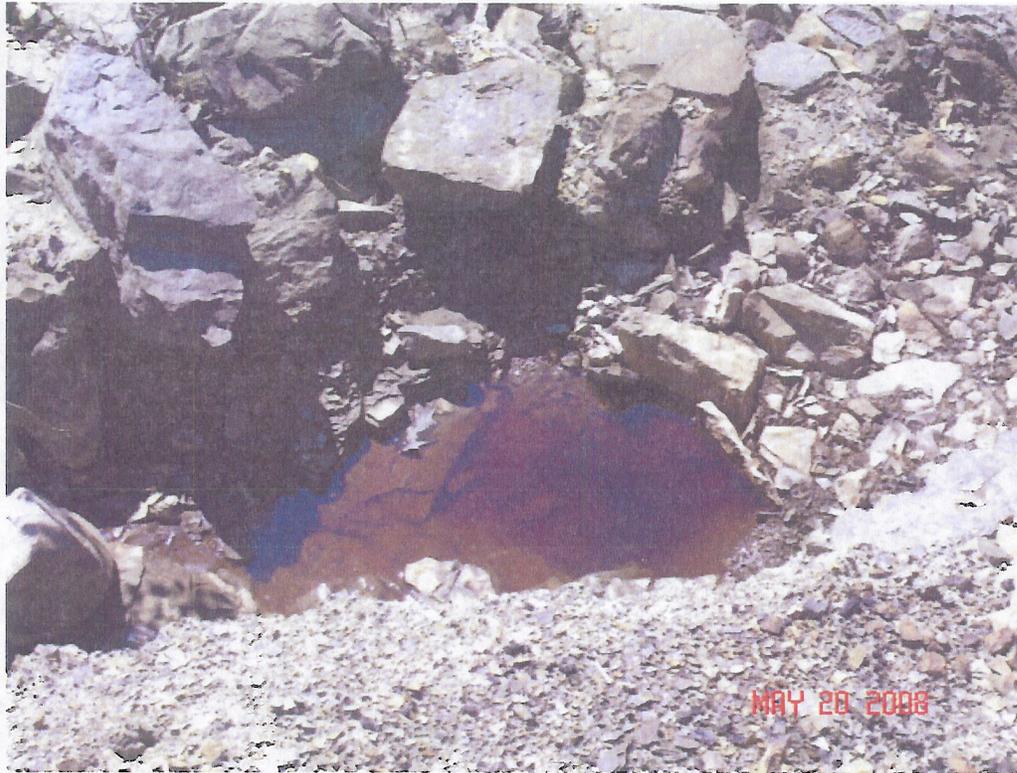
Ohio EPA and Dr. Stark also observed several pools of standing leachate within the rock let-down structure in the area where the leachate outbreak occurred in late April 2008 (see photos below). In addition, Ohio EPA and Dr. Stark observed leachate pooling in the stormwater drainage swale that leads to a stormwater sedimentation basin. Based upon these observations, it appeared this leachate was fresh which further indicated an ongoing release of leachate to the stormwater conveyance structure and drainage swale. These stormwater structures are not designed nor permitted to control, store, or transfer leachate. The operator's staff revealed that further remedial efforts in this area are being evaluated. Nevertheless, the operator's failure to properly manage the leachate constitutes a violation of OAC Rule 3745-27-19(K)(1)(a) which states,

From top to bottom: (a) leachate pool in upper portion of rock let down, (b) leachate pool in mid portion of rock let down, (c) leachate pool in lower portion of rock let down, (d) drainage swale with leachate.

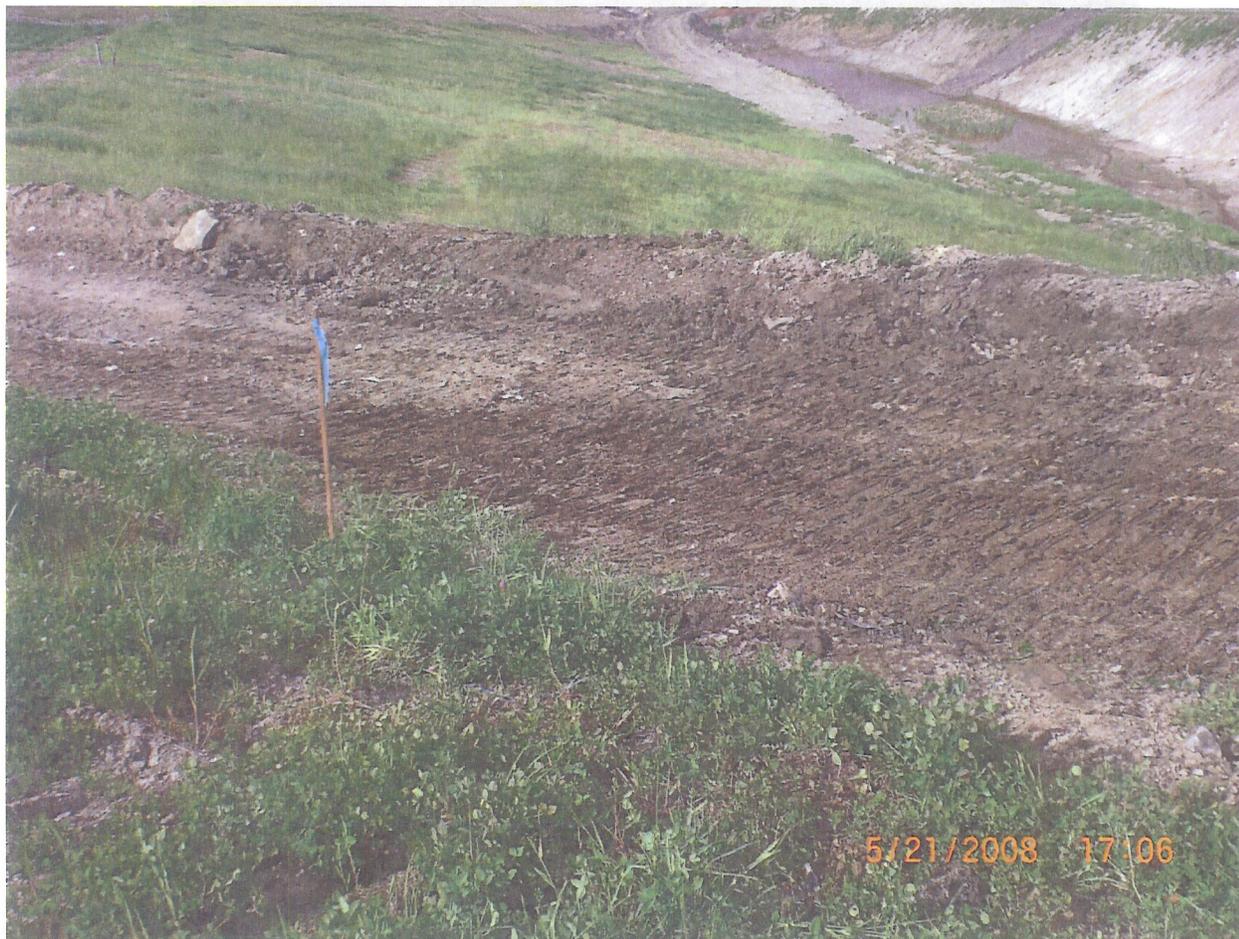
May 21, 2008 Photo of leachate repair in Cell 7

In the weeks since Ohio EPA and Dr. Stark observed the above leachate violations, Countywide has submitted the following photographs depicting their efforts to correct these violations. Ohio EPA will need to conduct field verification that these violations have been redressed.

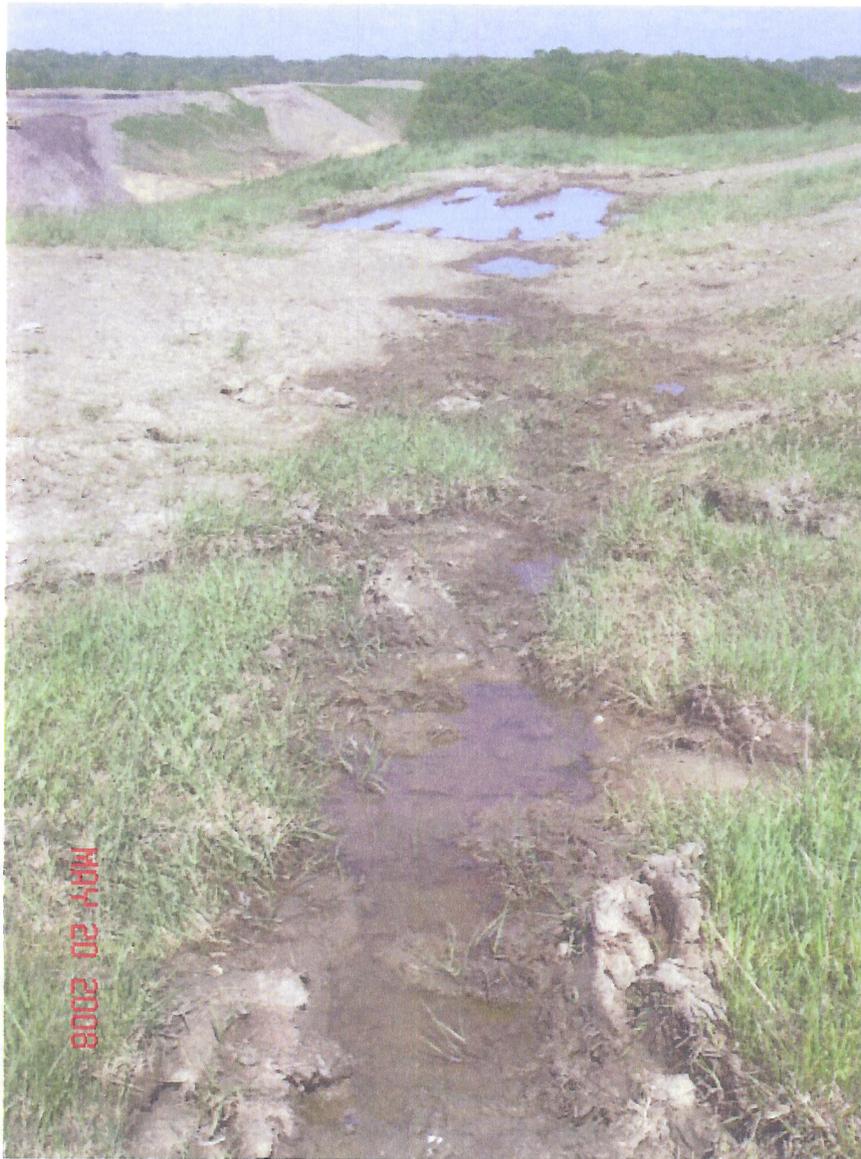
Ohio EPA and Dr. Stark observed ponding water North and East of the main haul road in Cells 4 and 1. The operator's failure to take actions to correct and establish positive drainage of stormwater constitutes a violation of OAC Rule 3745-27-19(J)(3) which states,

Photo of Ponding in Cell 1

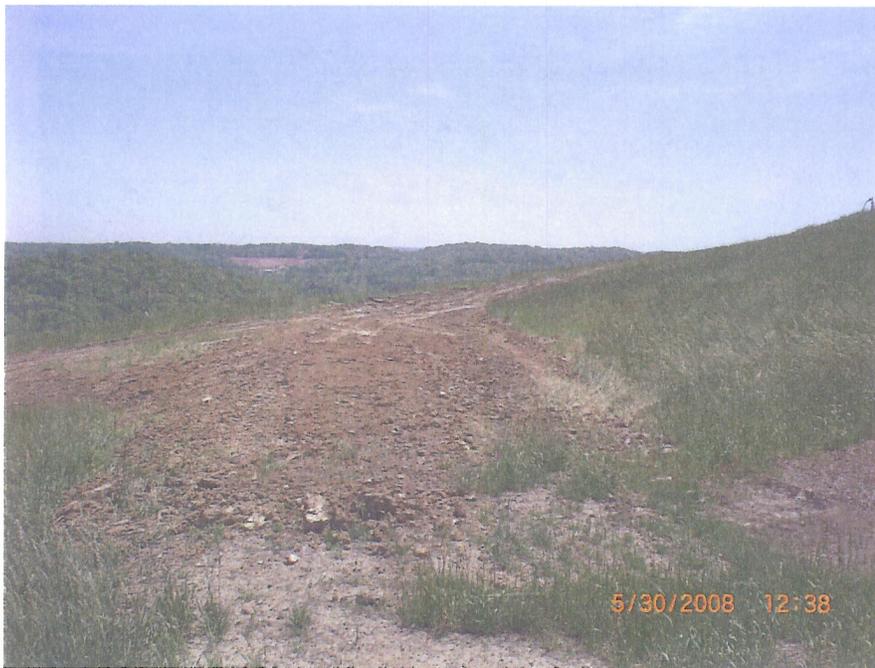
May 30, 2008 Photo of Cell 1

In the weeks since Ohio EPA and Dr. Stark observed this violation, Countywide has submitted the following photographs depicting their efforts to correct this violation. Ohio EPA will need to conduct field verification that this violation has been redressed.
