Down-Hole Cameras and Video Inspection Services

Capabilities of the Site Investigation Field Unit (SIFU)

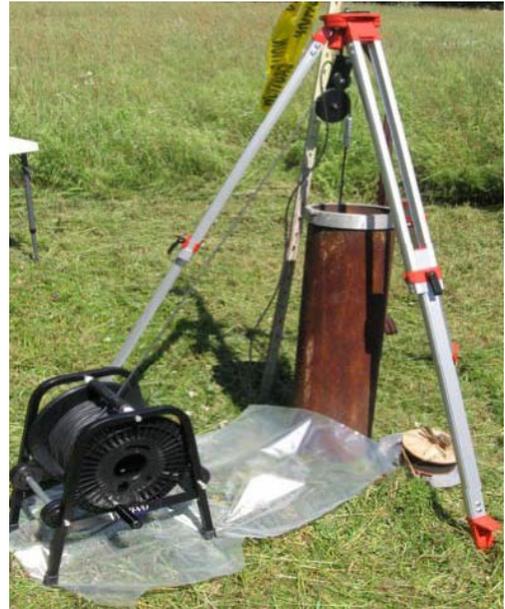
Well camera and tripod assembly

Ohio EPA's Site Investigation Field Unit (SIFU) provides down-hole video inspection services of wells and open boreholes using a Well-Vu™ Down-hole Camera to support environmental site investigations. The cylindrical, waterproof camera is connected to a spool of coaxial cable and produces real-time recordable video as it is lowered into a well or borehole.

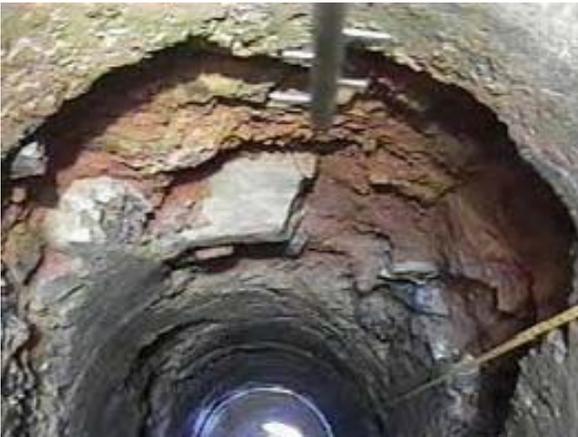
View of an open borehole using the down-hole well camera.

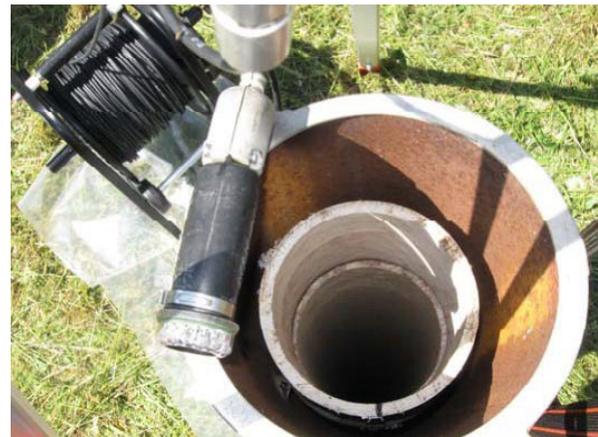
Preparing to use the down-hole camera to evaluate a well.
